SEISMIC BEHAVIOR AND RETROFIT OF OUTRIGGER KNEE JOINTS

NASIM KHALIL SHATTARAT

A dissertation submitted in partial fulfillment of the
requirements for the degree of

WASHINGTON STATE UNIVERSITY
Department of Civil and Environmental Engineering

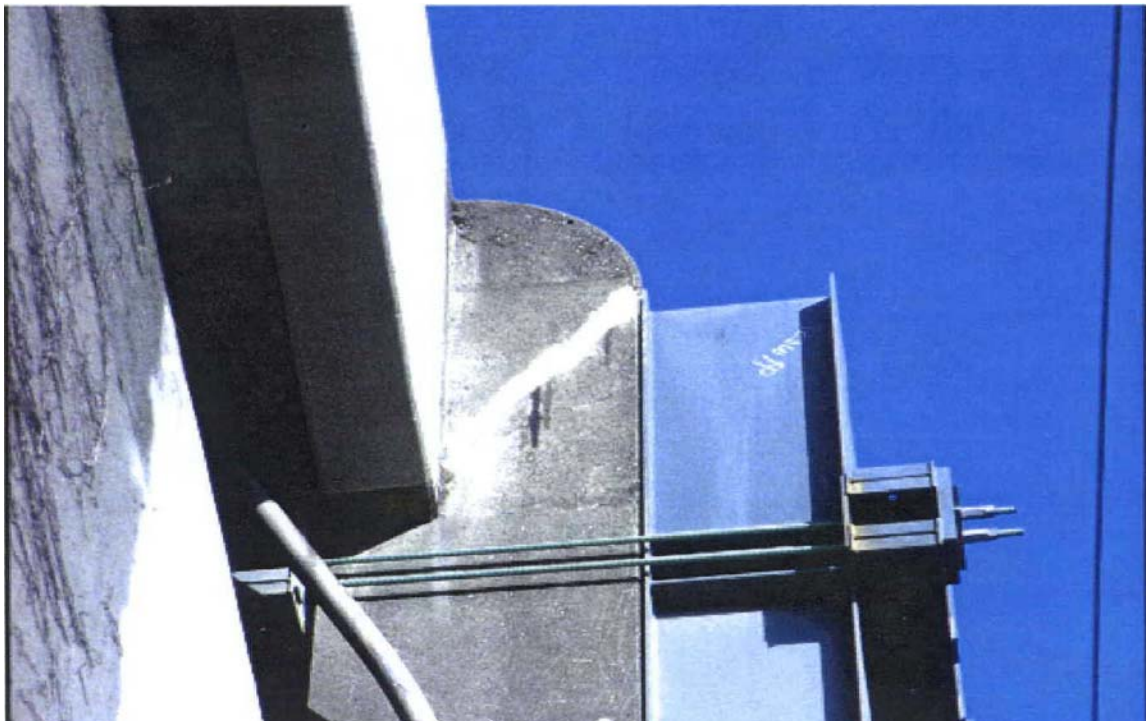
Figure 1.2 Damage to a Knee Joint in the Alaskan Way Viaduct

Following the February 28, 2001 Nisqually earthquake, there was notable structural damage to a curved bridge unit in the Alaskan Way Viaduct. Major concrete cracking in the knee joints of this unit was observed in the vicinity of welded reinforcing bar laps. Furthermore, there was concrete cracking in the transverse floor beams at one of the bents (T. Y. Lin International, 2001). Figure 1.2 shows damage to a knee joint in the Alaskan Way Viaduct.

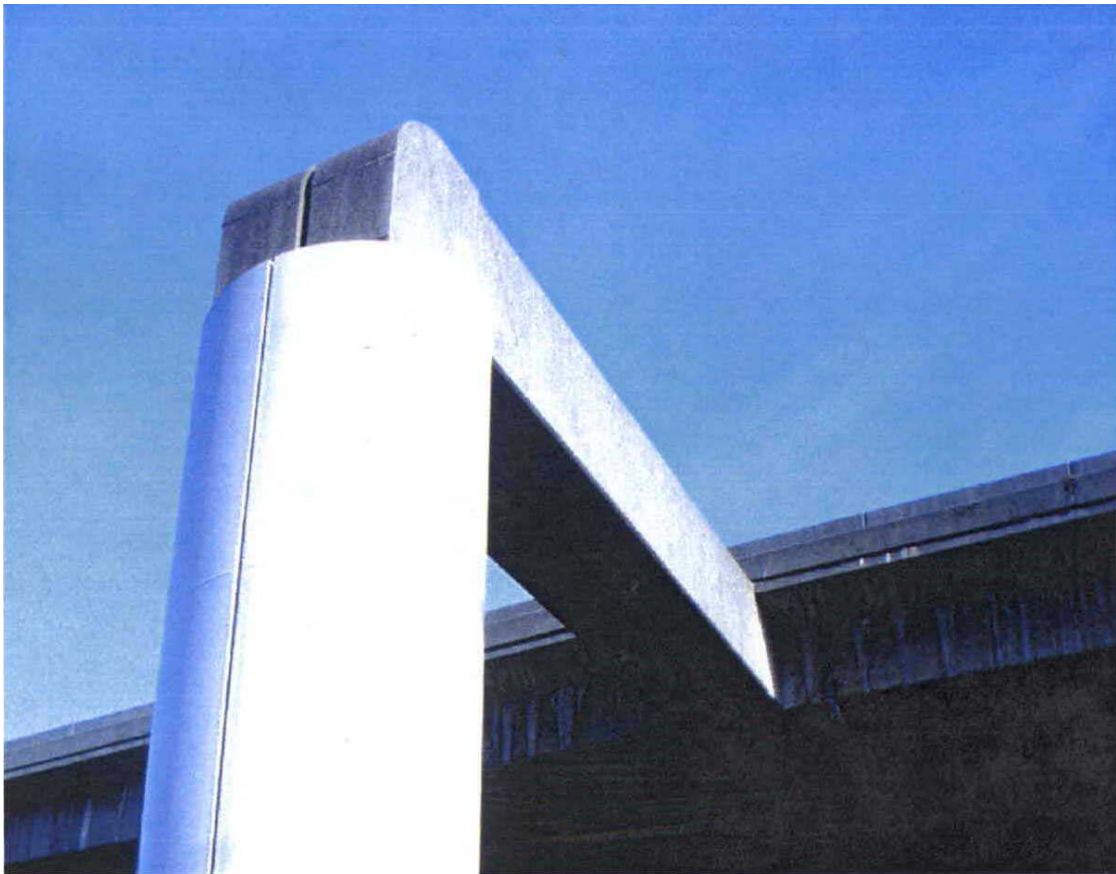
Figure 1.3 Retrofitted Split Columns in the SR 99 Spokane Street Overcrossing

Street Overcrossing replacement cost was estimated at \$46.7 million in 1996 (Zhang et al., 1996), while the replacement of the Alaskan Way Viaduct cost was estimated at \$879 million in 2001 (T. Y. Lin International, 2001). The necessary funds to replace these bridges are unlikely to become available in the immediate future. Consequently, it is imperative that the WSDOT maintain and strengthen the bridges to the extent that funds permit. WSDOT has implemented a first phase of retrofitting for the Spokane Street Overcrossing, including retrofitting the columns with steel jackets and installing joint restrainers. For the split columns, “D” shaped steel jackets were used in order to maintain the gap in the split columns, as shown in Figure 1.3.

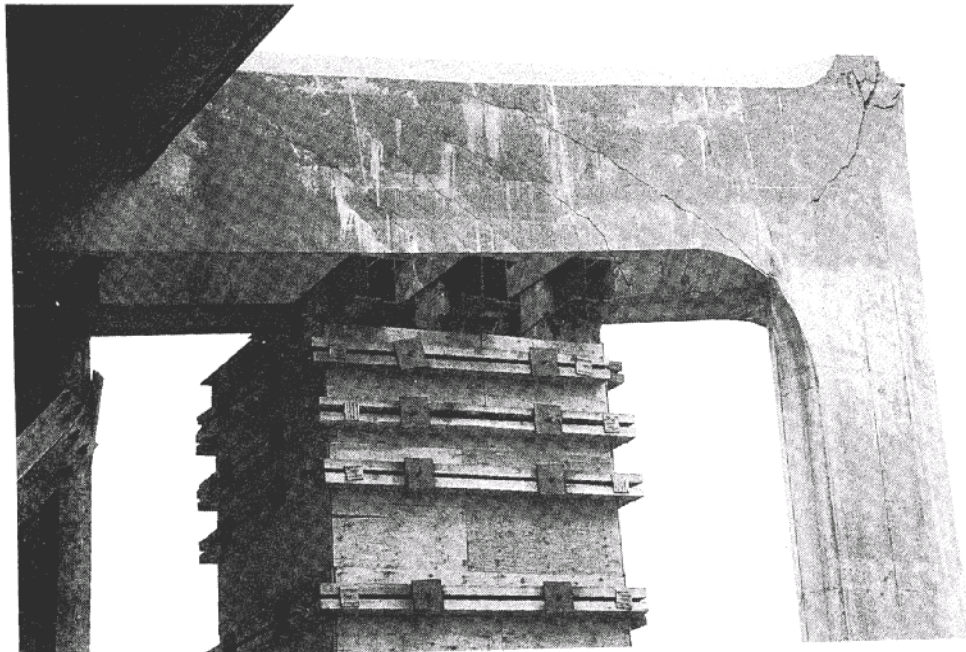
Figure 2.2 Damage to an Outrigger Bent in the I-280 China Basin Viaduct, 1989
Loma Prieta Earthquake (Adapted from Priestley et al., 1996)

vertical reinforcement (Priestley et al., 1996). Figures 2.2 through 2.4 show some examples of joint failures that occurred during the Loma Prieta Earthquake.

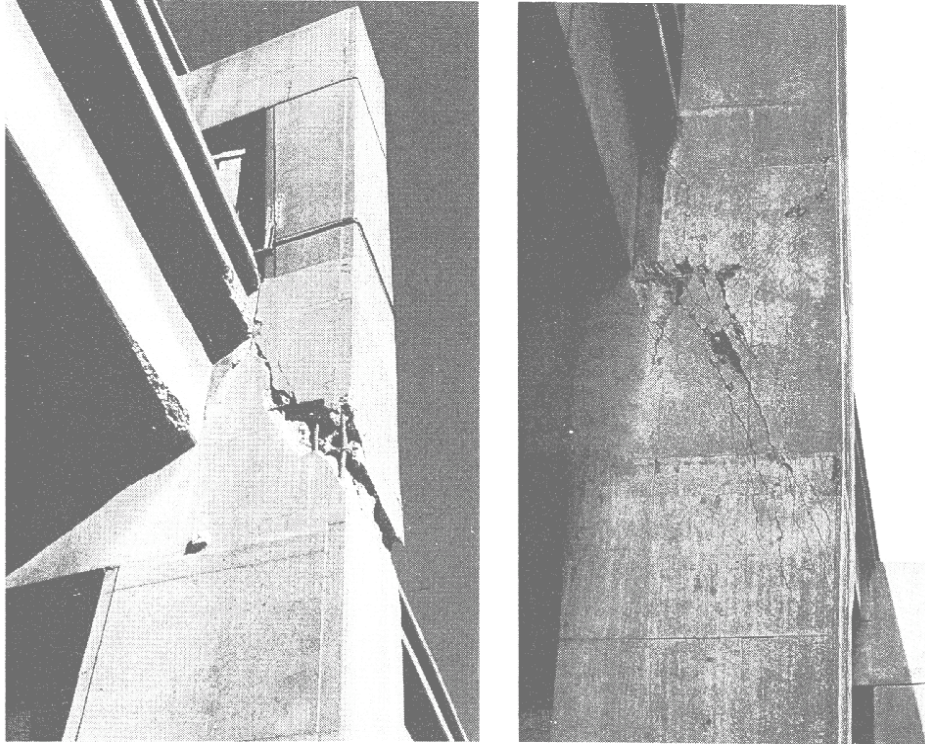
Figure 2.3 Joint Shear Failure, 1989 Loma Prieta Earthquake (a) I-880 Viaduct, (b) Embarcadero Viaduct (Adapted from Priestley et al., 1996)

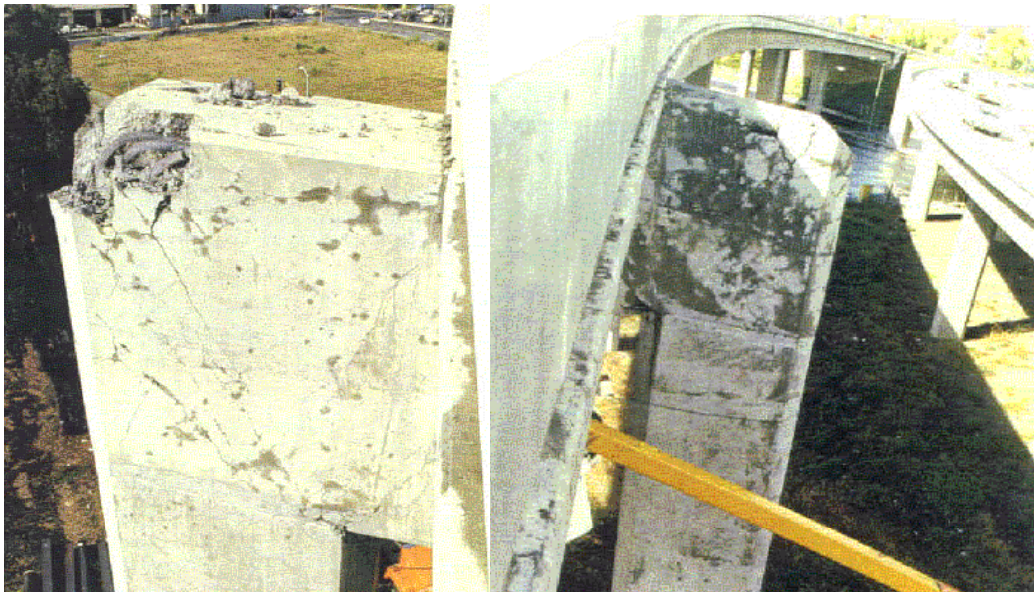
Figure 2.4 I-980 Joint Failure , 1989 Loma Prieta Earthquake (Adapted from Ingham et al., 1994a)

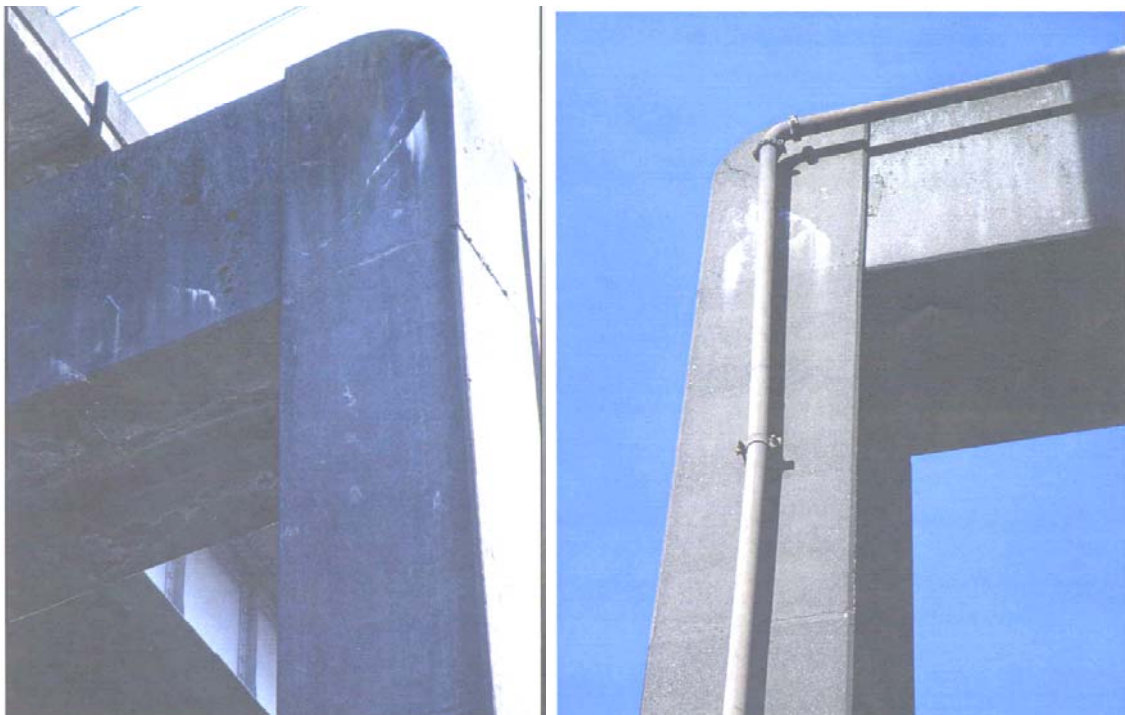
Figure 2.5 Cracks in Outrigger Knee Joints

In 2001, a significant earthquake occurred in the Puget Sound area of western Washington State, referred to as the Nisqually earthquake. In general, bridge structures performed very well during that earthquake, attributed to the retrofit efforts put forth by WSDOT (Filiatrault et al., 2001). However, there was observed damage in the outrigger bents of several bridges. Figures 2.5 and 2.6 show the damage to knee joints in the Spokane Street Overcrossing and in the Alaskan Way Viaduct near South Washington Street, respectively.

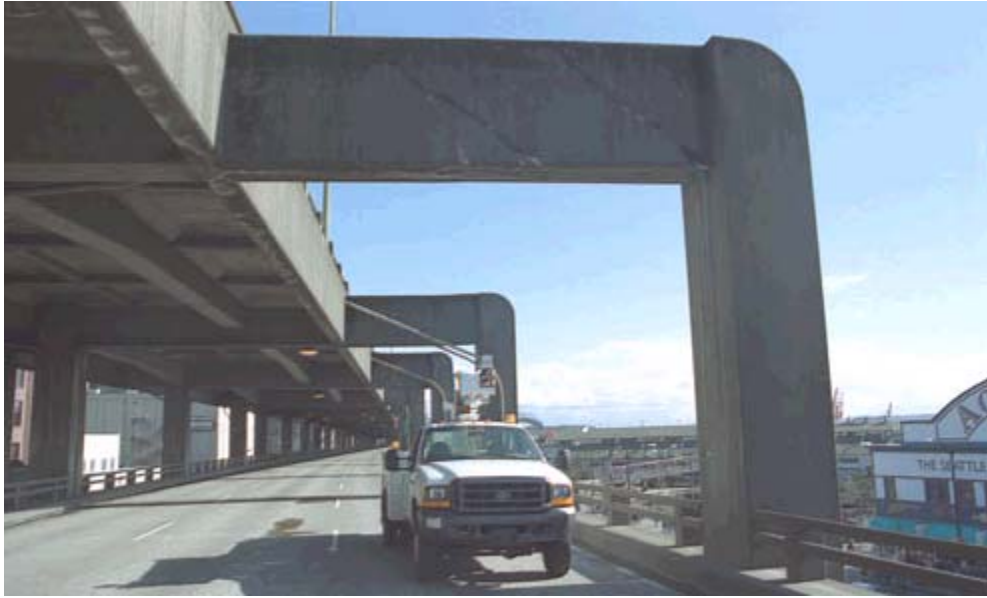
Figure 2.6 Cracking on Outrigger Beams, 2001 Nisqually Earthquake
(http://www.wsdot.wa.gov/projects/viaduct/deis/chapter1_1.htm)

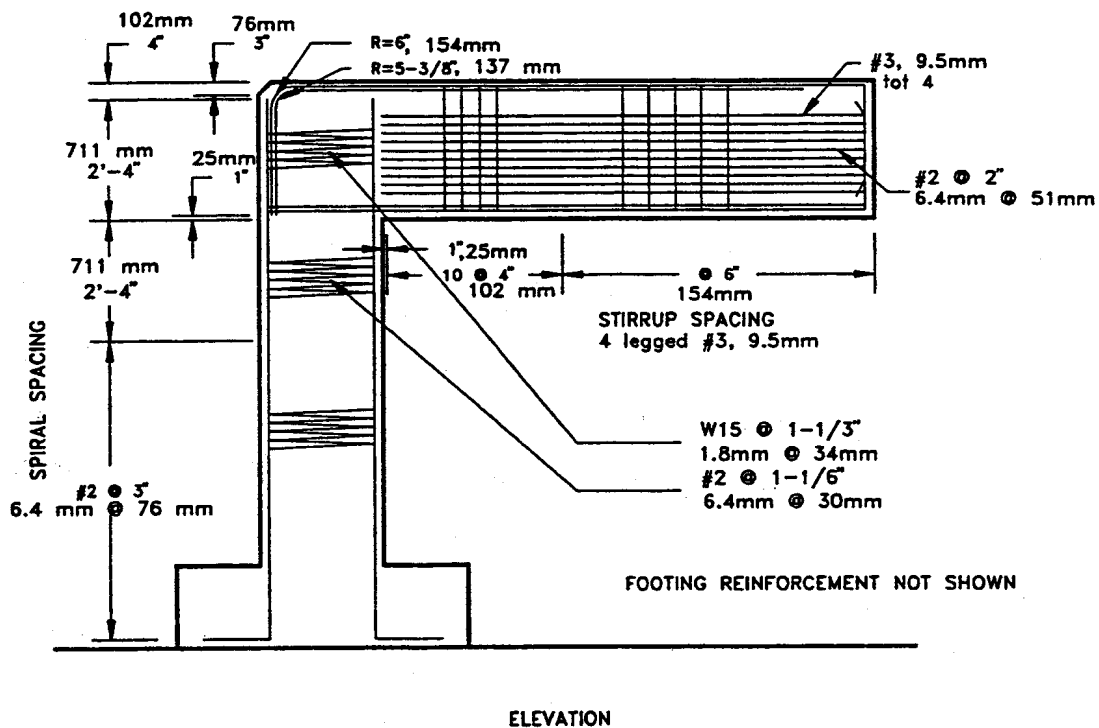
Figure 2.8 Reinforcement Details of as-Built Specimen with a Rectangular Column Configuration (Adapted from Ingham et al., 1994a)

Reinforcement details of the as-built specimen with a rectangular column configuration are shown in Figure 2.8. Experimental test results showed that the test specimen performed poorly in the joint-closing direction. Extensive diagonal splitting occurred before attaining the target displacement during cycling to a displacement ductility level (μ_{Δ}) of -0.8 in the closing direction. Following attainment of this displacement level, bond failure of the unconfined lap-splice between the vertical tails of the top cap beam reinforcement and the embedded longitudinal column reinforcement occurred, as shown in Figure 2.9.

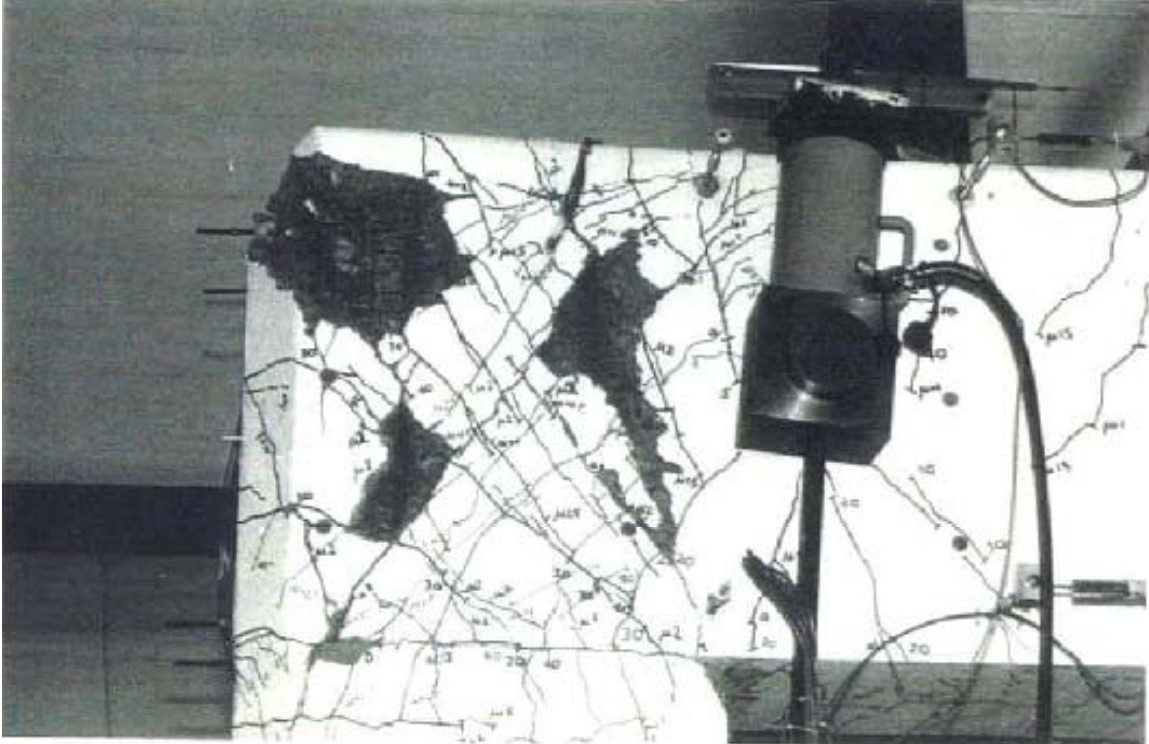
Figure 2.9 Joint Status at the End of the Test (Adapted from Ingham et al., 1994a)

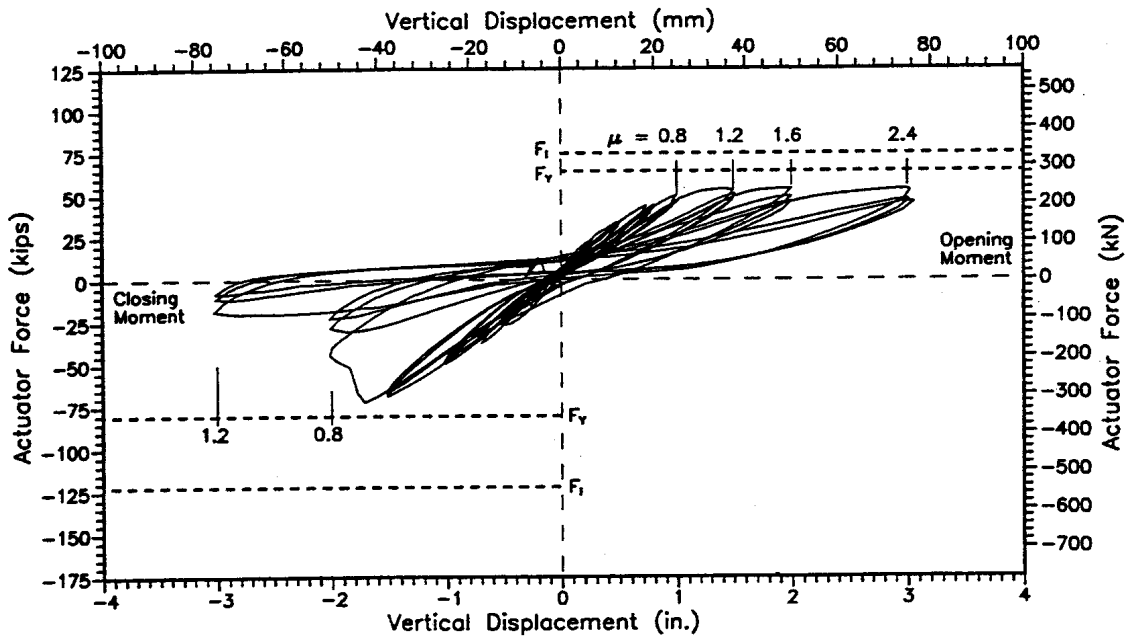
Figure 2.10 Actuator Force-Beam End Vertical Displacement History (Adapted from Ingham et al., 1994a)

ductilities of 2.4 and -1.2 were reported for opening and closing directions at the end of the test, respectively.

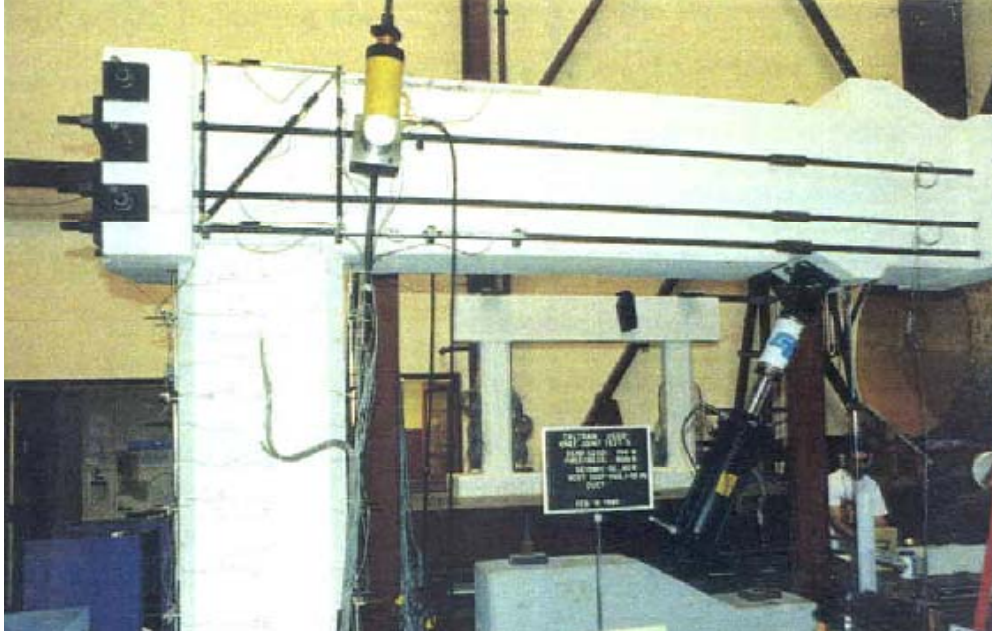
Figure 2.11 Retrofitted Technique Using External Prestressing (Adapted from Ingham et al., 1994a)

Following the test of the as-built specimen, a retrofit strategy was adopted which utilized external prestressing of the cap beam and joint incorporating bolsters on the back face of the joint, as shown in Figure 2.11. The aim of the retrofit measure was to force plastic hinging in the column under positive and negative moments. Thus, the level of the prestressing force was chosen to ensure sufficient flexural strength of the cap beam, provide confining pressure to the lap splice between the longitudinal column reinforcement and the vertical tails of the top cap beam reinforcement, and to provide hook restraint for the top cap beam reinforcement.

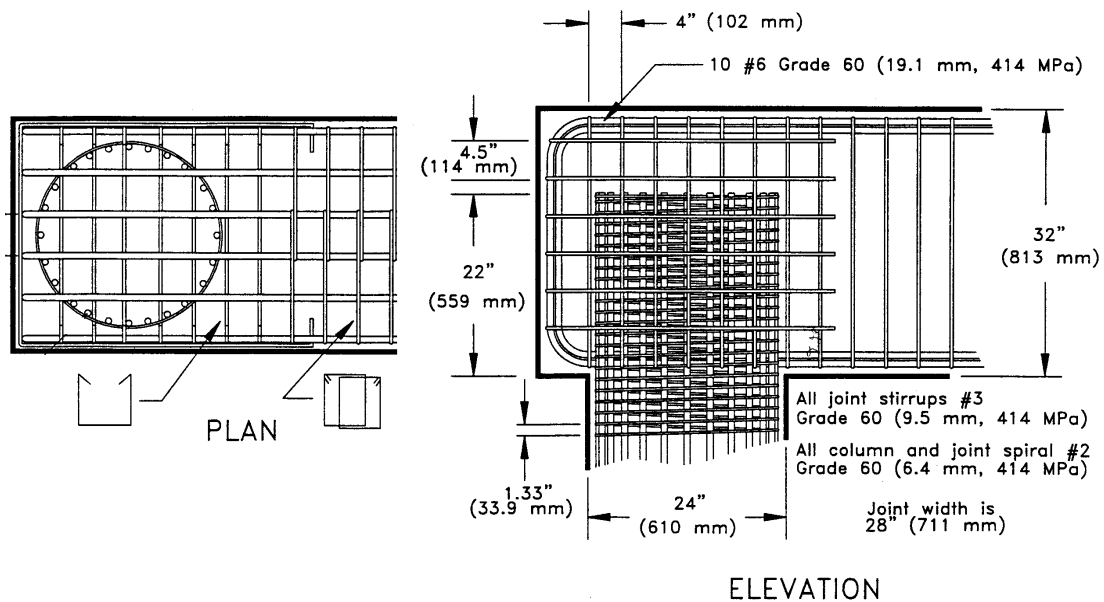
Figure 2.13 Joint Reinforcement Details of as-Built Specimen with a Circular Column (Adapted from Ingham et al., 1994b)

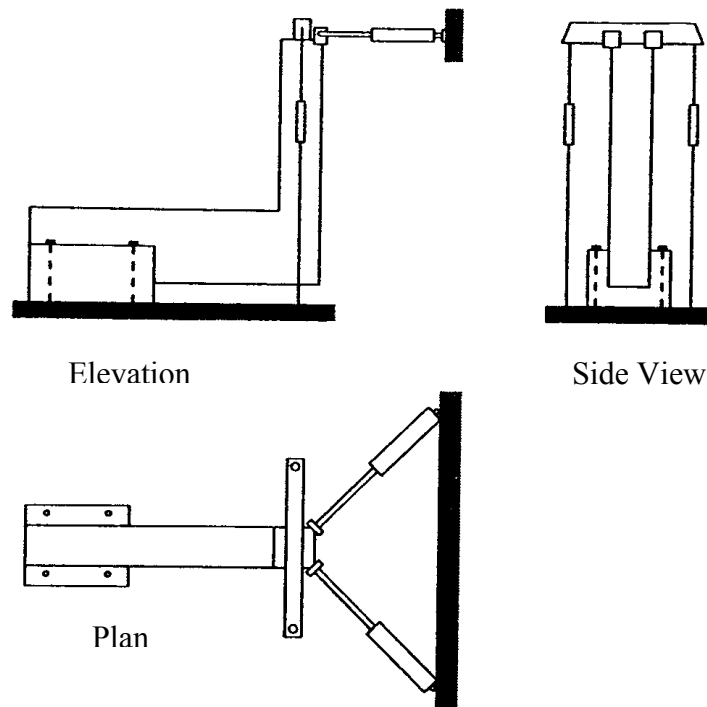
Figure 2.18 Test Setup (Adapted from Stojadinovic and Thewalt, 1995)

Researchers at the University of California at Berkeley investigated the performance of as-built outrigger knee joints under in-plane and out-of-plane seismic loading simultaneously. Two as-built half-scale models, one with a long and one with a short outrigger beam, were constructed and tested to evaluate the performance and establish the failure mechanism of existing systems. A simultaneous bi-directional displacement pattern simulating the anticipated motion of the prototype under the effect of an earthquake was applied using a pair of horizontal 150-kip (667-kN) actuators positioned at an approximately 40-degree angle to the beam axis. Vertical loading simulating the changes in the column axial load caused by the outrigger bent frame action, and the gravity load was applied using a pair of 50 kips (224 kN) vertical actuators. Figure 2.18 shows the test setup utilized in the study.

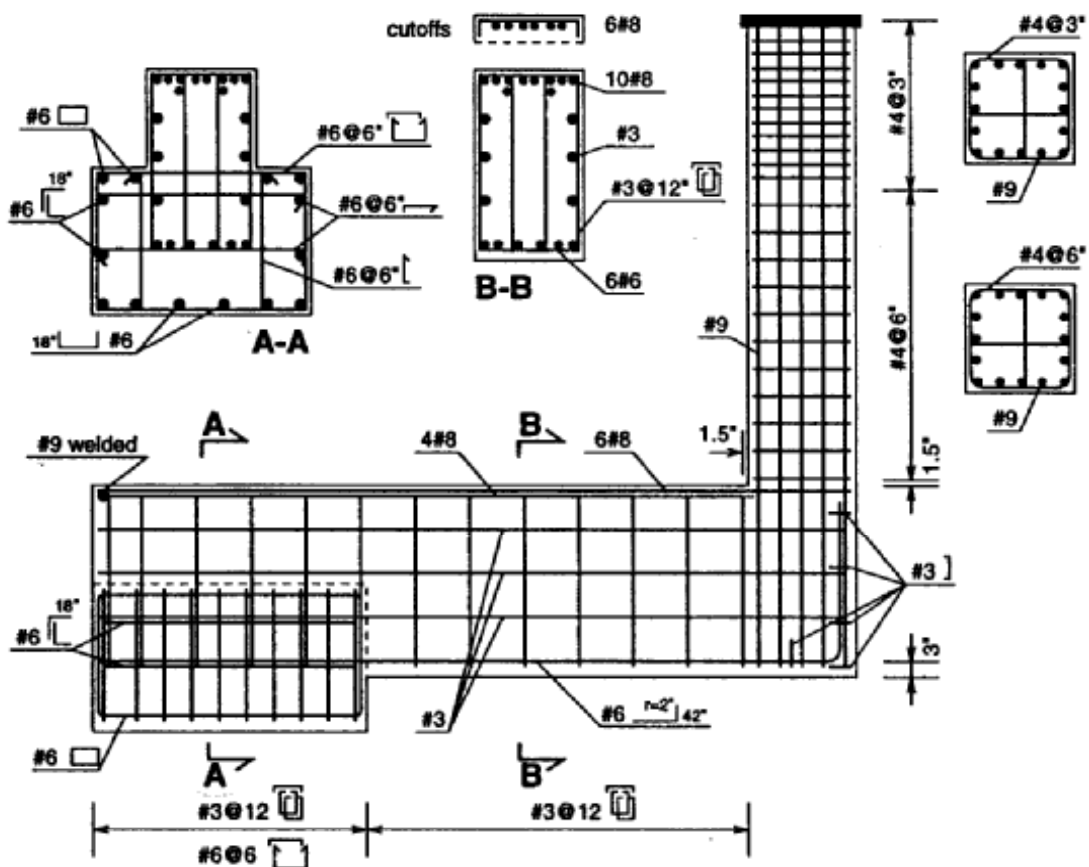
Figure 2.19 Reinforcement Details of the As-Built Long Beam Specimen (Adapted from Stojadinovic and Thewalt, 1995)

The specimen with the long outrigger beam was a replica of bent B20 on the I101/I280 Interchange at Alemany Boulevard in San Francisco, while the specimen with the short beam was a model of a typical knee joint system found on elevated highway structures. Both of the specimens had inadequate joint confinement and detailing. The beam transverse reinforcement consisted of open U-shaped stirrups topped with U-shaped caps. Figures 2.19 and 2.20 show the reinforcement details of the as-built short and long specimen, respectively.

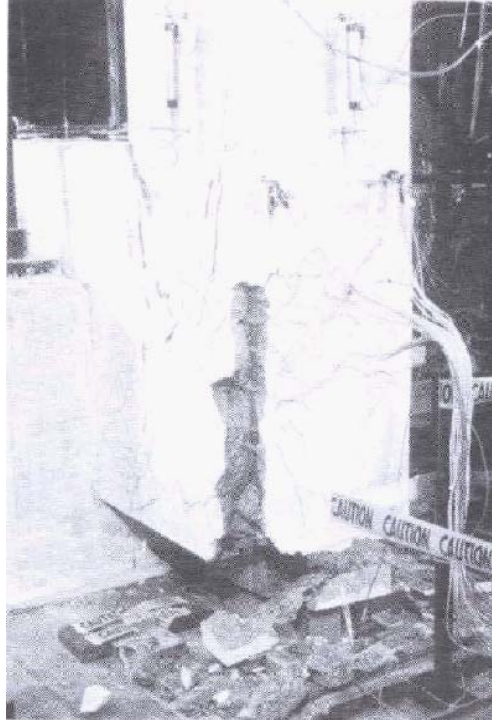
Figure 2.23 Bond Split Failure of the Knee Joint in the As-Built Short Specimen(Adapted from Stojadinovic and Thewalt, 1995)

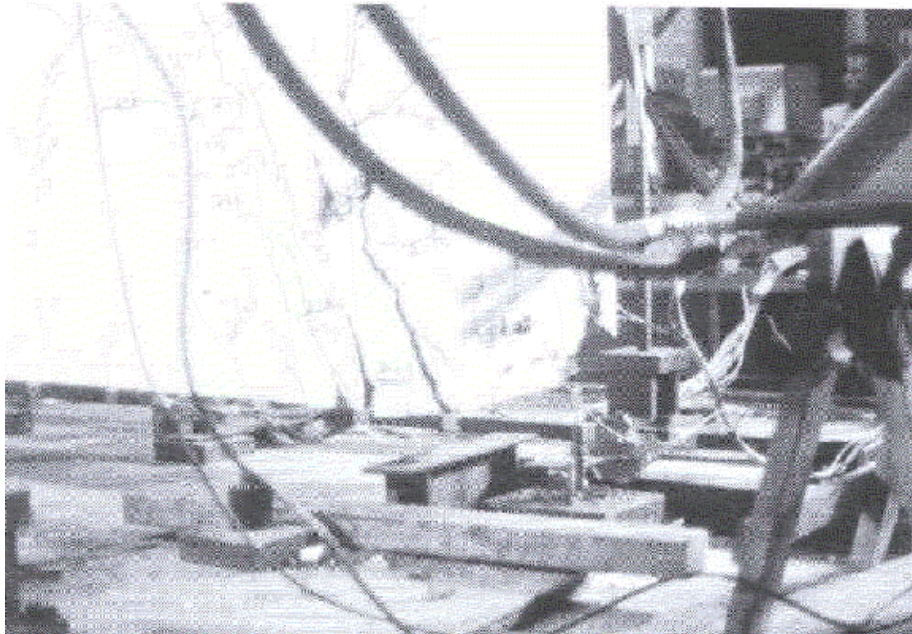
Figure 2.24 Spalling in the Knee Joint of the As-Built Long Specimen(Adapted from Stojadinovic and Thewalt, 1995)

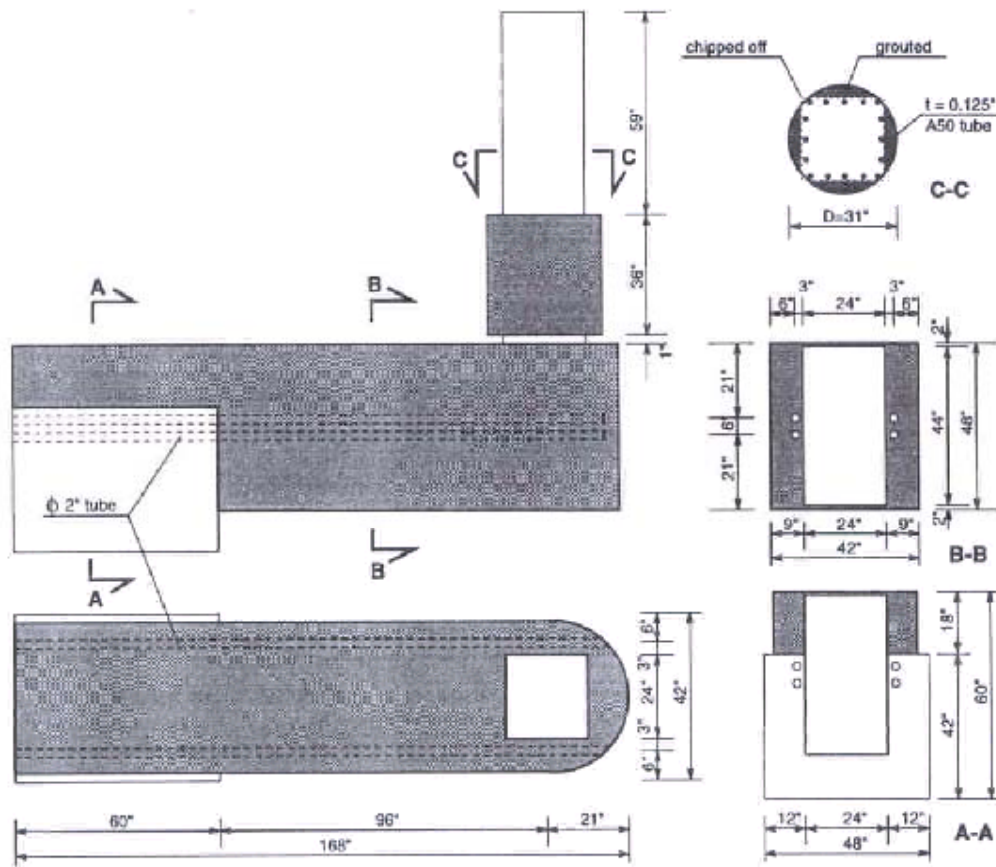
Figure 2.25 Final Concrete Upgrade Details of the As-Built Long Specimen (Adapted from Stojadinovic and Thewalt, 1995)

bolster around the joint. The column was upgraded using a grouted cylindrical steel casing with a 1-in. (2.5-cm) clearance above the beam. Figure 2.25 shows the upgraded test specimen. Testing showed that the specimen behaved according to the strong upgrade philosophy. The plastic hinge formed in the column, the joint remained virtually intact and the outrigger beam remained in the cracked pre-yield torsion response stage. However, there was a 25% difference in resistance between the longitudinal and the transverse directions. This behavior was related to the bi-directional loading protocol and the difference in the torsional and bending stiffness of the beam. Force-displacement curves for this specimen are shown in Figure 2.26.

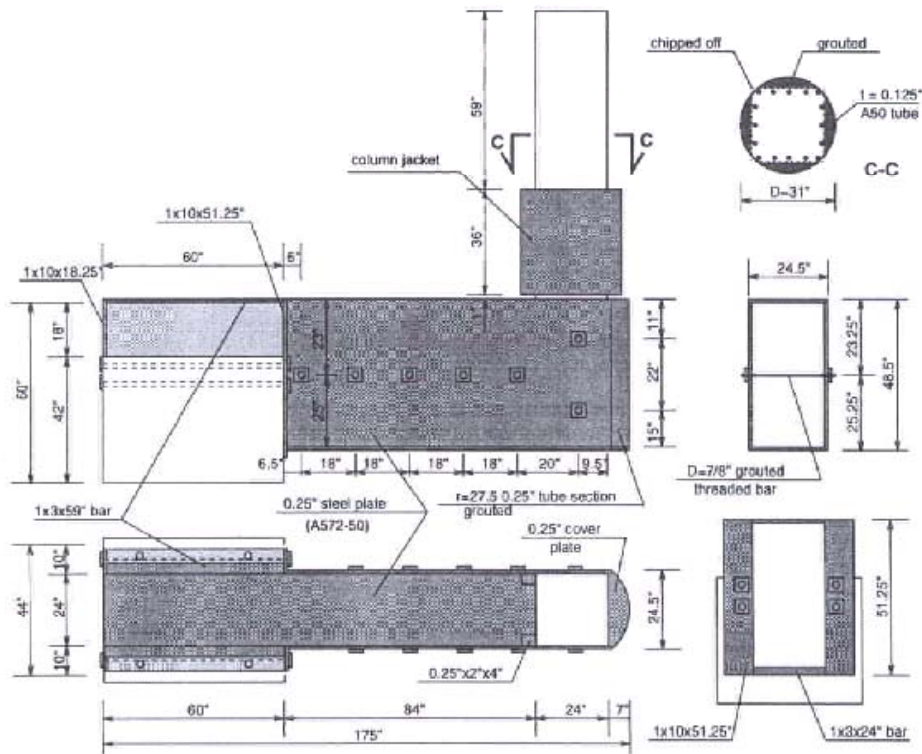
Figure 2.27 Final Steel Upgrade Details of the As-Built Long Specimen (Adapted from Stojadinovic and Thewalt, 1995)

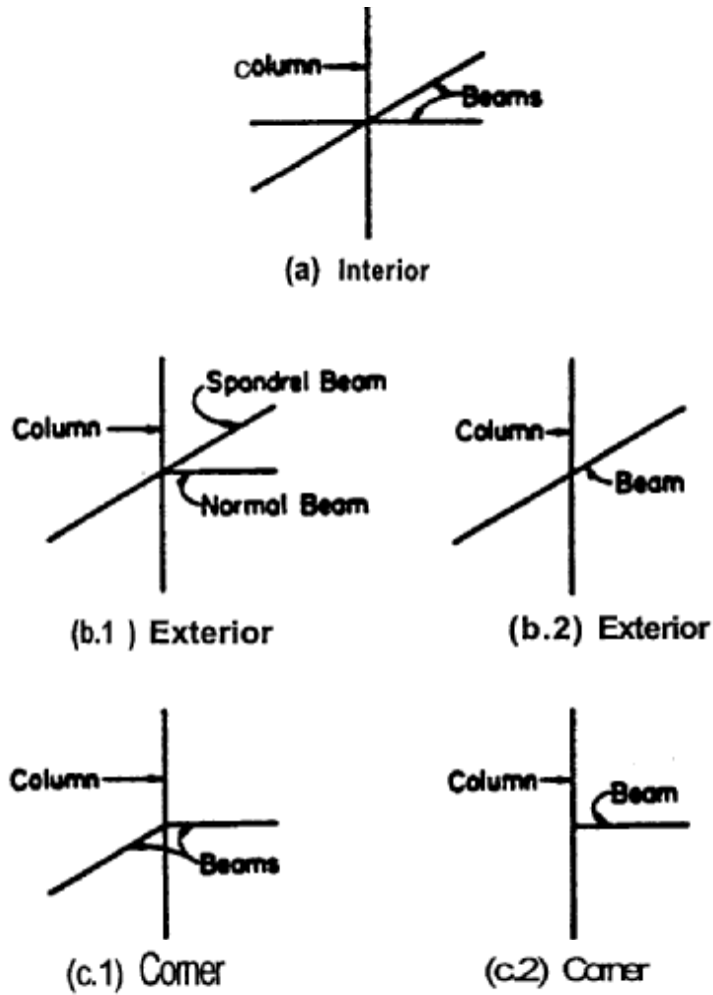
Figure 2.28 Geometric Description of Joints (Adapted from ACI-ASCE Committee 352)

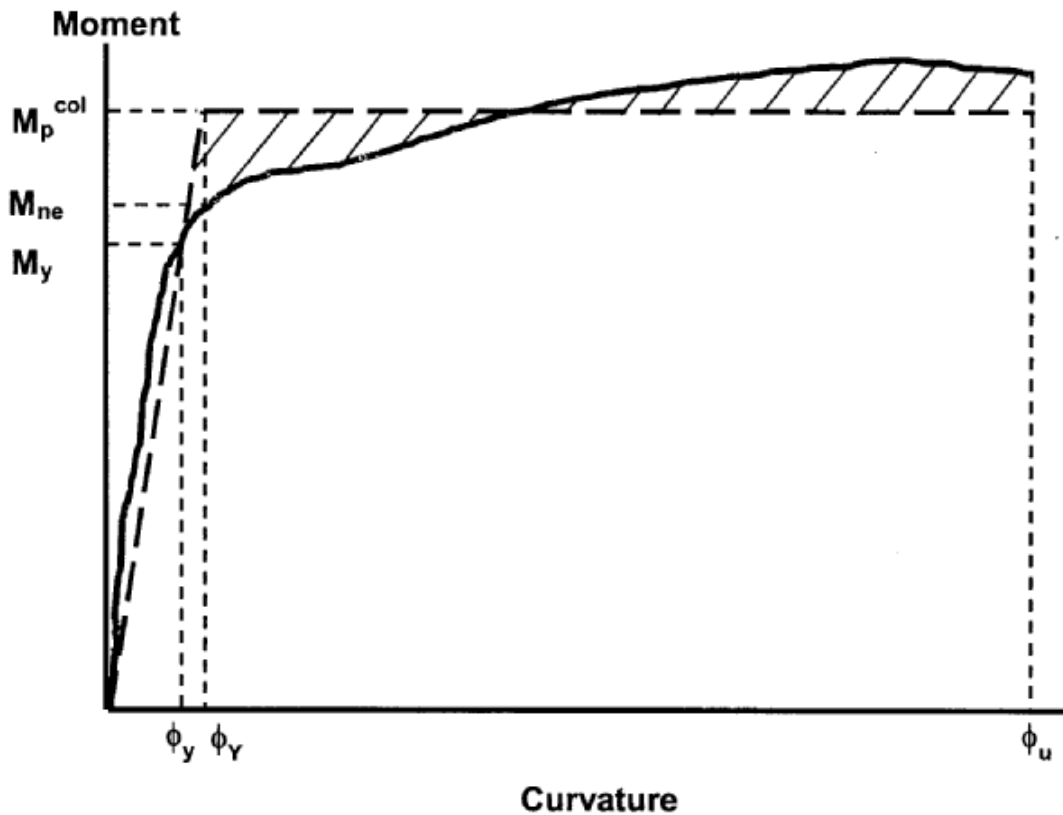
Figure 2.30 Moment Curvature Curve (Adapted from Caltrans, 2001)

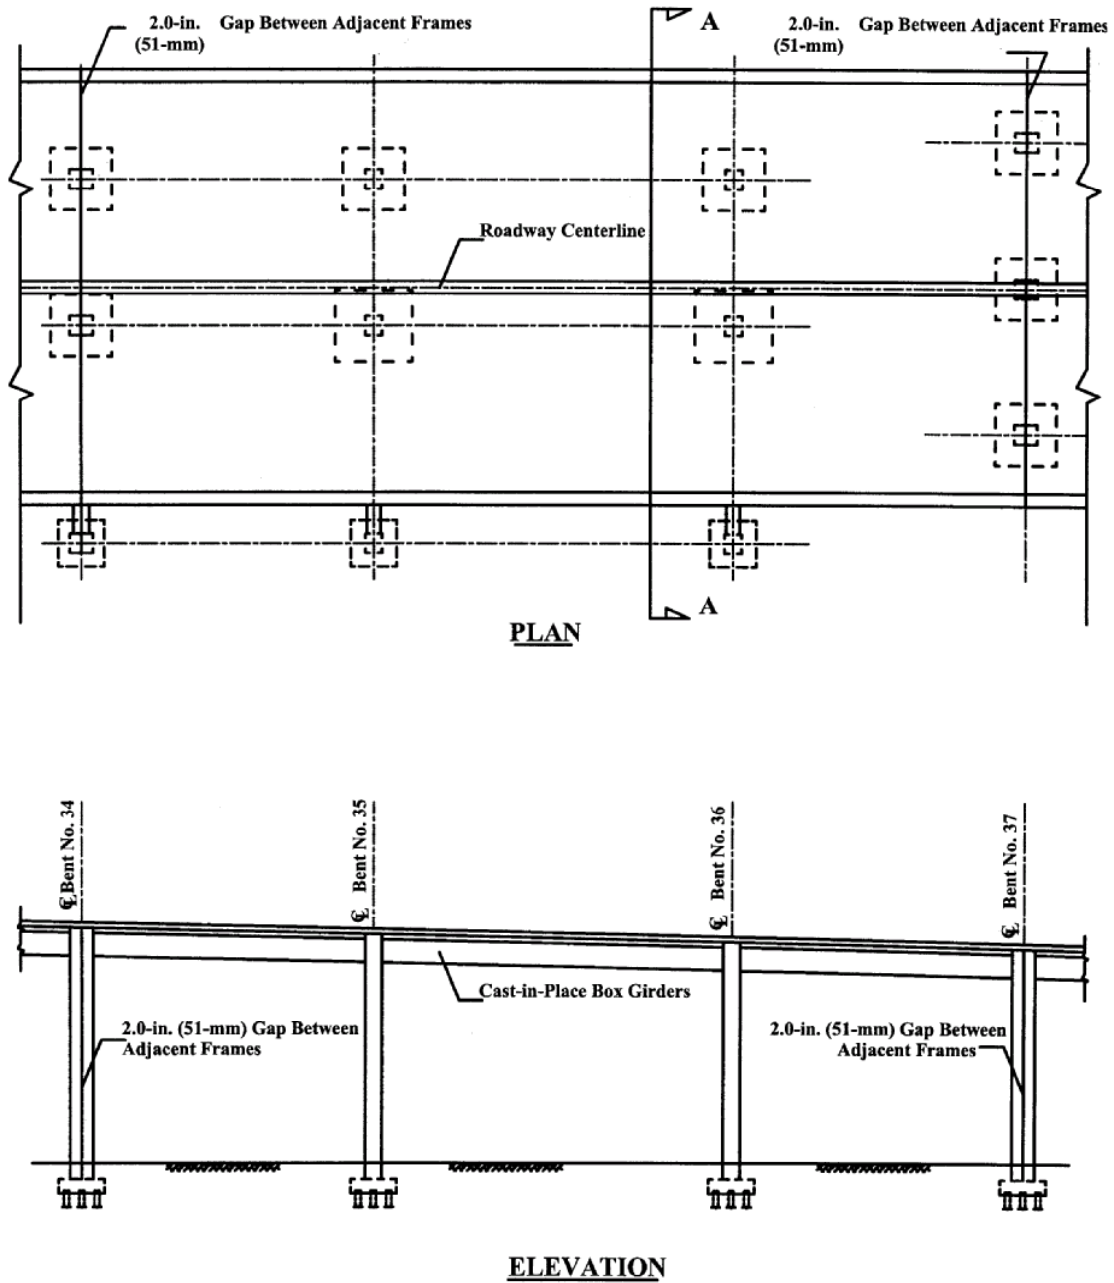
Figure 3.1 A Typical Section in the SR 99 Spokane Street Overcrossing, Plan and Elevation

precast concrete. The concrete compressive strength is specified in the original drawings, dated 1957, as $f'_c = 4000$ psi (28 MPa). This value is usually a low estimate of the actual strength expected in the field because of conservative mix design procedures used at the time and the strength gain of concrete with age.

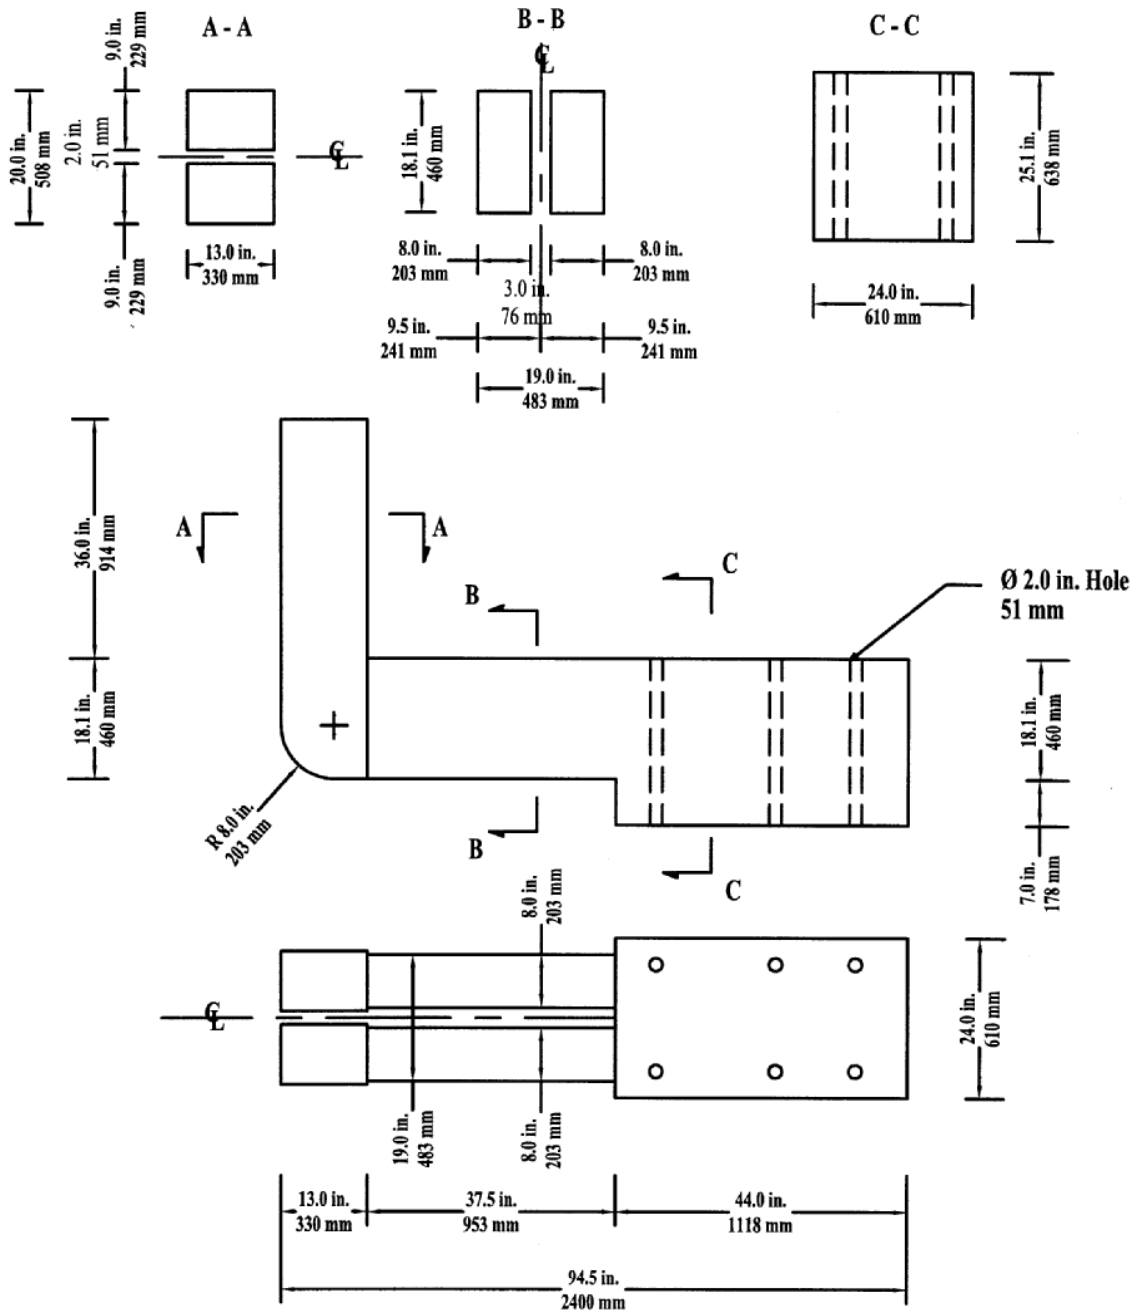
Figure 3.7 As-Built Split Long Outrigger Specimen Dimensions

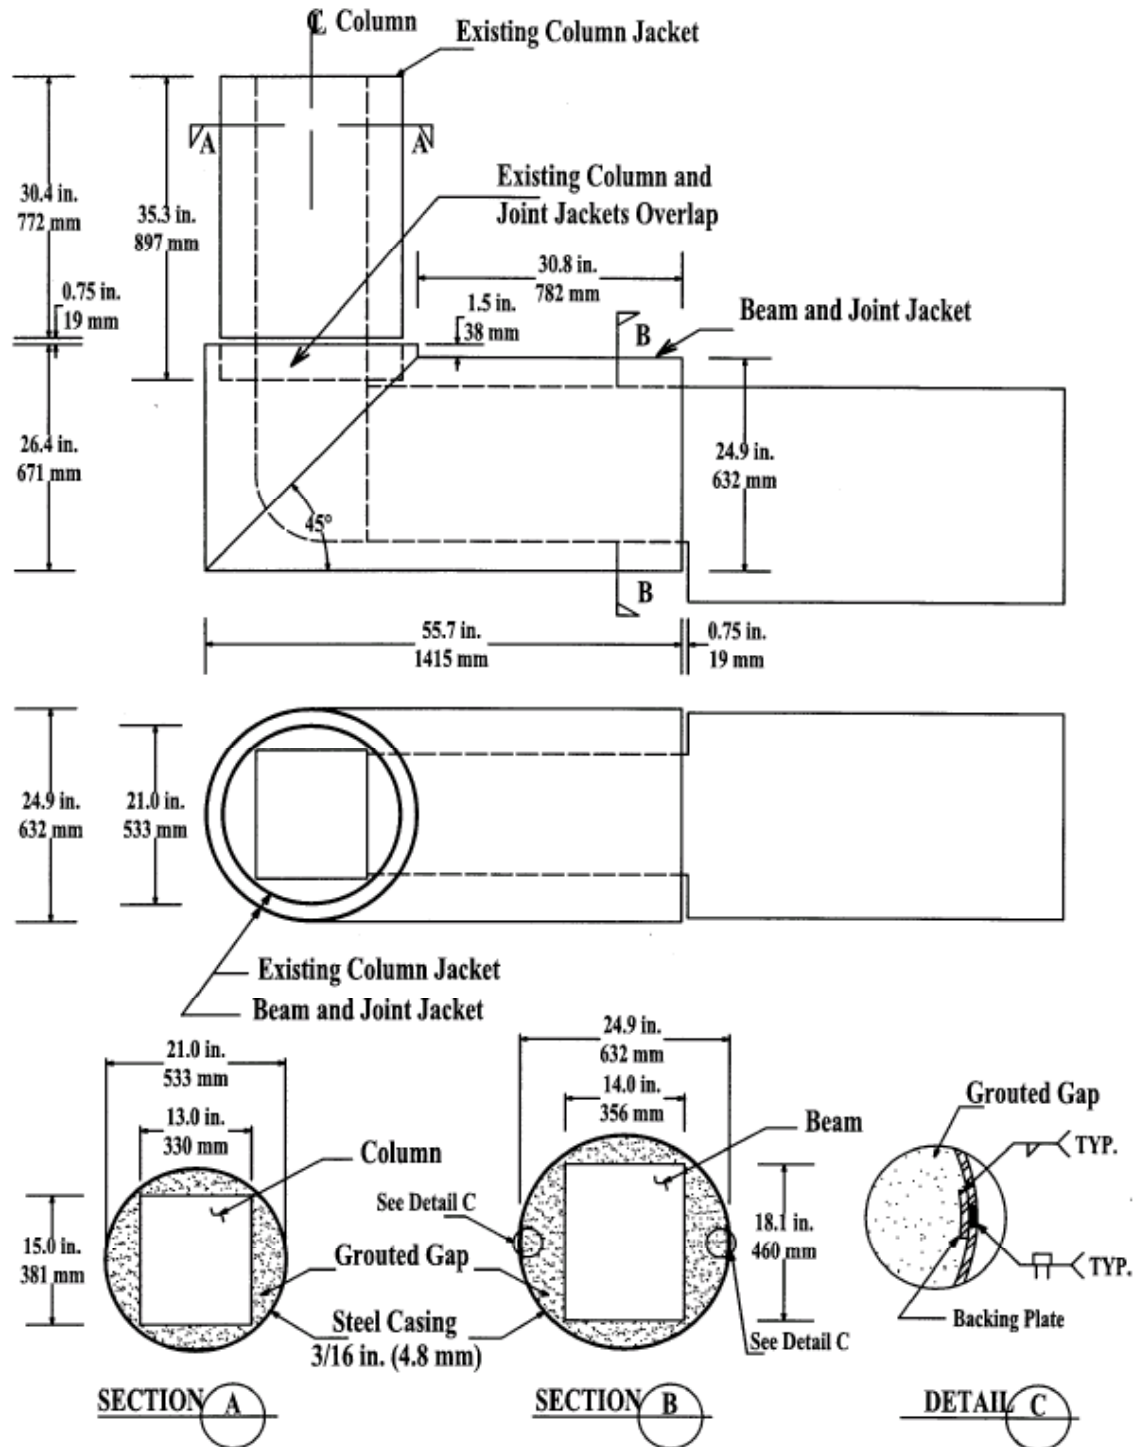
Figure 3.15 Beam and Joint Jackets Details for Specimen RLI

The clamshells were fabricated by curving a flat plate to form a pipe section with the required length and radius. The pipe was then cut at a 45-degree angle to the required length to jacket the beam. By rotating the leftover piece (eventually forming the joint jacket) in-plane by 90-degrees, followed by a 180-degree out-of-plane rotation, the piece was then welded to the beam jacket along the 45-degree seam using a full capacity weld forming an elbow shape. The jacket overlapped the existing column jacket above the beam-joint interface with a lip distance of 1.5 in. (38 mm) over the beam jacket. Finally, the difference between the beam and the joint and the steel jacket was filled by high strength grout. Figure 3.16 shows an overall view of Specimen RLI.

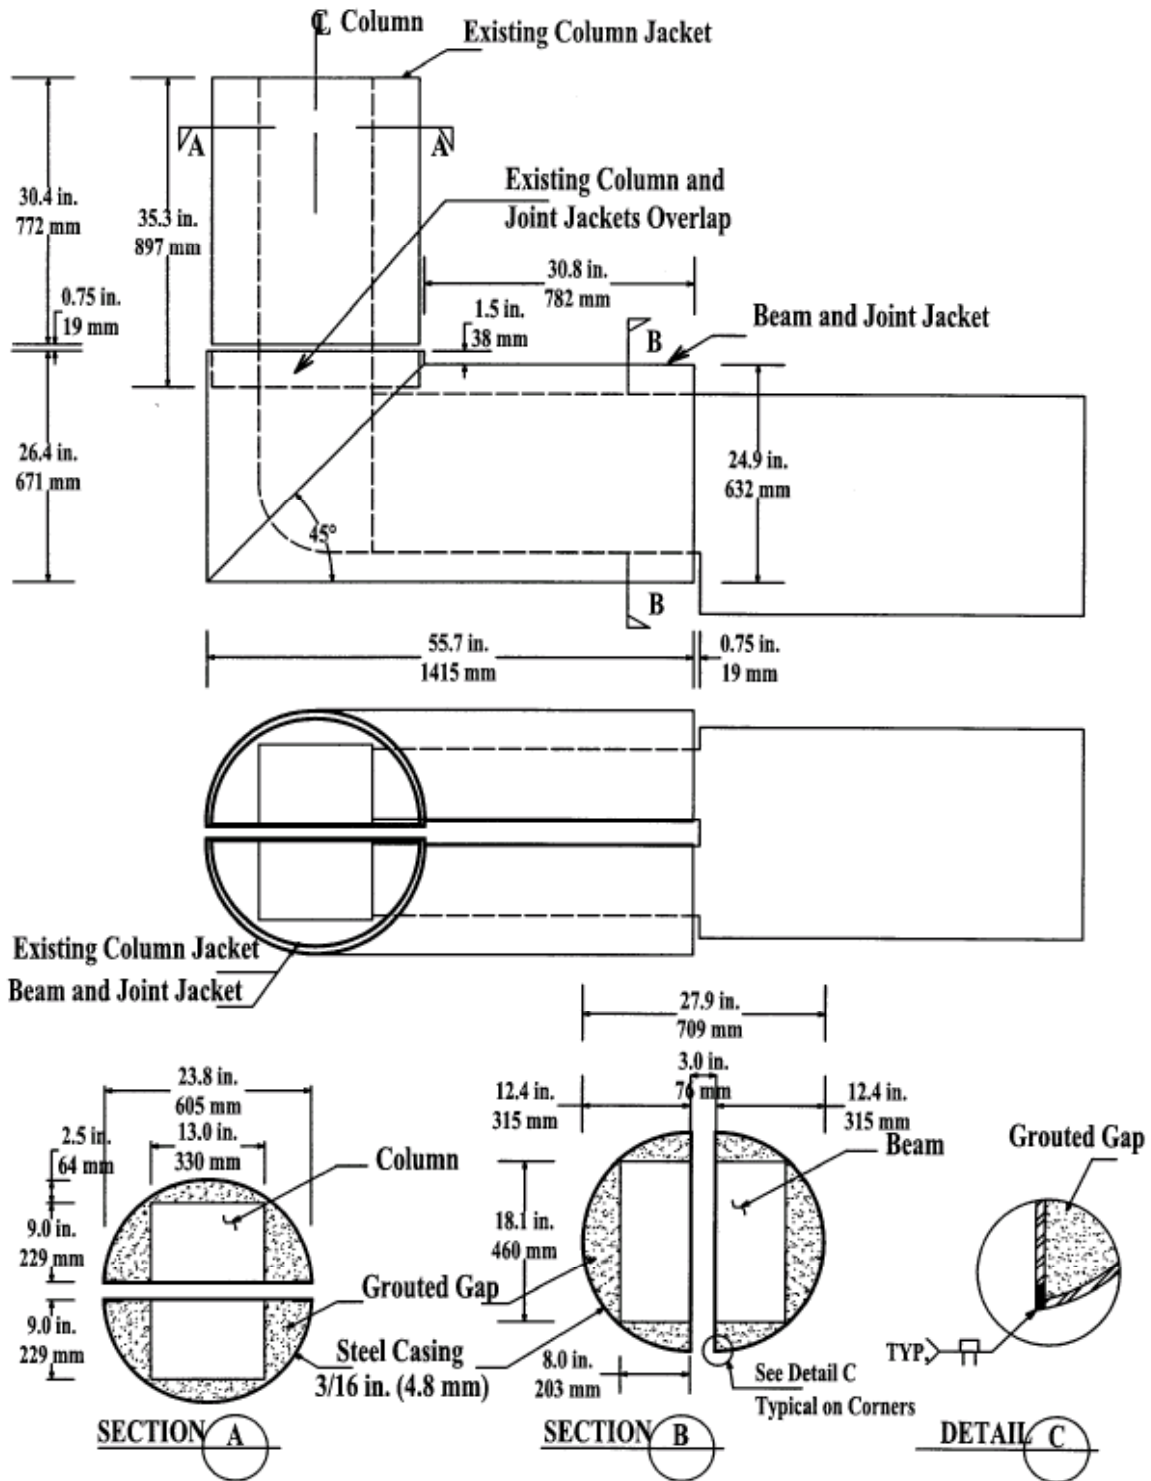
Figure 3.24 Retrofitted Long Outrigger Clamshell Dimensions (Front View)
