SEISMIC BEHAVIOR AND RETROFIT OF OUTRIGGER KNEE JOINTS

NASIM KHALIL SHATTARAT

A dissertation submitted in partial fulfillment of the
requirements for the degree of

WASHINGTON STATE UNIVERSITY
Department of Civil and Environmental Engineering

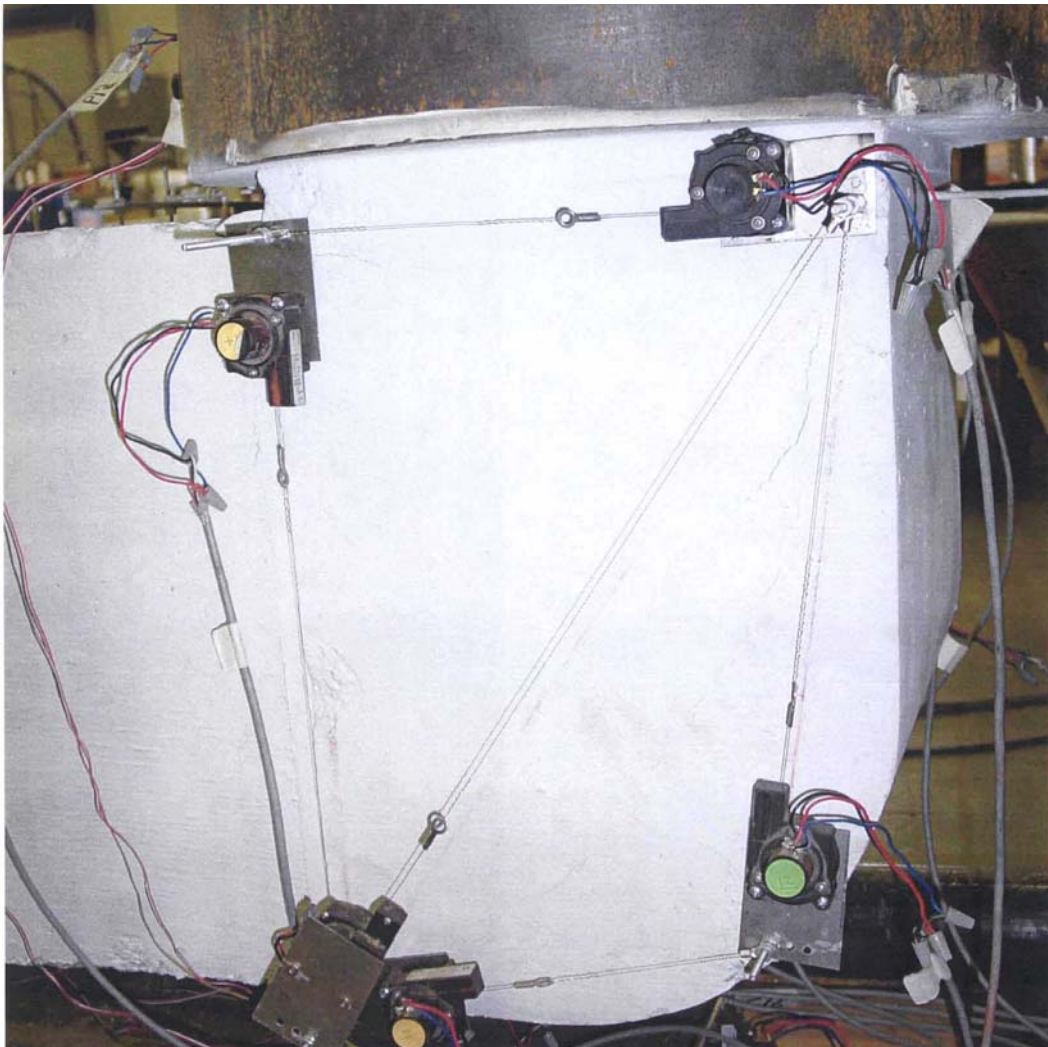
Figure 4.2 Specimen ALI at the End of 1.5-in. (38-mm) Displacement Level

as cracks formed in the same plane where the beam bottom reinforcement and column rebars were hooked together and overlapped within the joint. These cracks started to extend beyond the beam-joint interface towards the beam and terminated at the column-joint interface. The largest measured actuator force at this displacement level in the closing direction was 17.8 kips (79.2 kN) and -11.9 kips (-52.9) in the opening direction showing, thus, a slight increase over the actuator forces in the previous stage. A picture of the joint at the end of this displacement level is shown in Figure 4.3.

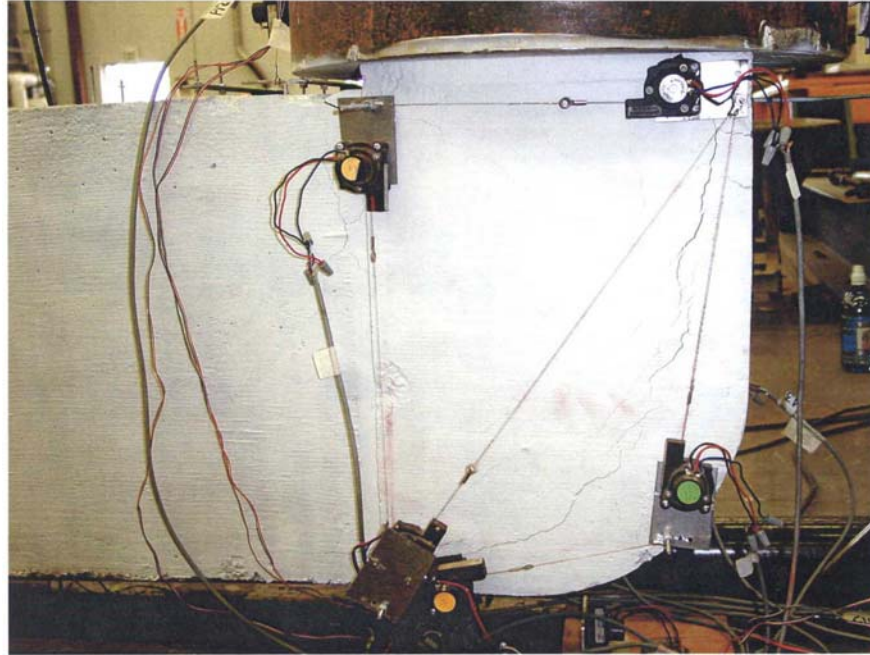
Figure 4.3 Specimen ALI at the End of 2.0-in. (51-mm) Displacement Level

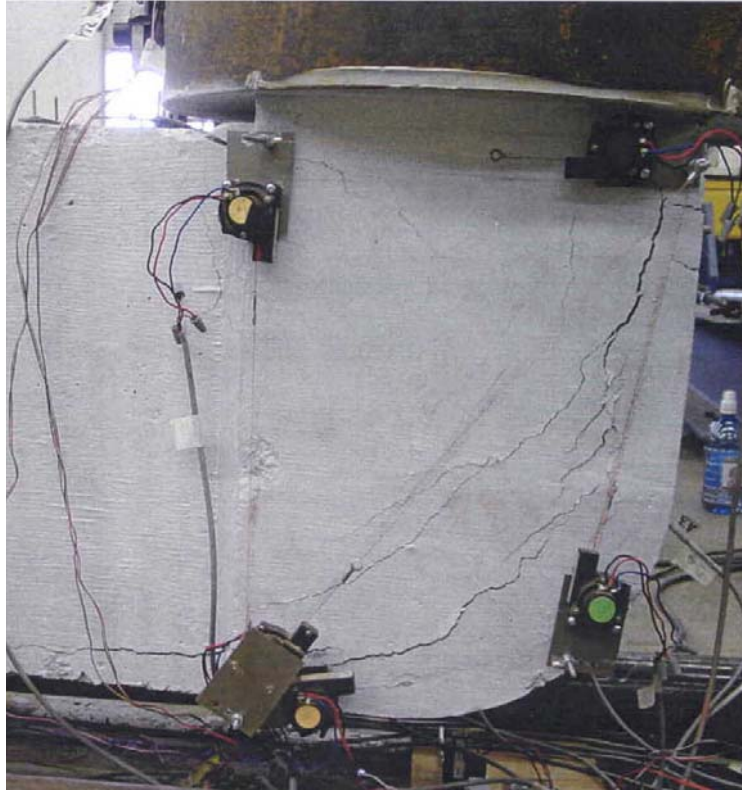
Figure 4.4 Specimen ALI at the End of 2.5-in. (64-mm) Displacement Level

During cycling to a displacement level of ± 2.5 in. (± 64 mm), additional joint shear cracks developed along with further opening of the existing shear and splitting cracks within the joint. Horizontal splitting cracks on the back face of the joint were clearly visible. The vertical crack at the beam-joint interface became wider. In the closing direction, the maximum measured actuator forces were 17.7 kips (78.7 kN), 16.2 kips (72.1 kN) and 14.8 kips (65.8 kN) following the first, second and third cycles of loading, respectively. This deterioration in the strength supported the physical observation of the widening of the shear and splitting cracks in the joint with repeated cycling. The largest actuator force in the closing direction was -11.0 kips (-48.9 kN), which is less than that recorded in the previous cycles. Pictures of the joint at the end of this displacement level are shown in Figures 4.4 and 4.5.

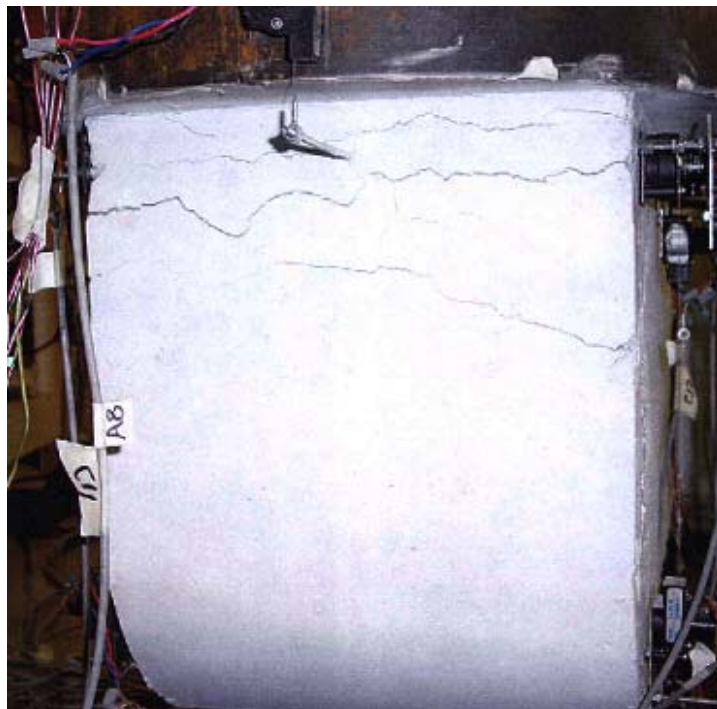
Figure 4.5 Back Face of the Joint in Specimen ALI at the End of 2.5-in. (64-mm) Displacement Level

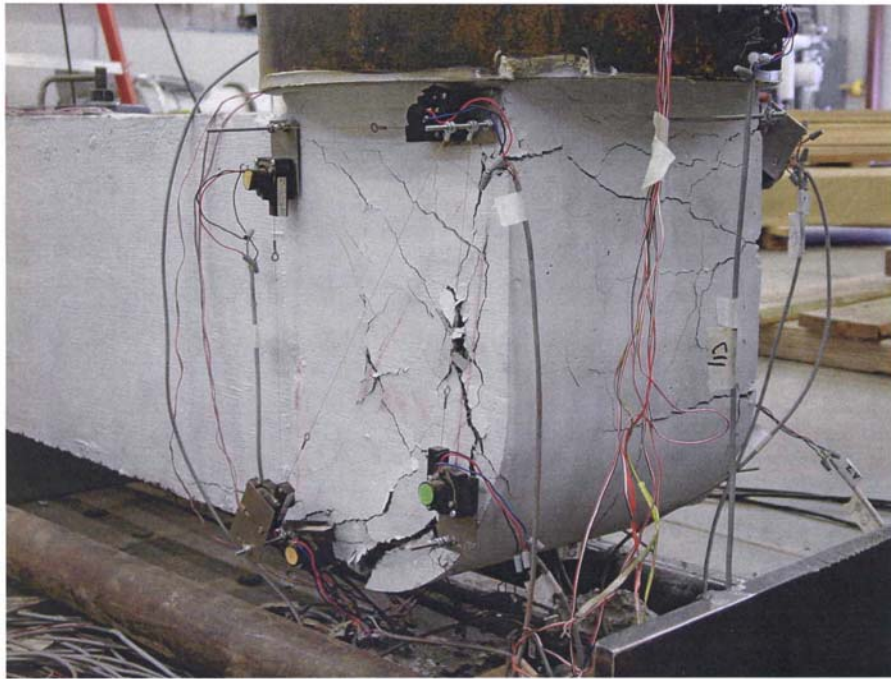
Figure 4.6 Shear Distress to the Joint in Specimen ALI

During cycles to ± 3.0 in. (76 mm) displacement level, the column hook extensions became visible as concrete at the curved side of the joint face spalled off at a displacement level of 2.19 in. (56 mm). Joint shear distress was also noticeable at this displacement level prior to the bond splitting cracks. In addition to the physical degradation of the joint strength, degradation of the system can be seen by comparing the maximum actuator forces to those of the previous cycles. Maximum forces of 7.1 kips (31.6 kN) and -8.7 kips (-38.7 kN) were recorded in the closing and opening direction at the end of the first cycle, respectively. This is equivalent to a 60% and 21% decrease in the strength in the closing and opening direction, respectively. Testing was stopped following the second closing cycle to this displacement level. At the end of testing, the specimen was still capable of sustaining the applied axial load. Figures 4.6 and 4.7 show the damage to the test specimen at the completion of the test.

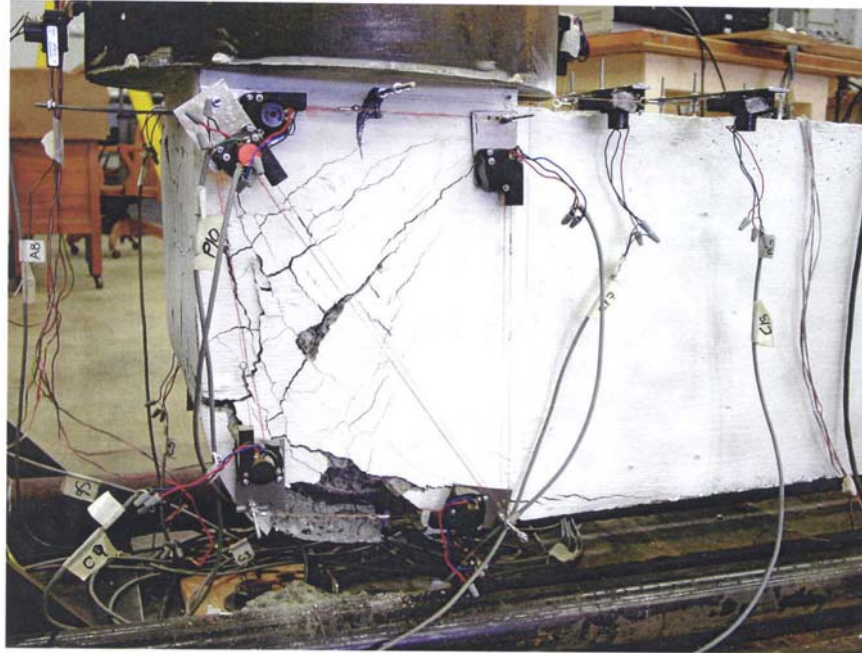
Figure 4.7 Bond Splitting Failure of the Column Rebars in the Joint Region

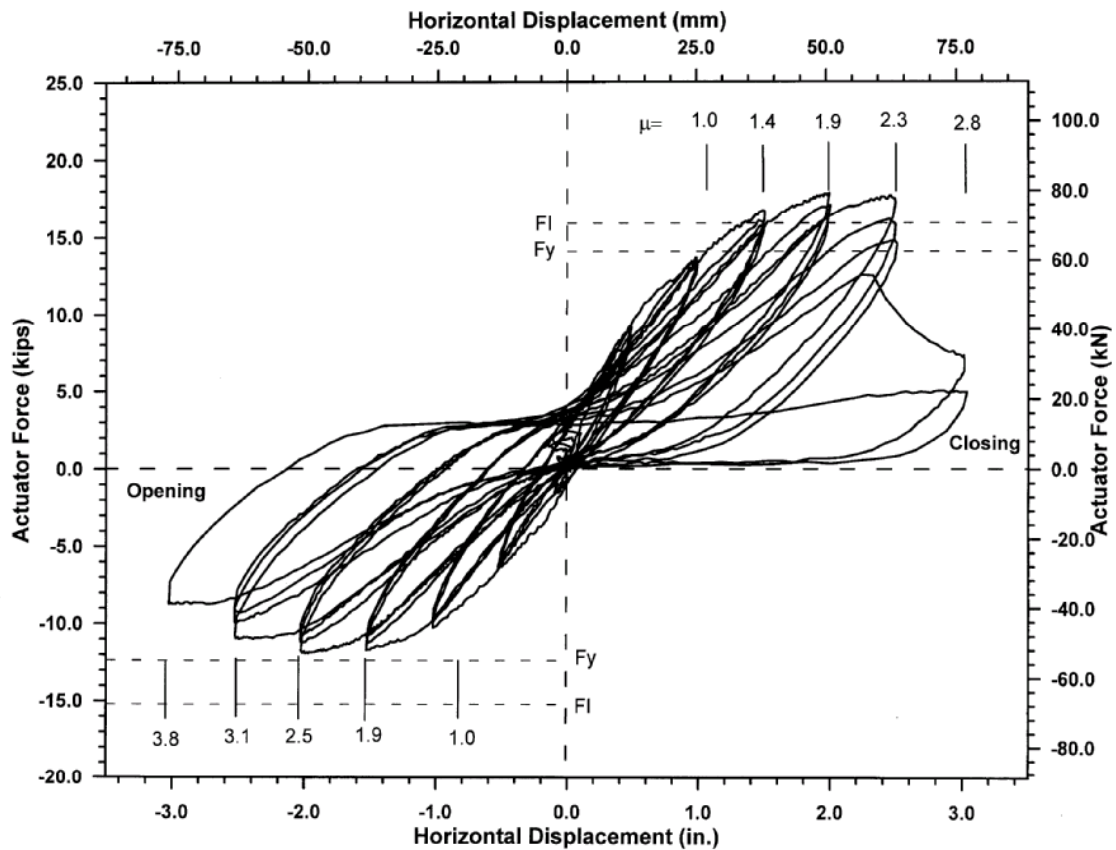
Figure 4.8 Actuator Force-Horizontal Displacement History for Specimen ALI

The shape of the force-displacement history shows narrowing of the curves near the origin, referred to as pinching, due to cracking of the joint concrete and degradation of the overall performance of the joint. The specimen was able to withstand displacements up to 2.5 in.(64 mm) in both directions before the abrupt drop in the actuator force while looping to close the joint to 3.0 in. (76 mm) displacement level, as shown in Figure 4.8. Specimen ALI was able to attain a maximum ductility level of 2.8 at a drift ratio of 3.4% in the closing direction and a ductility of -3.8 at a drift ratio of -3.4% in the opening direction.

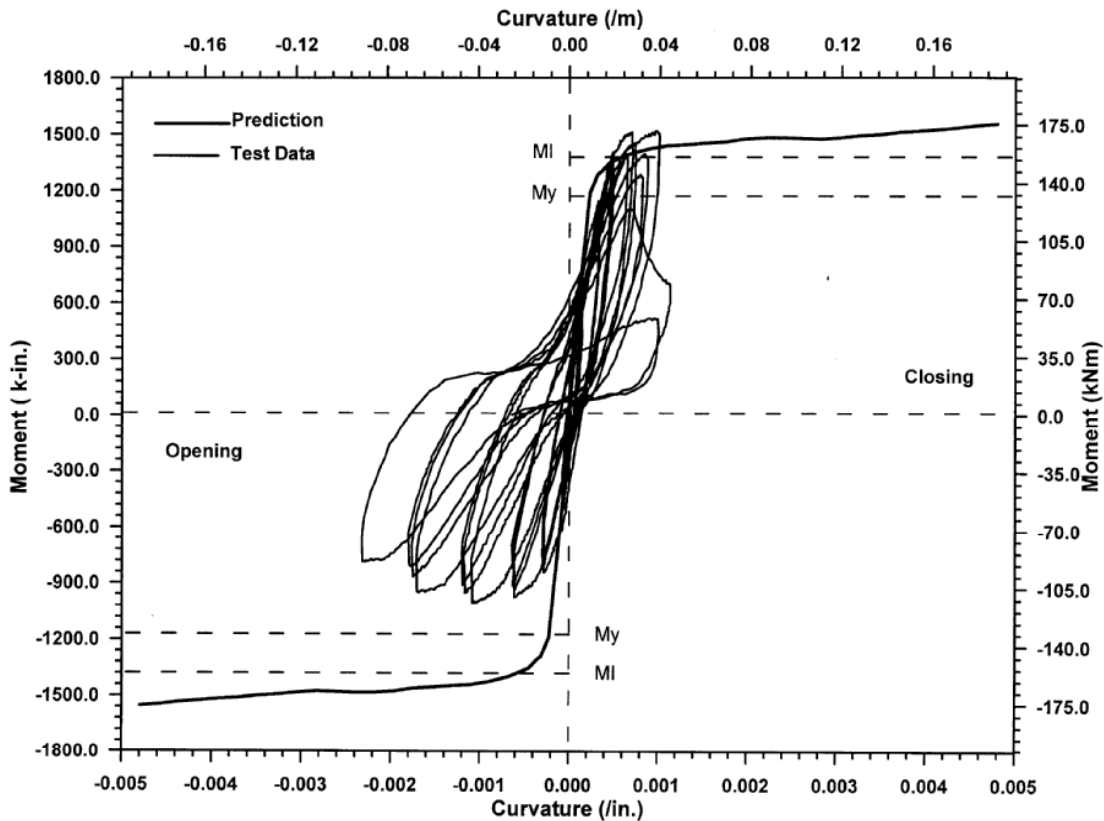
Figure 4.9 Column Moment-Curvature Response for Specimen ALI

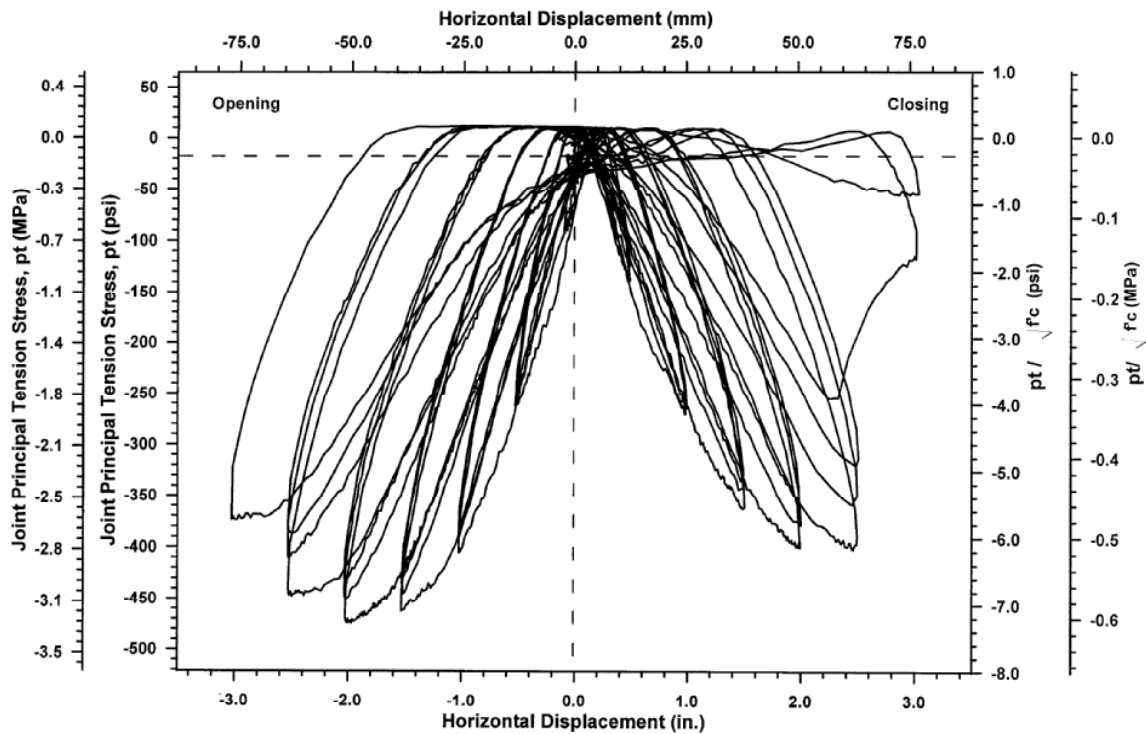
Figure 4.10 Joint Principal Tension Stress History for Specimen ALI

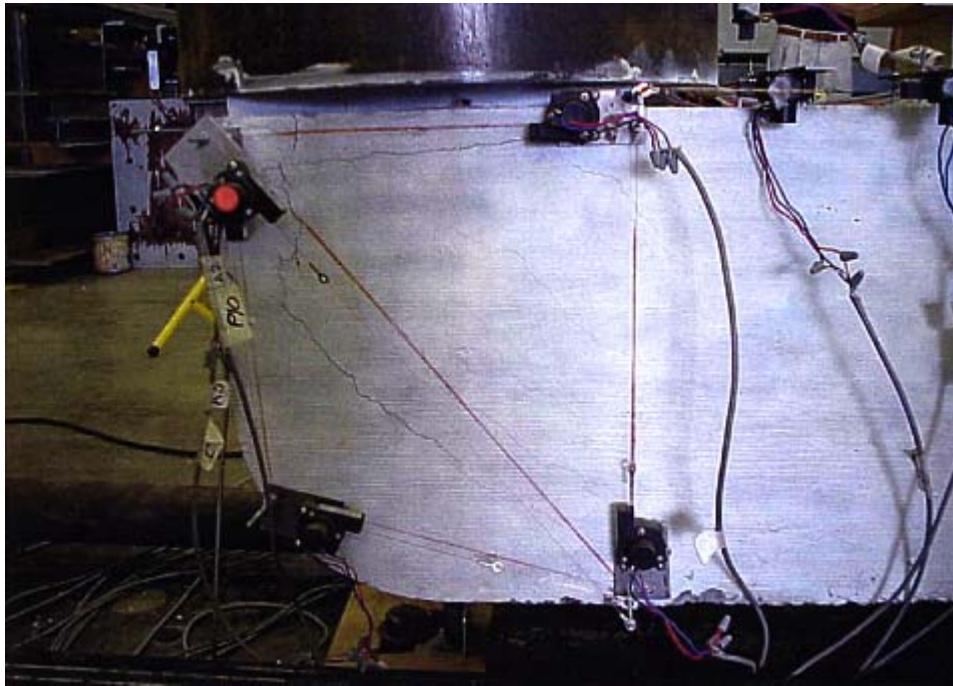
Figure 4.11 Specimen ASI at the End of 1.5 in.(38 mm) Displacement Level

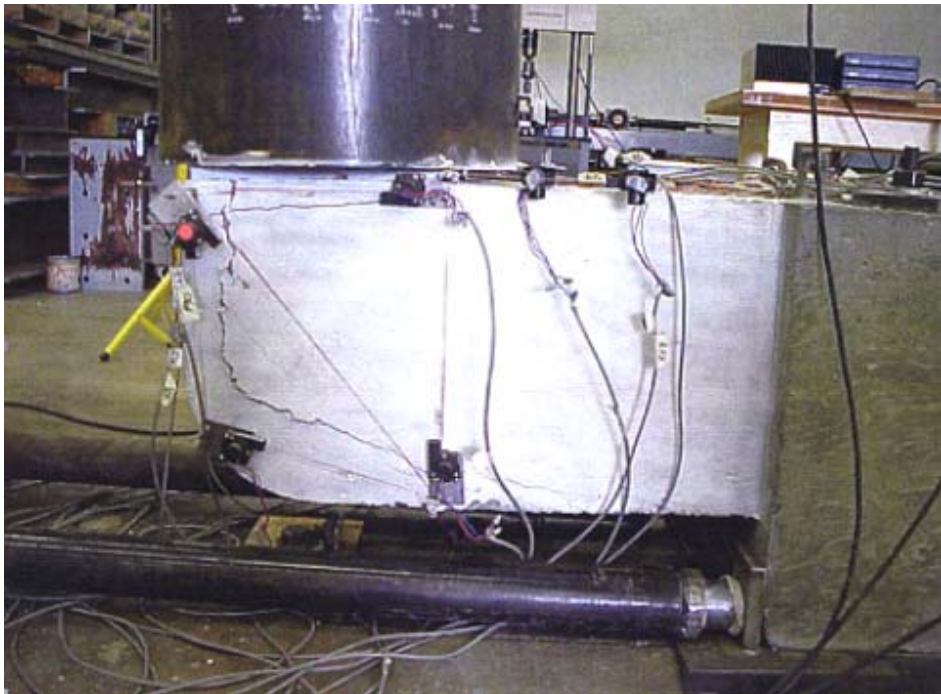
Figure 4.12 Specimen ASI at the End of 2.0 in. (51 mm) Displacement Level

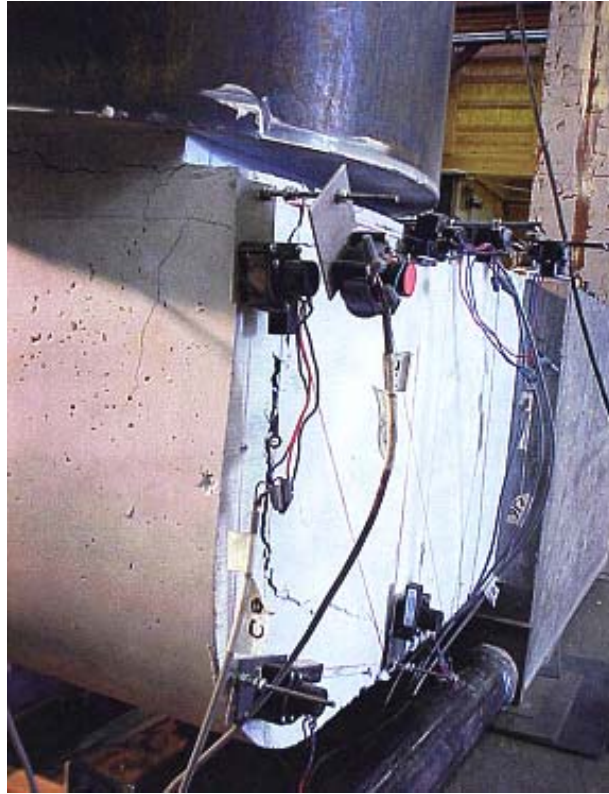
Figure 4.13 Bond Splitting Cracks on the Back Face of Specimen ASI

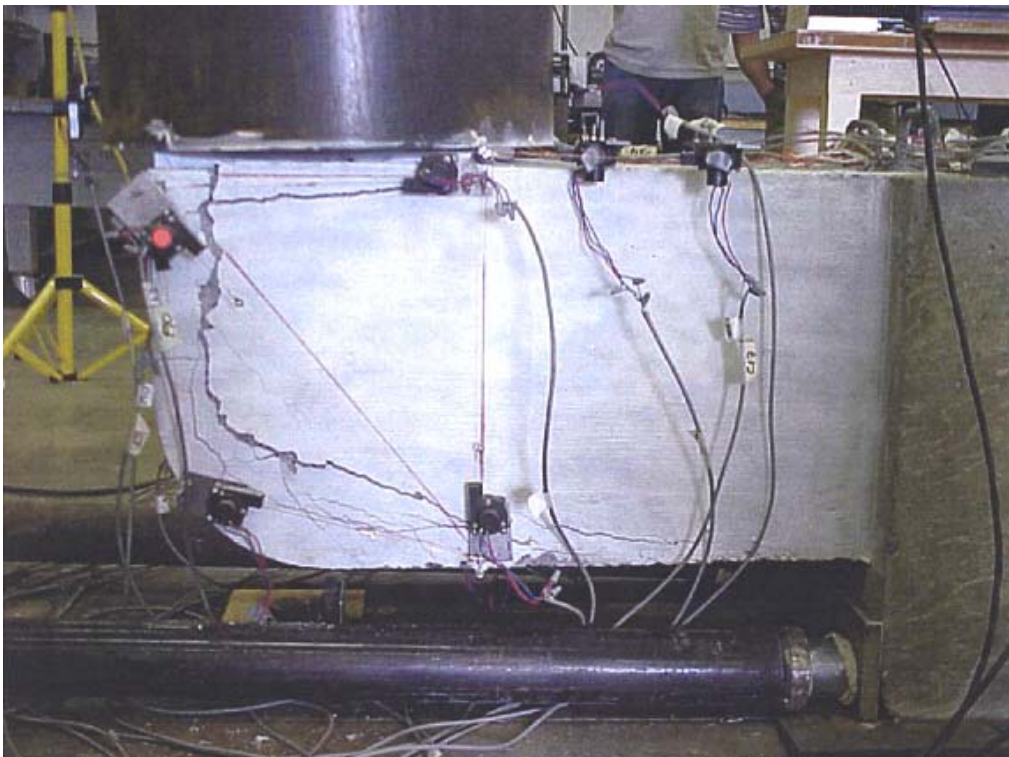
Figure 4.14 Specimen ASI at the End of 2.5 in. (64 mm) Displacement Level

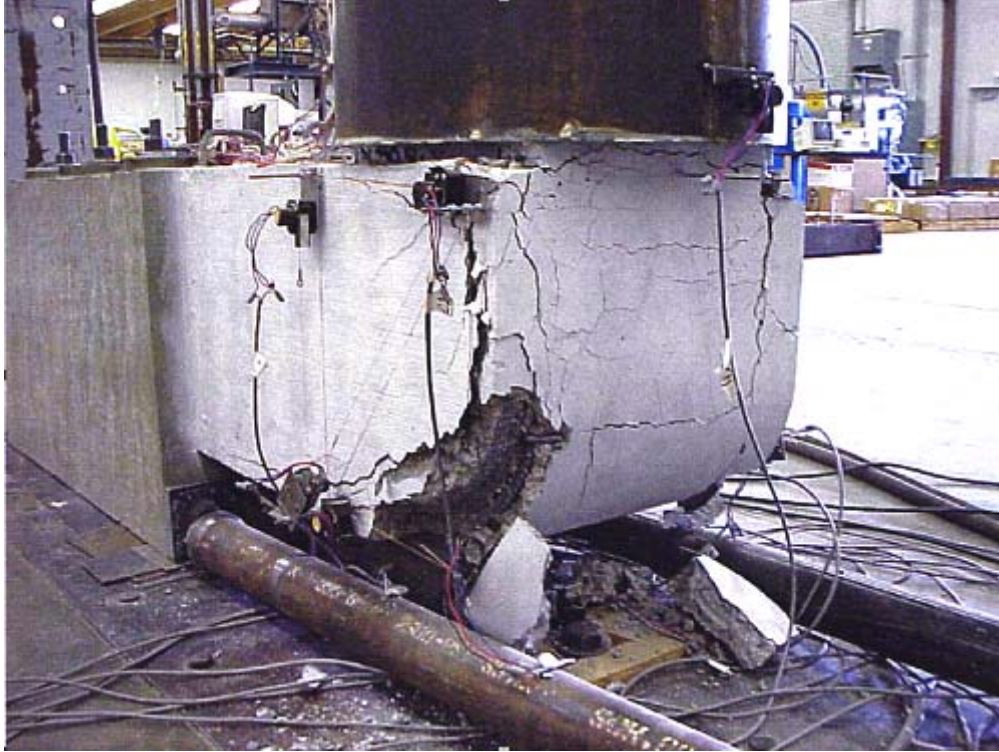
Figure 4.15 Concrete Spalling off as a Result of Splitting Bond Failure of the Column Reinforcement Within the Joint of Specimen ASI

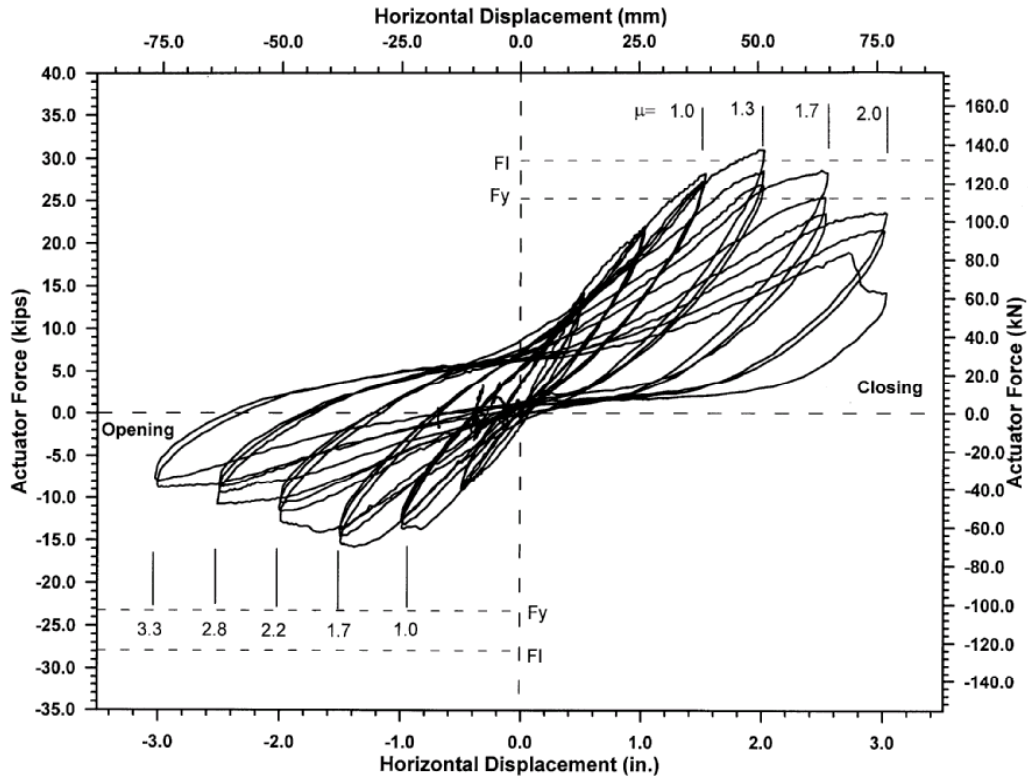
Figure 4.16 Actuator Force-Horizontal Displacement History for Specimen ASI

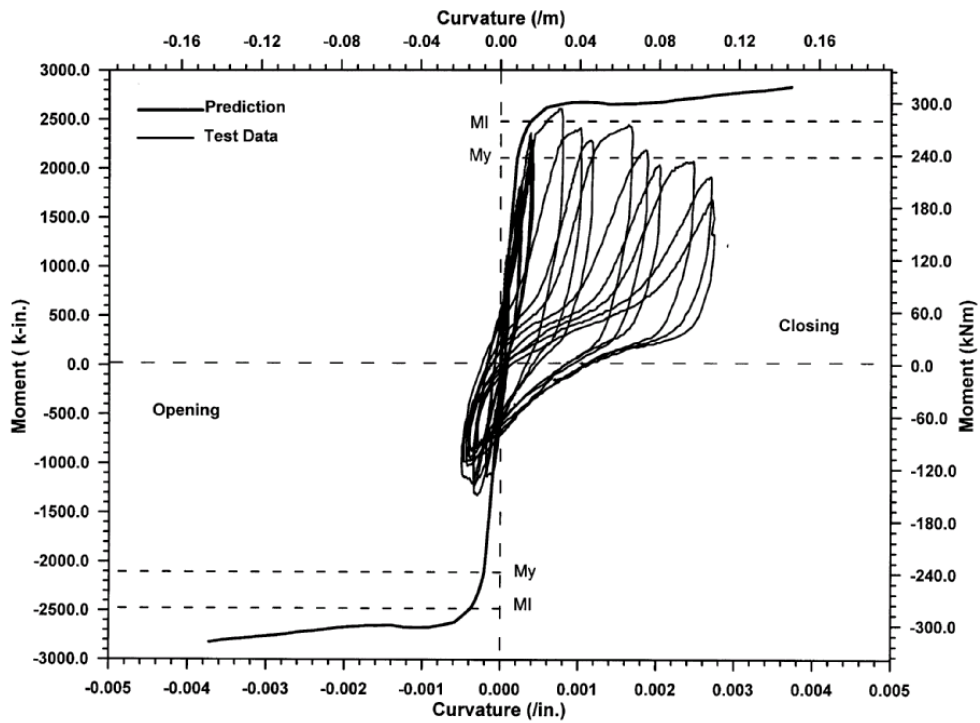
Figure 4.17 Column Moment-Curvature Response for Specimen ASI

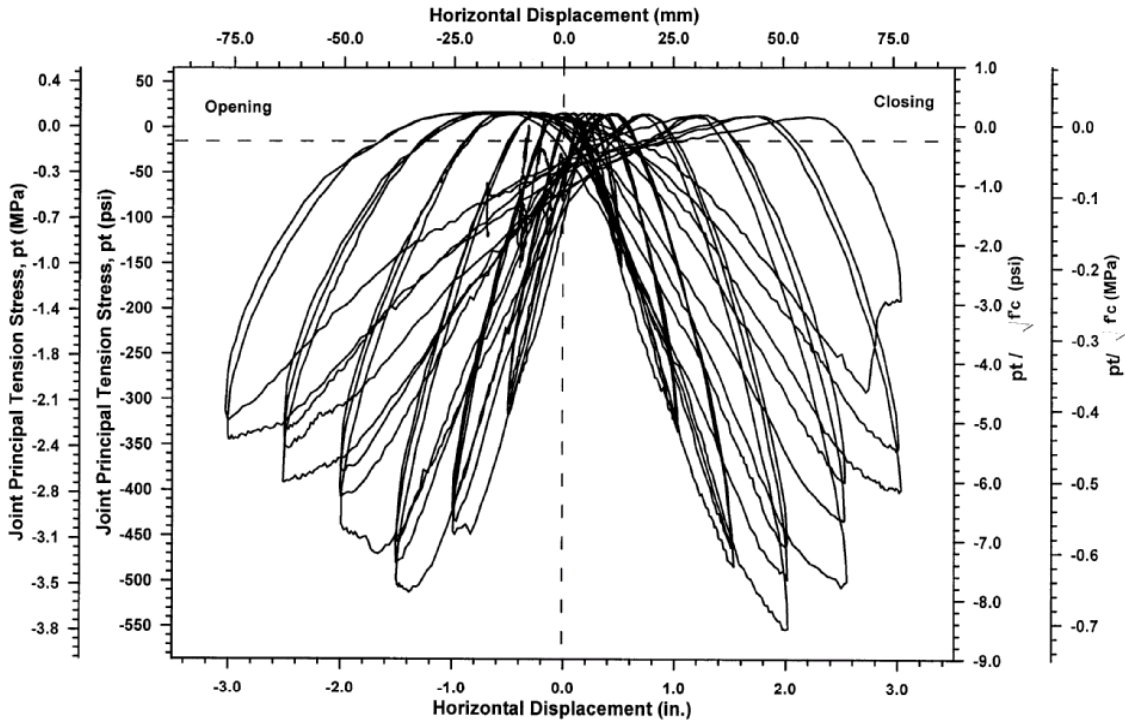
Figure 4.18 Joint Principal Tension Stress History for Specimen ASI

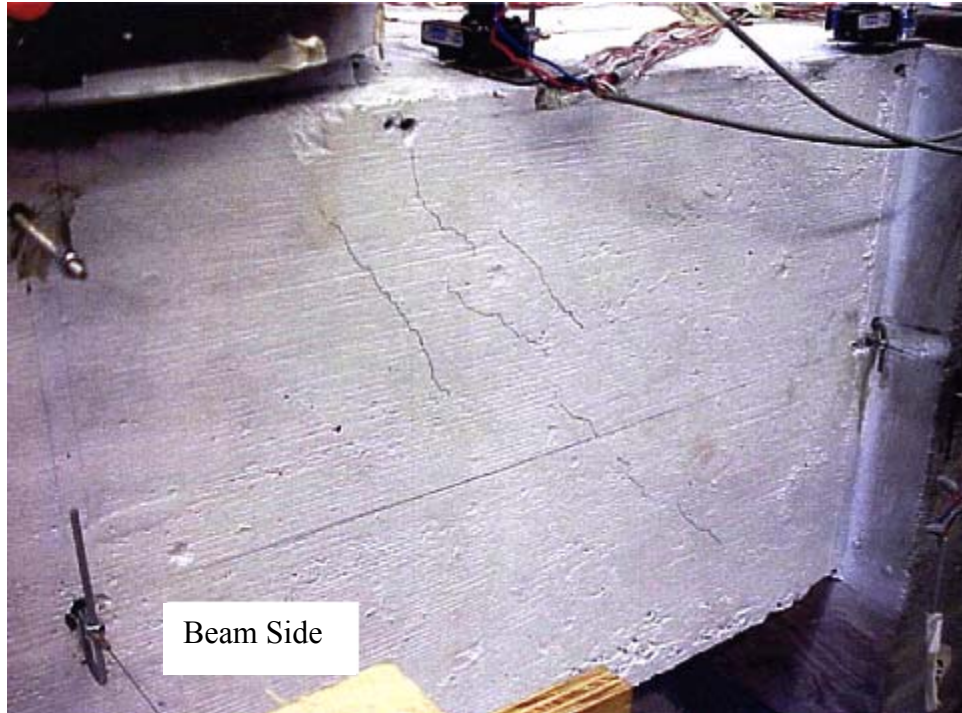
Figure 4.19 Early Torsional Cracking in the Outrigger Beam of Specimen ASO

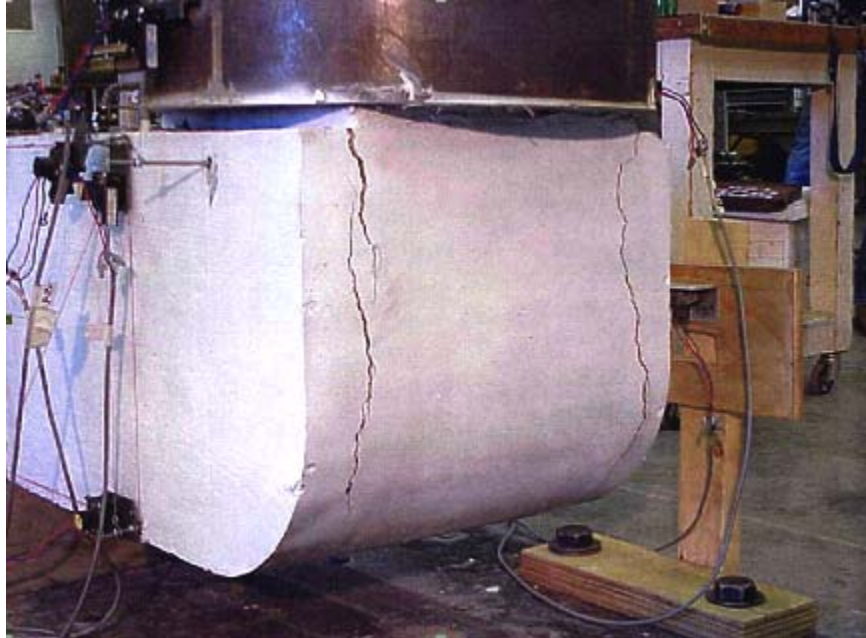
Figure 4.20 Bond Splitting Failure in the Back Face of Specimen ASO

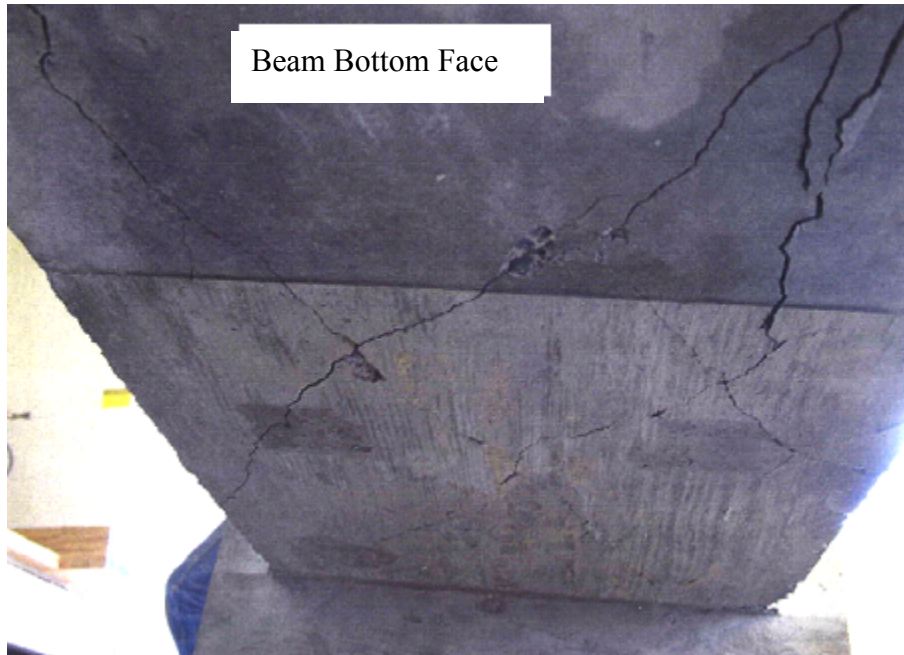
Figure 4.21 Torsional Cracks on the Bottom Face of Specimen ASO

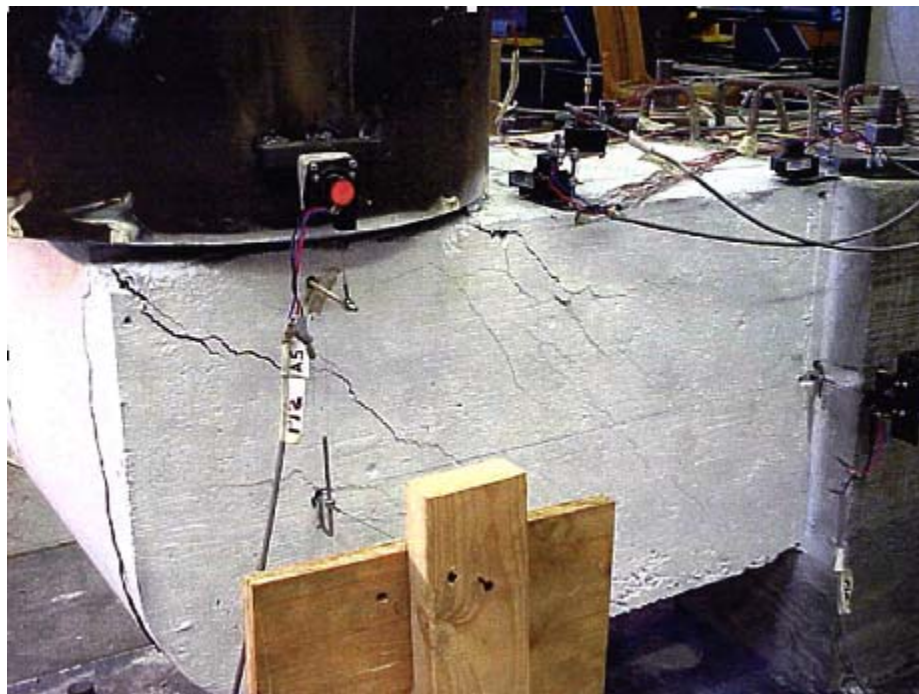
Figure 4.22 Torsional Cracks in the Outrigger Beam and the Joint of Specimen ASO at the End of the Test

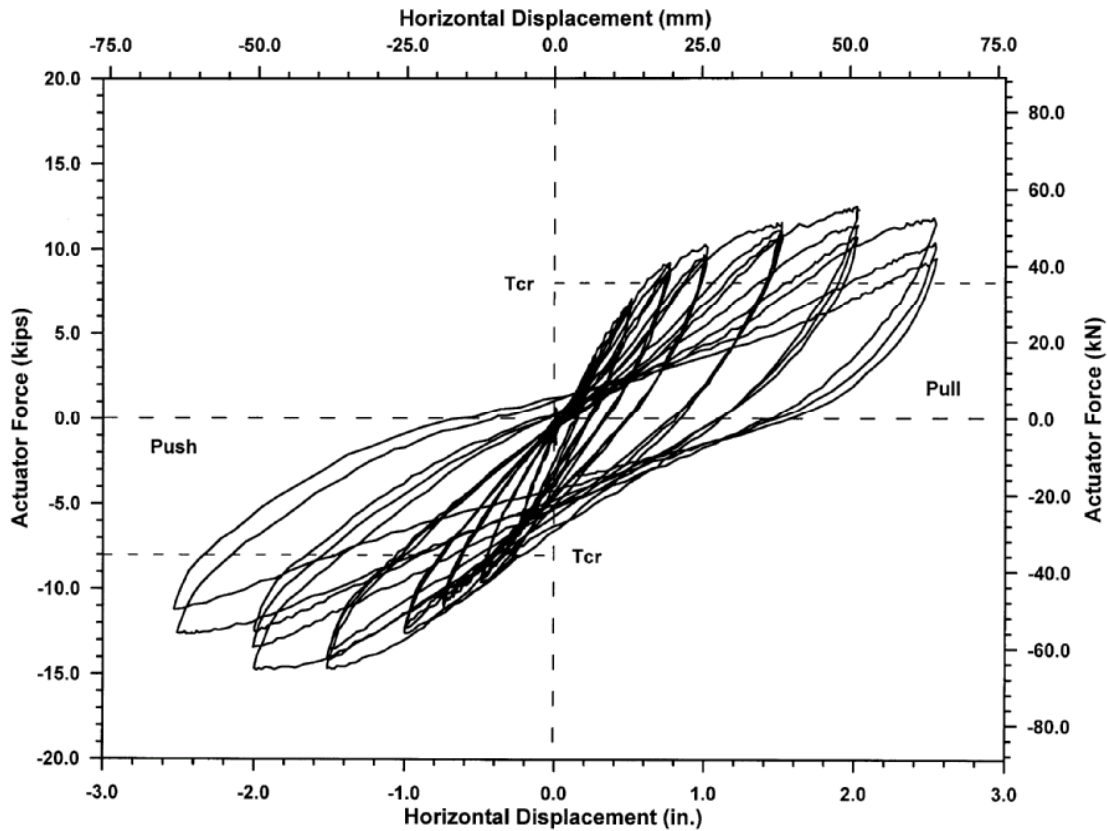
Figure 4.23 Actuator Force-Horizontal Displacement History for Specimen ASO

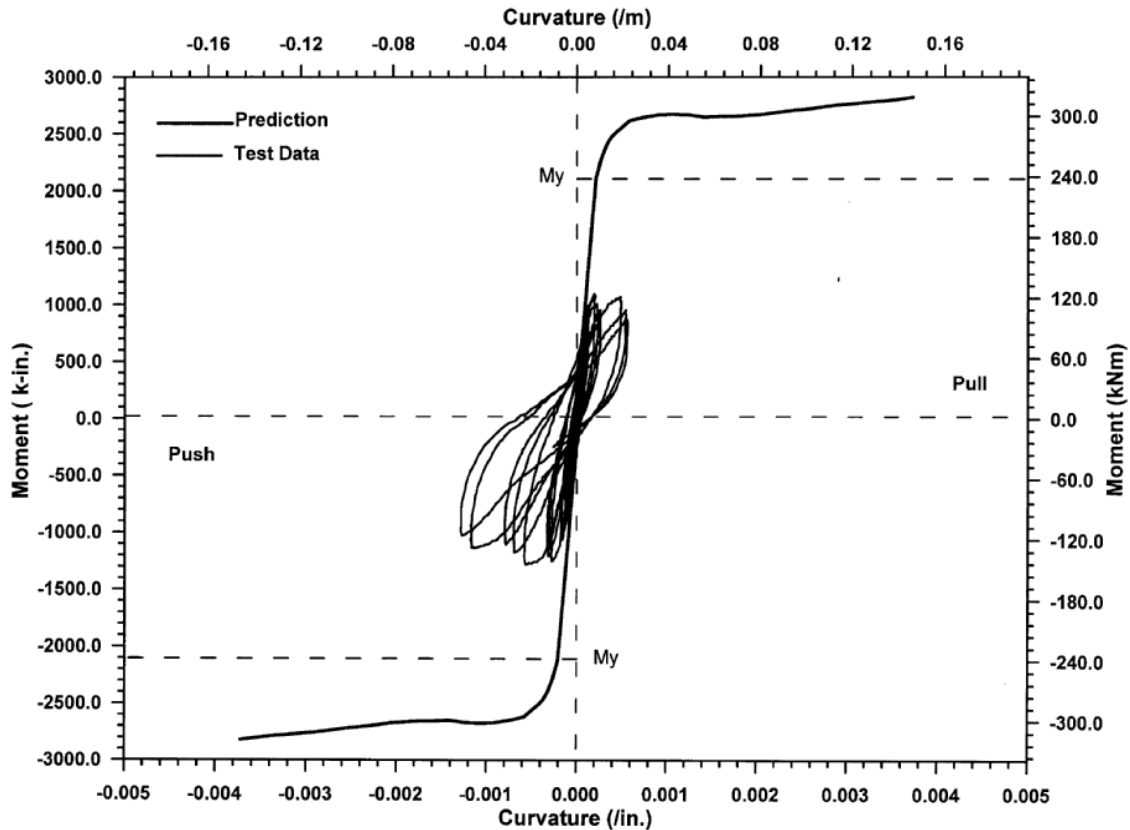
Figure 4.24 Column Moment-Curvature Response for Specimen ASO

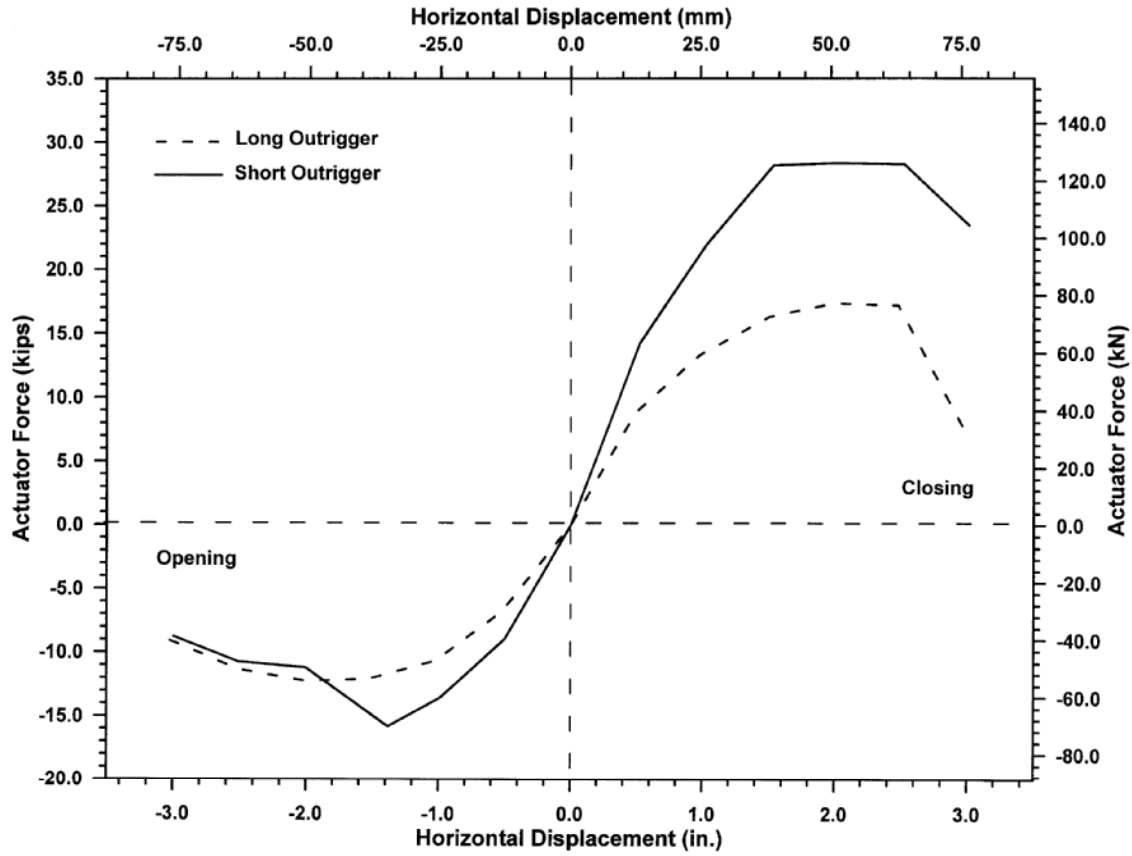
Figure 4.25 Actuator Force-Horizontal Displacement Envelopes for the As-Built Specimens Under In-Plane Loading

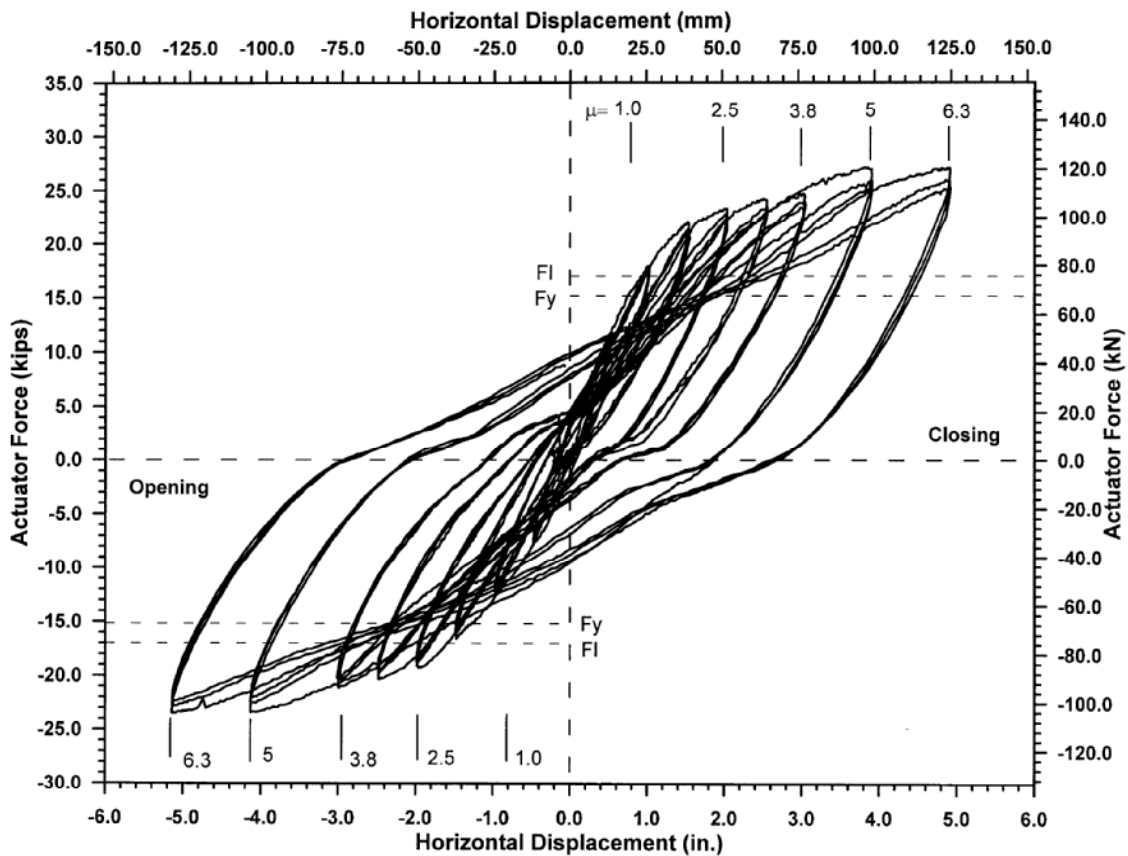
Figure 4.27 Actuator Force-Horizontal Displacement History for Specimen RLI

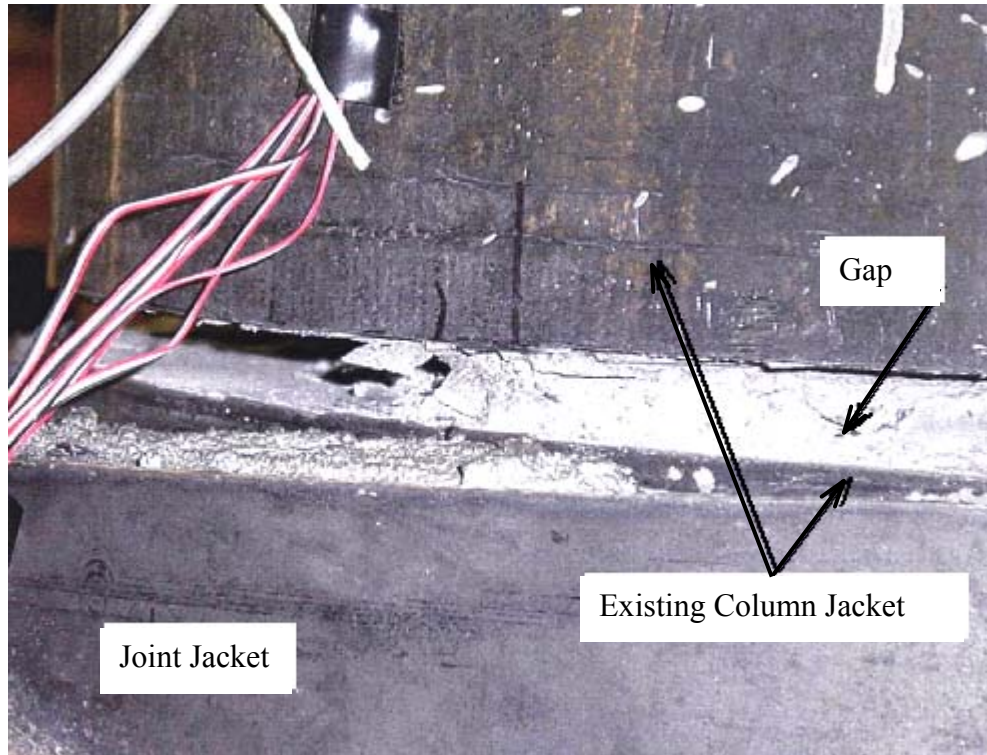
Figure 4.31 Spalling off Concrete at Column Corners for Specimen RSI

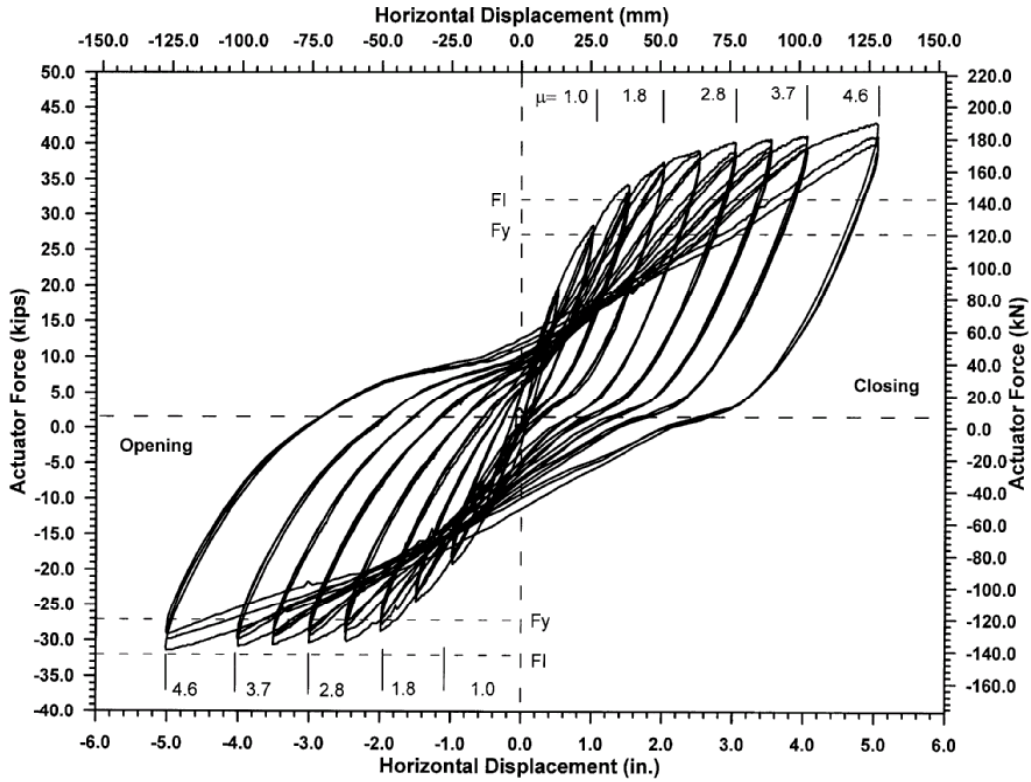
Figure 4.32 Actuator Force-Horizontal Displacement History for Specimen RSI

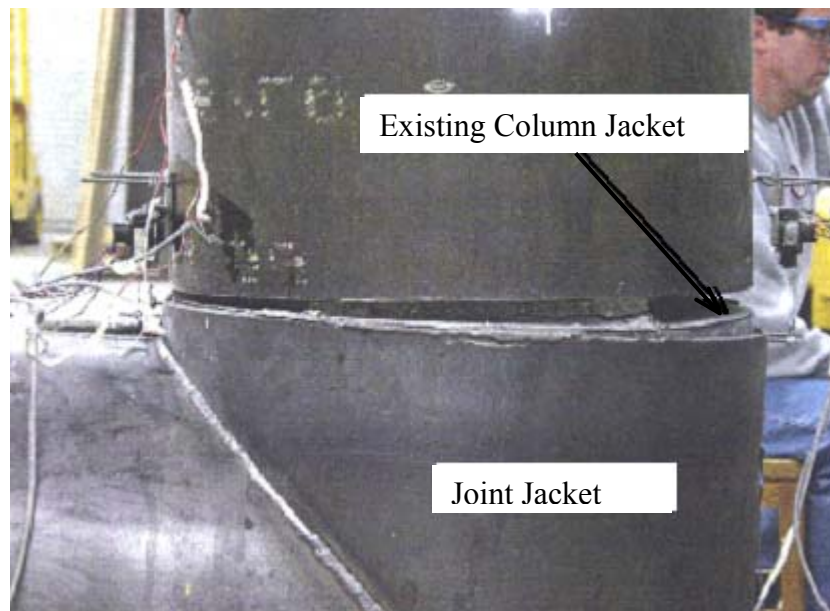
Figure 4.34 Slippage of the Existing Column Jacket Within the Joint Jacket

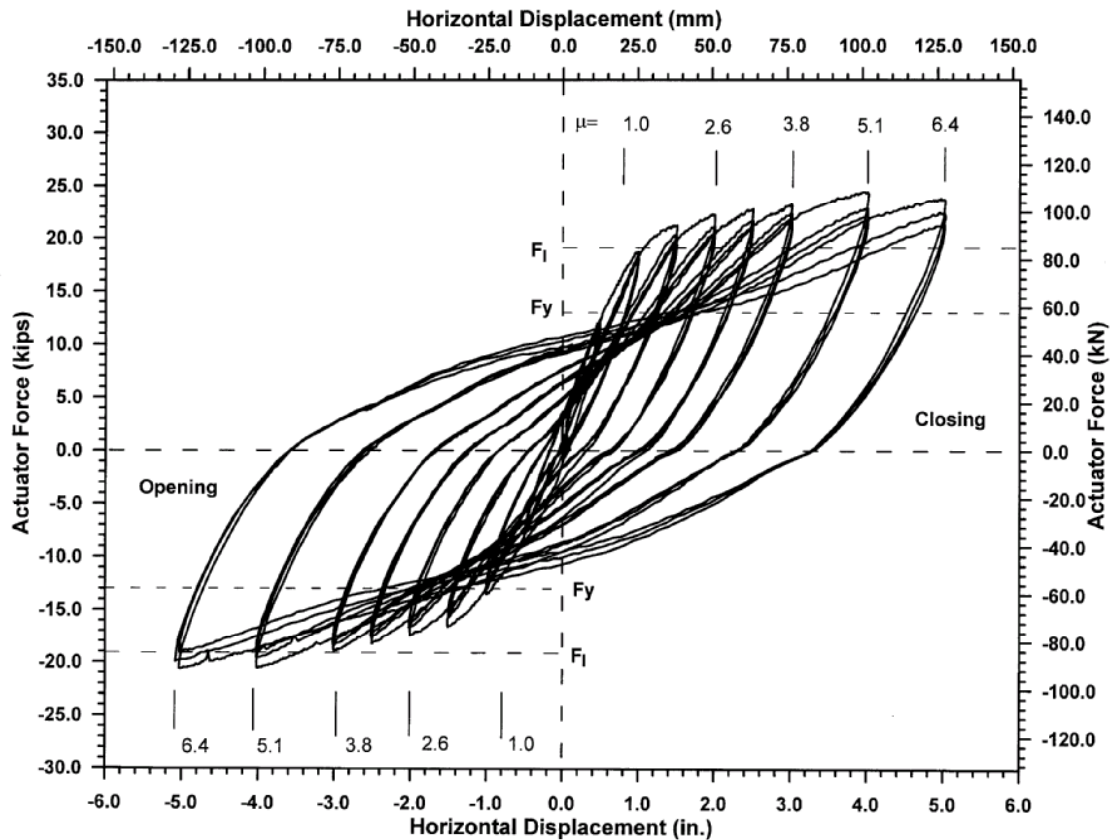
Figure 4.35 Actuator Force-Horizontal Displacement History for Specimen RSPLI
