SEISMIC BEHAVIOR AND RETROFIT OF OUTRIGGER KNEE JOINTS

NASIM KHALIL SHATTARAT

A dissertation submitted in partial fulfillment of the
requirements for the degree of

WASHINGTON STATE UNIVERSITY
Department of Civil and Environmental Engineering

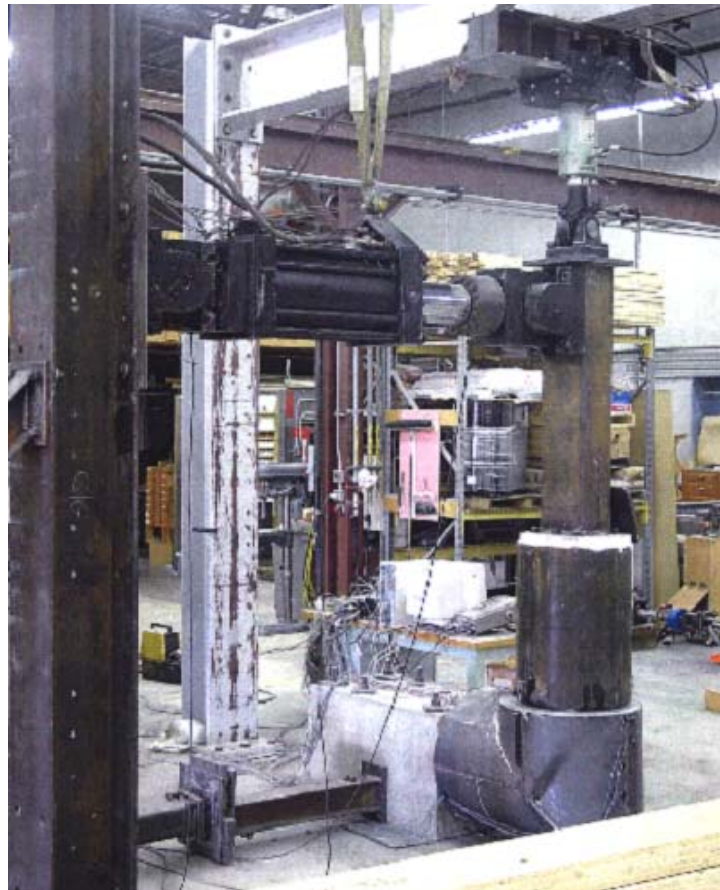
Figure 4.37 Specimen RSO at the End of Testing

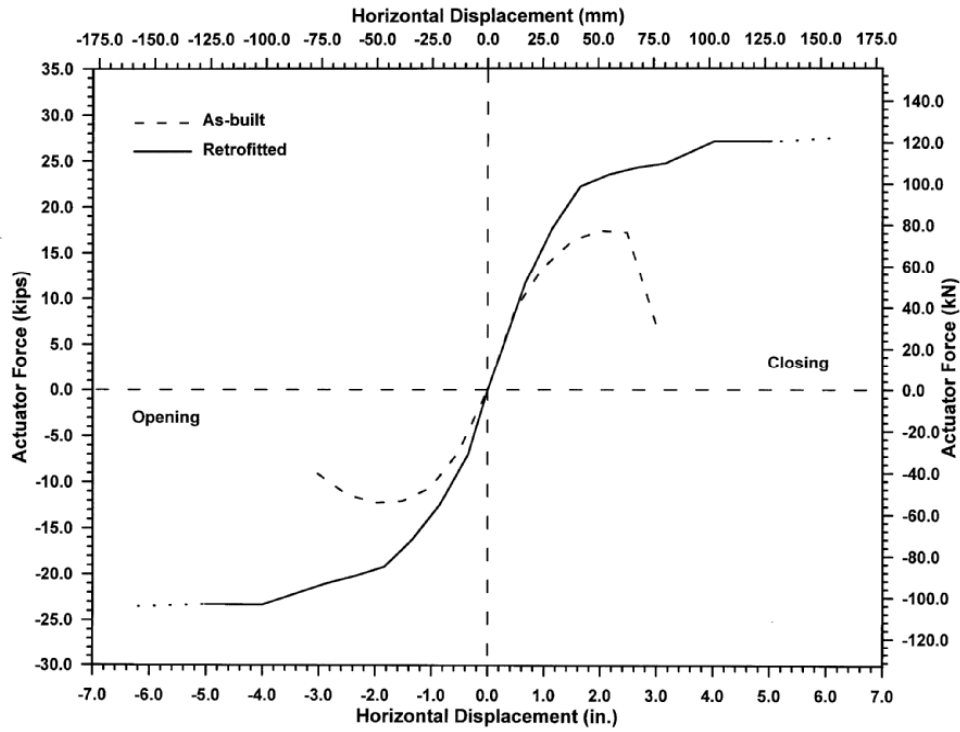
Figure 4.40 Force-Displacement Envelopes For Long Outrigger Specimens Under In-Plane Loading

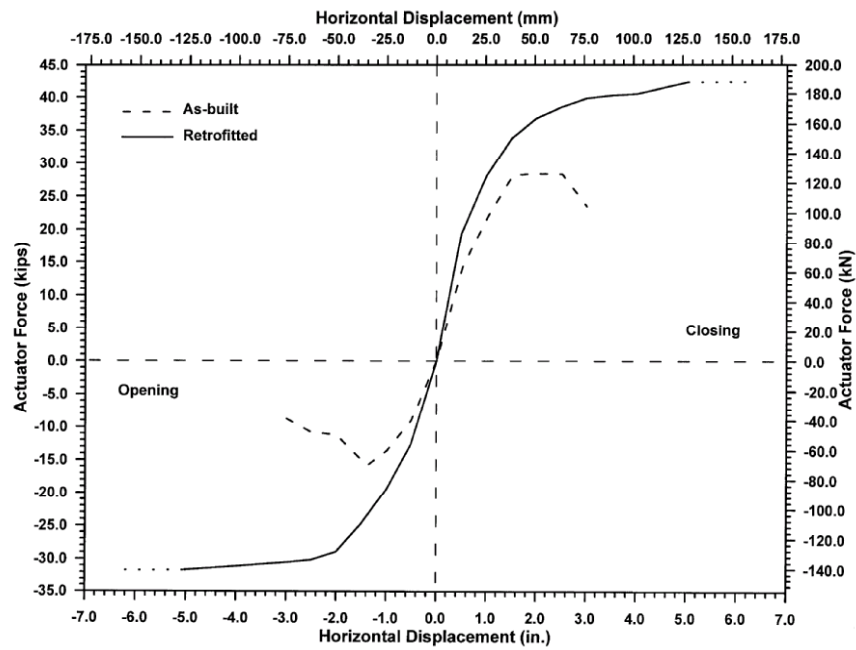
Figure 4.41 Force-Displacement Envelopes For Short Outrigger Specimens Under In-Plane Loading

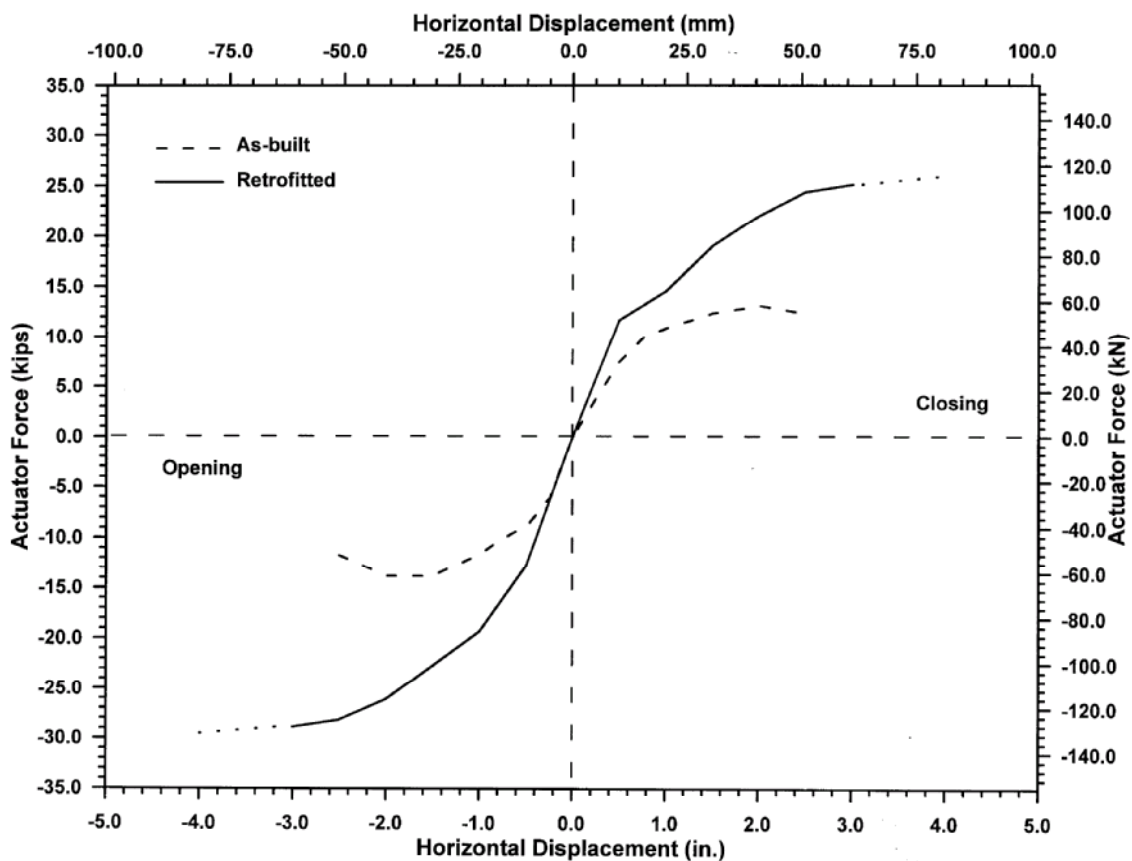
Figure 4.42 Force-Displacement Envelopes For Short Outrigger Specimens Under Out-of-Plane Loading

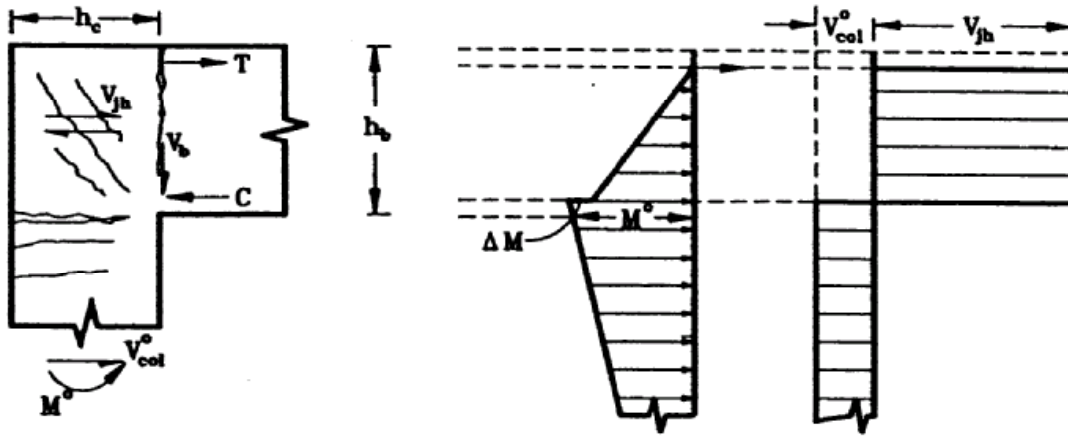
Figure 5.2 Moment and Horizontal Shear Force Distribution in a Knee Joint at Column Overstrength Condition (Adapted from Priestley et al., 1996)

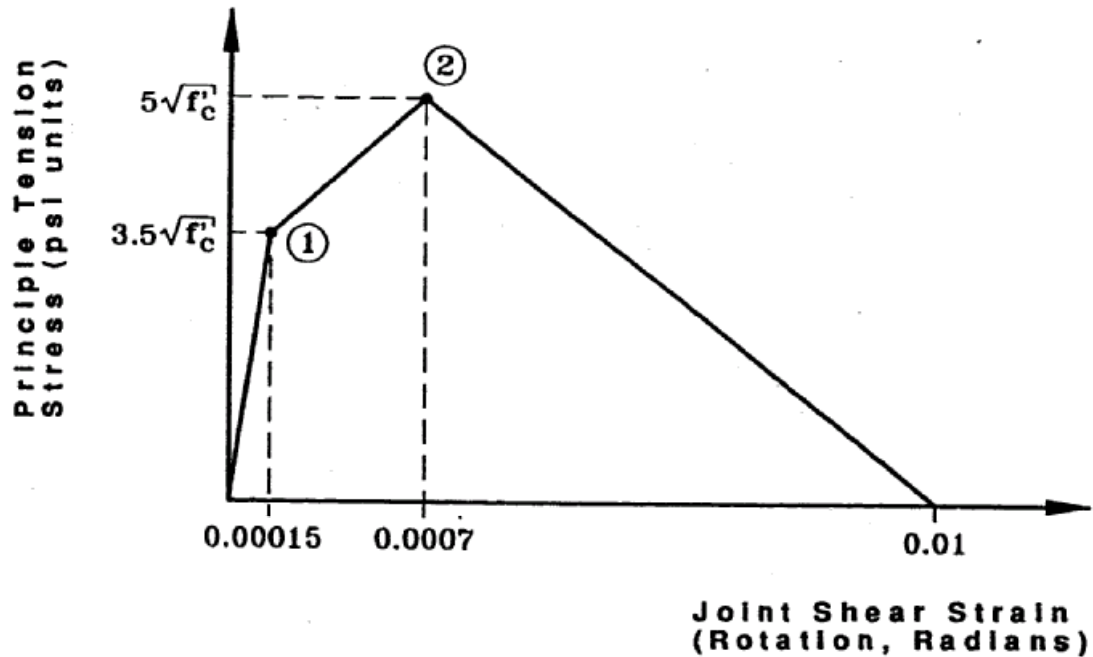
Figure 5.4 Proposed Failure Mechanism for Existing Knee Joints (Adapted from Priestley, 1993)

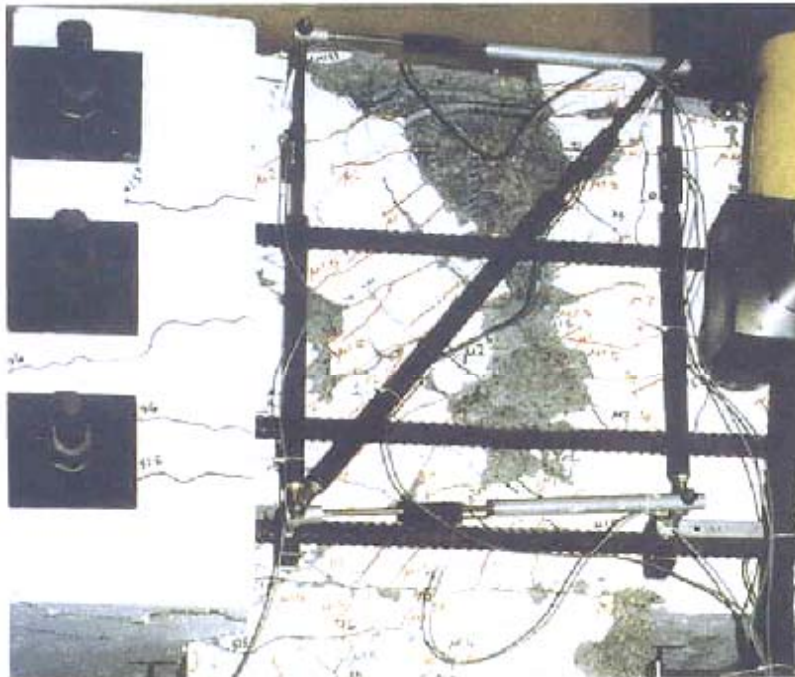
Figure 6.1 Crushing Failure Mode in a Knee Joint (Adapted from Sritharan and Ingham, 2003)

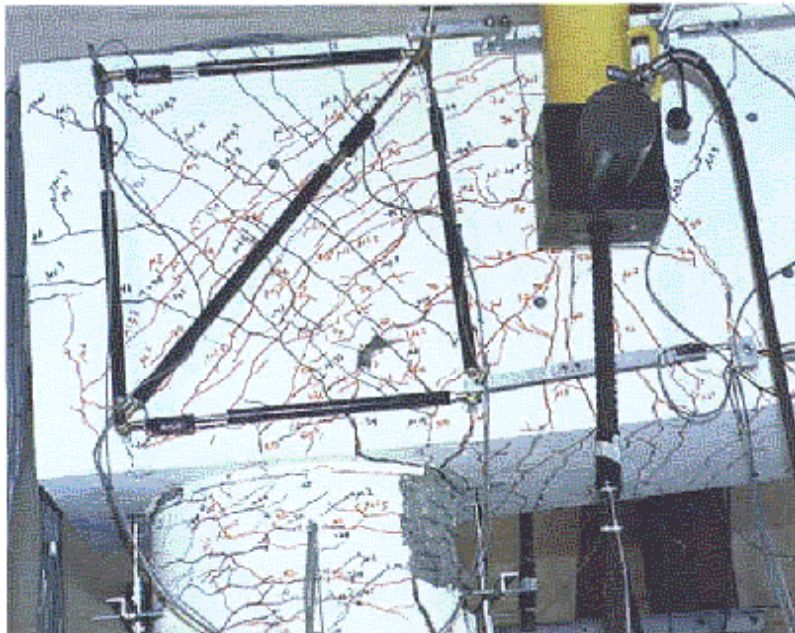
Figure 6.2 Anchorage Failure Mode in a Knee Joint (Adapted from Sritharan and Ingham, 2003)

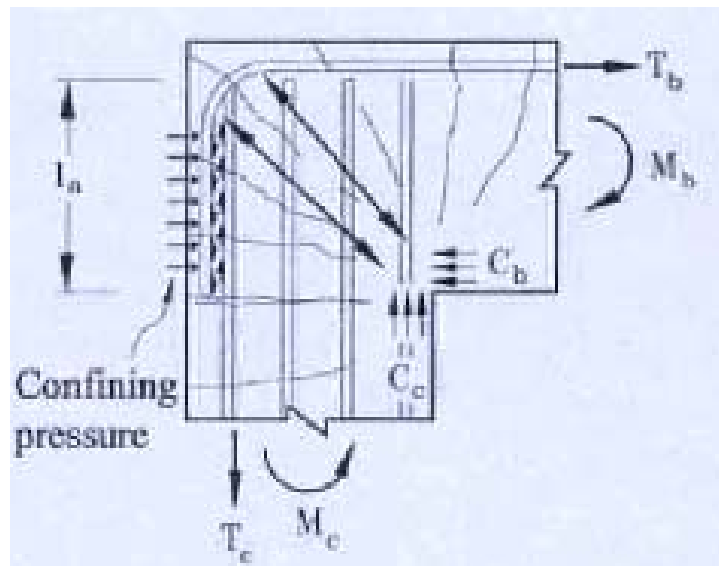
Figure 6.3 Force Transfer by Bond in a Lap Splice With Adequate Confining Pressure (Adapted from Sritharan and Ingham, 2003)

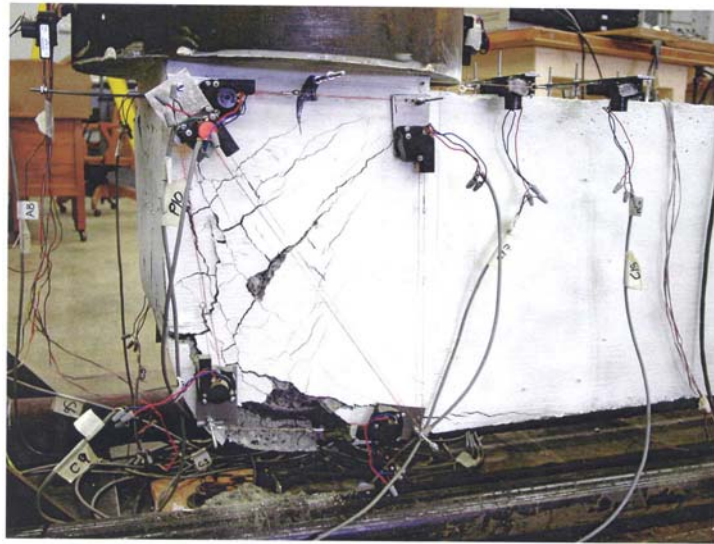
Figure 6.4 Bond Splitting Failure Mode in a Knee Joint

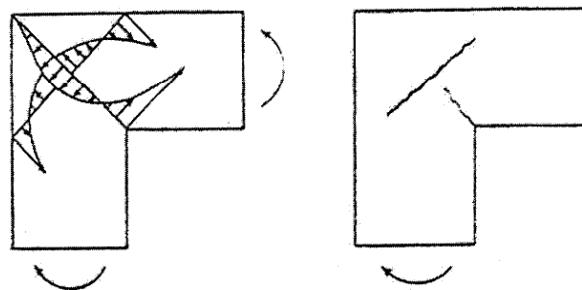
Figure 6.5 Tensile Stress Distribution and Associated Cracking Pattern
<http://best.umd.edu/publications/stm.pdf>

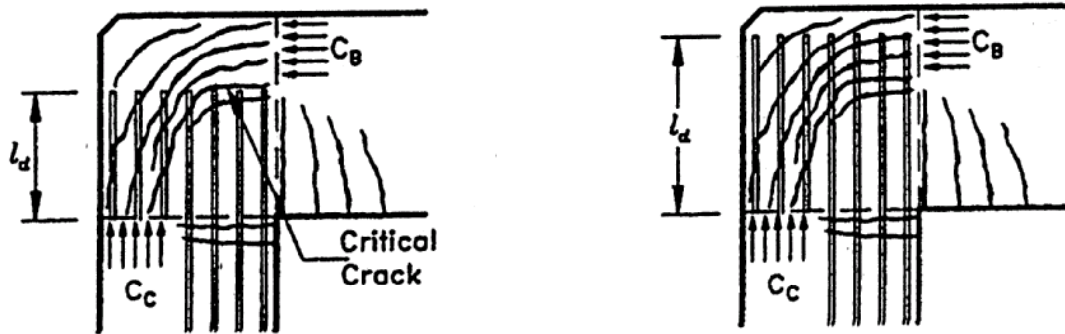
Figure 6.8 Cracking Pattern Under Opening of the Joint for Insufficient and Sufficient Embedment Rebar Lengths (Adapted from Ingham, 1995)

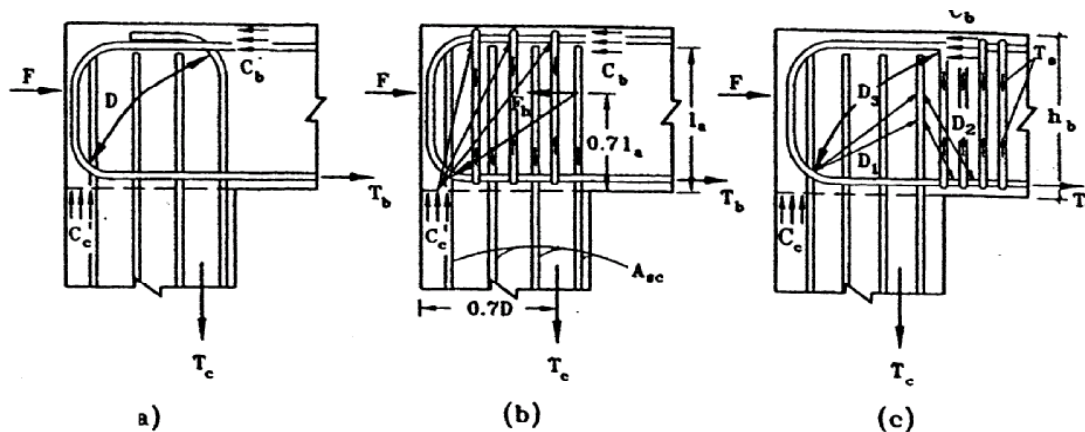
Figure 6.9 Knee Joint Reinforcement Under Opening Moments (Adapted from Priestley et al., 1996)

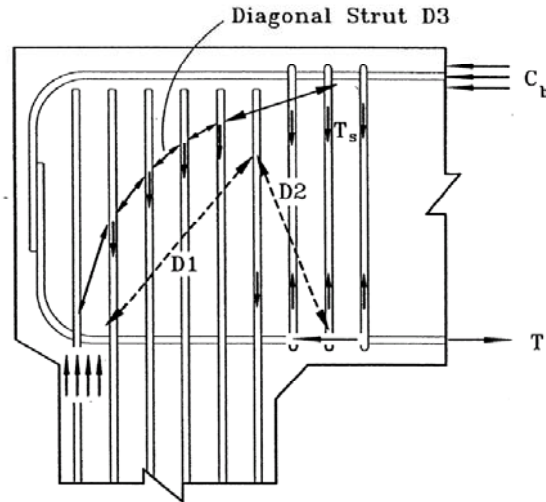
Figure 6.10 Force Transfer Mechanism In a Knee Joint Under Opening Moment (Adapted from Priestley et al., 1996)

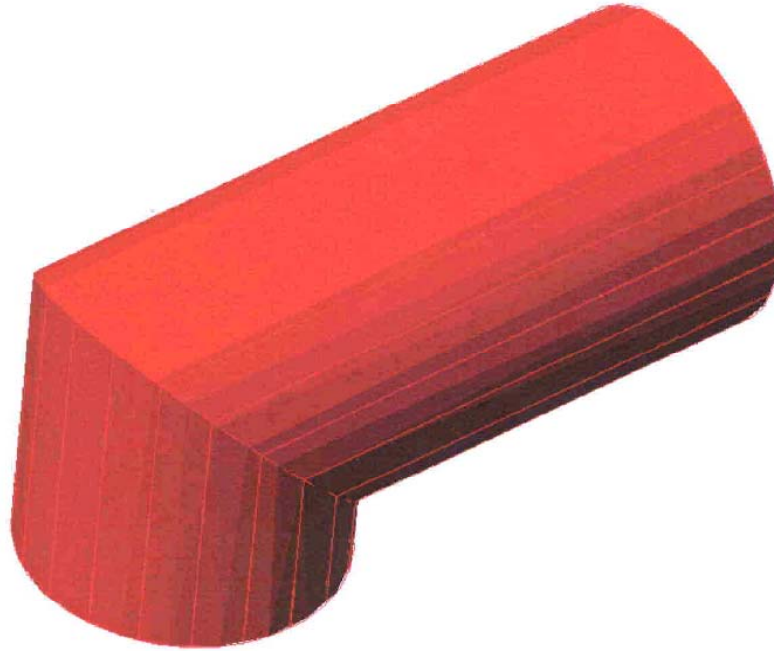
Figure 6.16 Isometric shape of the Beam-Joint Steel Jacket
