NONDESTRUCTIVE DETECTION OF POST-TENSIONING TENDONS AND SIMULATED
VOIDS IN CONCRETE SPECIMENS USING THERMAL IMAGING

This thesis submitted in partial fulfillment of
the requirements for the degree of

MASTER OF SCIENCE IN CIVIL ENGINEERING

WASHINGTON STATE UNIVERSITY
Department of Civil and Environmental Engineering

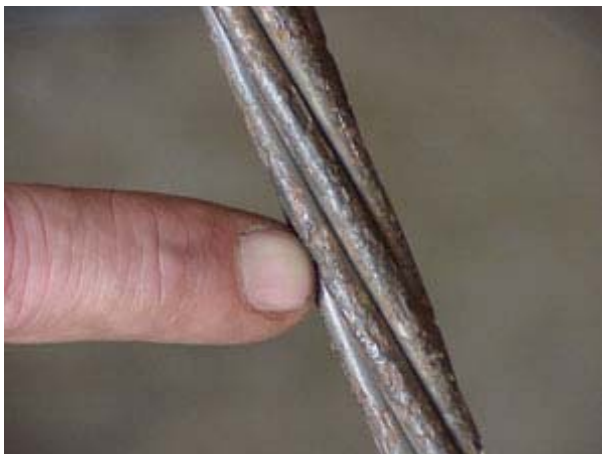
Figure 1.2 – Pitting corrosion on a post-tensioning strand from the Mid-Bay Bridge, Florida (Beitelman, 2000)

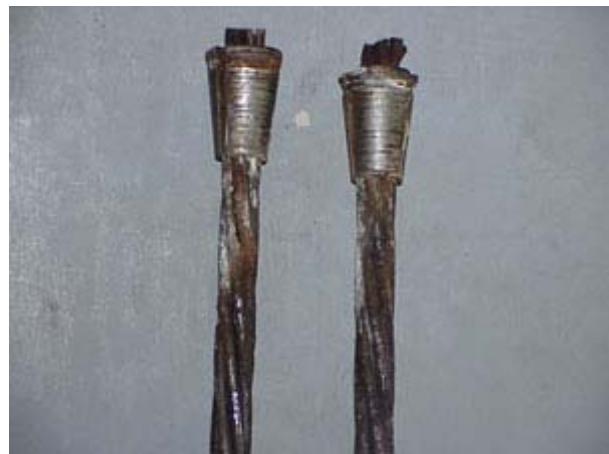
Figure 1.3 – Corroded strand ends removed from an anchorage in the Mid-Bay Bridge, Florida (Beitelman, 2000)

Corrosion of the steel strands was observed at various locations along the length of the tendons and at the anchorages. The corrosion of the strands near the anchorages was determined to be caused by two contributing factors. Possible accumulation of bleed water in the voids near the anchorage as indicated in Figure 1.1 and moisture and chloride penetration around the end protection were the main sources of the corrosion. This would not have been as much of a factor if the voids in those locations were not present. The voids near the anchorages were a result of excessive accumulations of bleed water, improper water content in the grout, and improper grouting practices (FDOT, 2001).

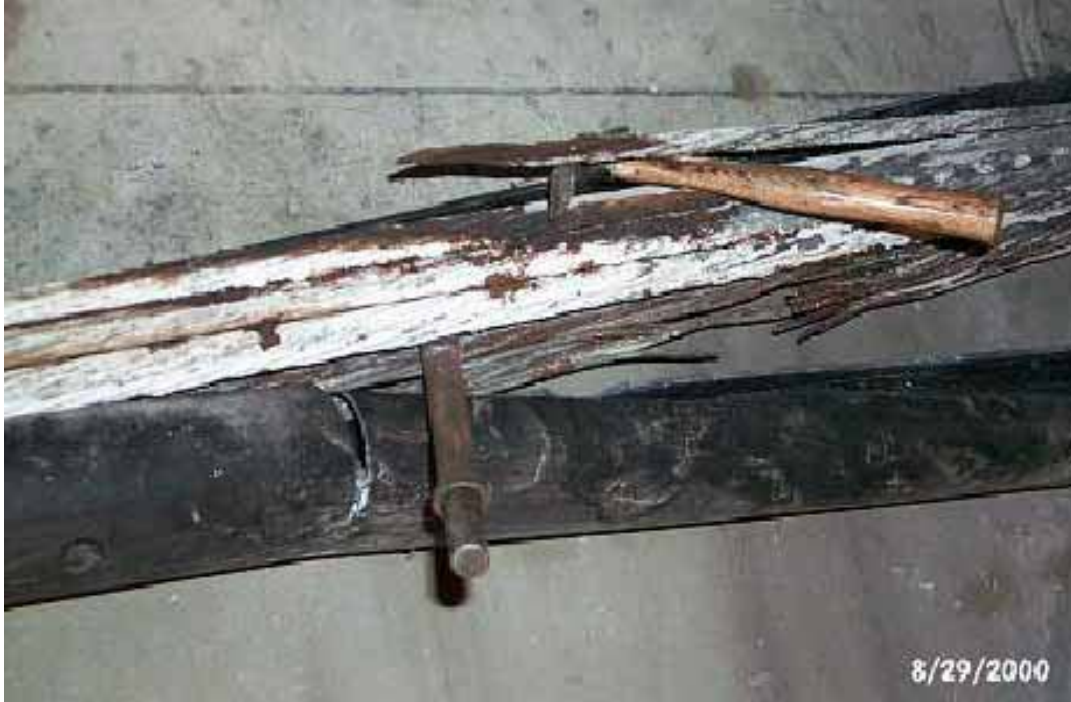
Corrosion along the length of the tendons also was caused by multiple factors. Bleed water in the voids and cracks or splits in the HDPE ducts were the most notable problems. The voids found along the length of the tendons were also a result of excessive accumulations of bleed water, improper water content in the grout, and improper grouting practices (FDOT, 2001). Testing was conducted on the HDPE ducts and it was established that the environmental stress cracking resistance (ESCR) of the HDPE material did not meet the standards at the time the bridge was constructed. Mechanical damage to the ducts was also observed in limited cases. The primary damage noted was intentional punctures. These punctures had been made in the ducts to check for voids in the grout during construction (Frank et al., 2003). Figure 1.4 shows a failure along the length of one of the tendons in the Mid-Bay Bridge.

Figure 1.4 – Failure of a tendon in the
Mid-Bay Bridge, Florida
(Breen et al., 2004)

As can be seen in the figures above, after only seven years of service, the Mid-Bay Bridge had significant structural damage to the post-tensioning system. After the inspections were completed and all of the major problems were addressed, eleven of the tendons had to be replaced at a cost of approximately \$1 million dollars (Frank et al., 2003). Since the Mid-Bay Bridge had an external post-tensioning system, the tendons were not encased in the concrete cross section of the bridge, but the problems observed could occur in a similar fashion on an internal post-tensioning system.

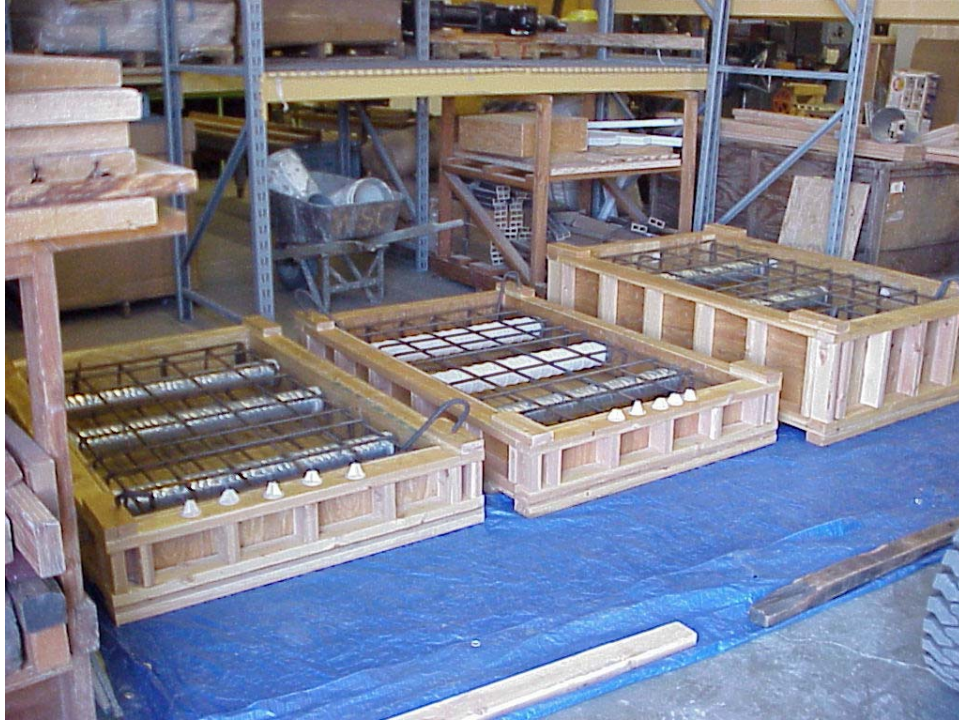
Each specimen contained three post-tensioning ducts extending across the 102 cm (40 in) width, spaced at approximately 40 cm (16 in) on center. The ducts in the 20 cm (8 in) thick specimens and one 30 cm (12 in) specimen were placed at mid-thickness in the specimens to achieve identical concrete cover on both surfaces. In the other 30 cm (12 in) and 40 cm (16 in) thick specimens, the ducts were positioned at different depths in the specimens to provide varying concrete cover to each face (Pearson, 2003). In some of the specimens, the ducts shifted slightly from their original positions during construction. Figure 4.1 shows the formwork, rebar, and post-tensioning ducts for two 20 cm (8 in) thick specimens and one 40 cm (16 in) thick specimen.

Figure 3.1 - Formwork, rebar and post-tensioning ducts in 20 cm (8 in) and 40 cm (16 in) thick specimens (Pearson, 2003)

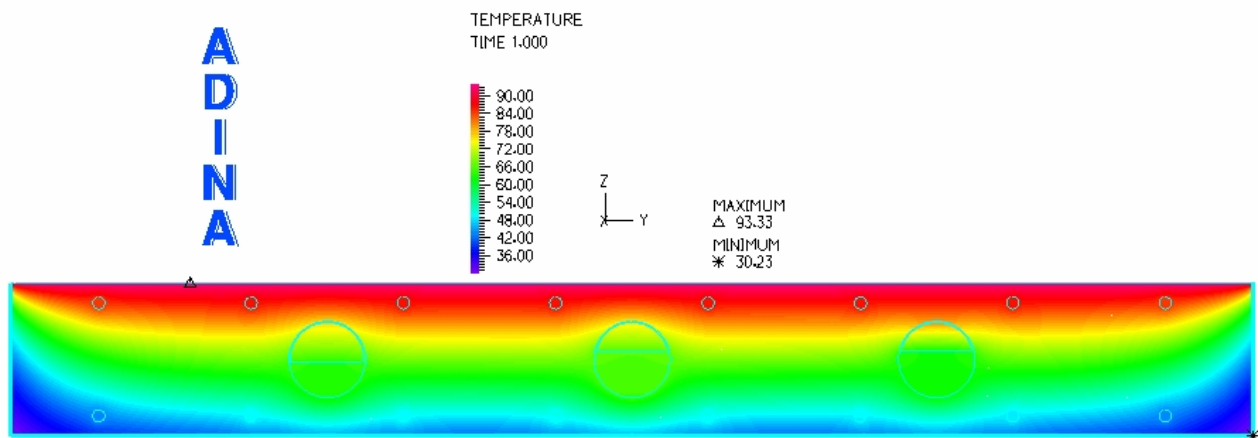
All of the ducts in 20 cm (8 in) thick Specimen 1 were steel. The bottom duct (located near the right edge of the specimen in Figure 3.5) contained 30 post-tensioning steel strands with a 15 cm (6 in) long by 3.7 cm (1.5 in) thick simulated void. The top duct (located near the left edge of the specimen in Figure 3.5) contained 20 steel strands and the center duct contained 30 steel strands, each without simulated voids. The depth of concrete cover to each of the tendons was 5 cm (2 in). Figure 3.5 displays the temperature distribution throughout the cross-section of Specimen 1 for a 93.3°C (200°F) applied temperature loading.

Figure 3.5 – Temperature distribution throughout Specimen 1 with a 93.3°C (200°F) temperature loading from ADINA

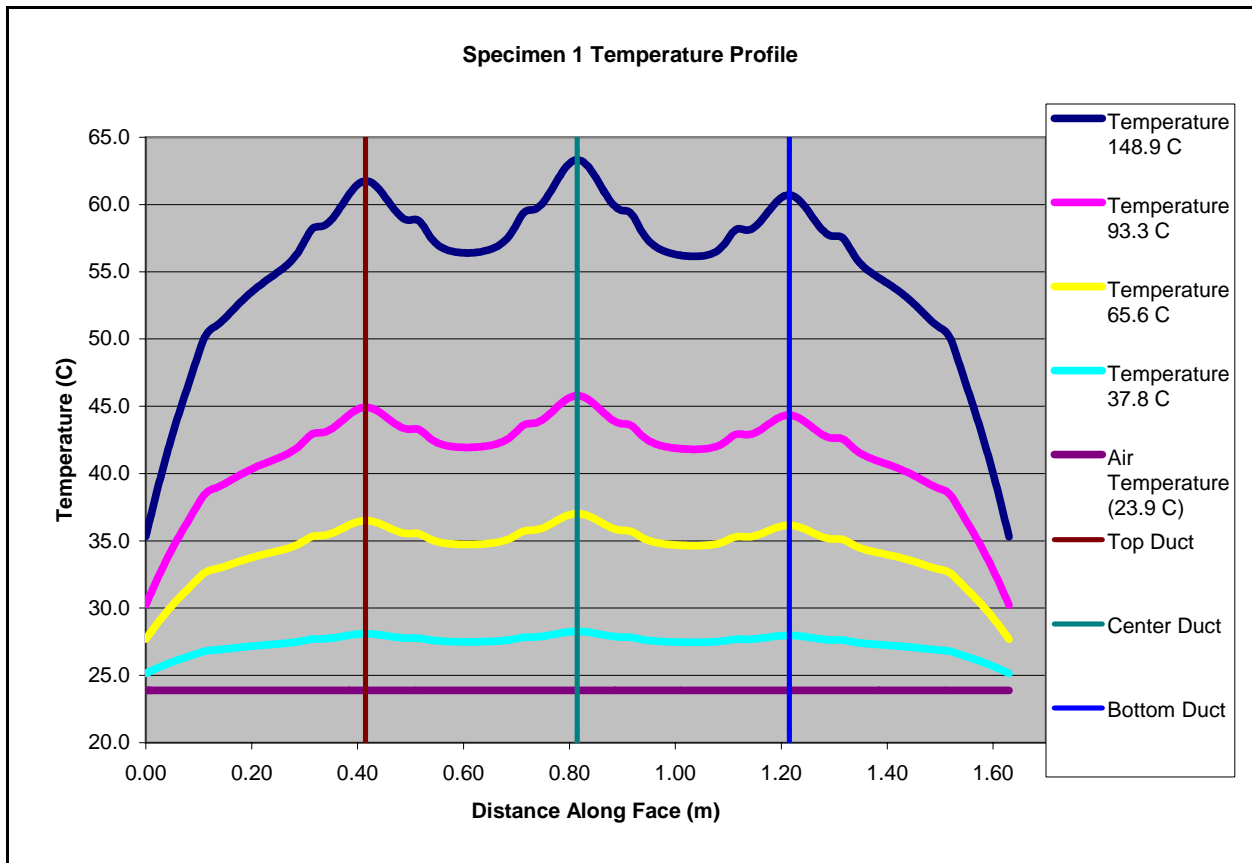
specimens where the convection cooling was more predominant, the surface temperature variations caused by materials embedded in the specimens were more difficult to detect near the edges of the specimens. Warm spots on the unheated specimen surface caused by embedded steel were masked by the convection cooling.

Figure 3.6 – Temperature profile along bottom surface of Specimen 1 for various temperature loadings

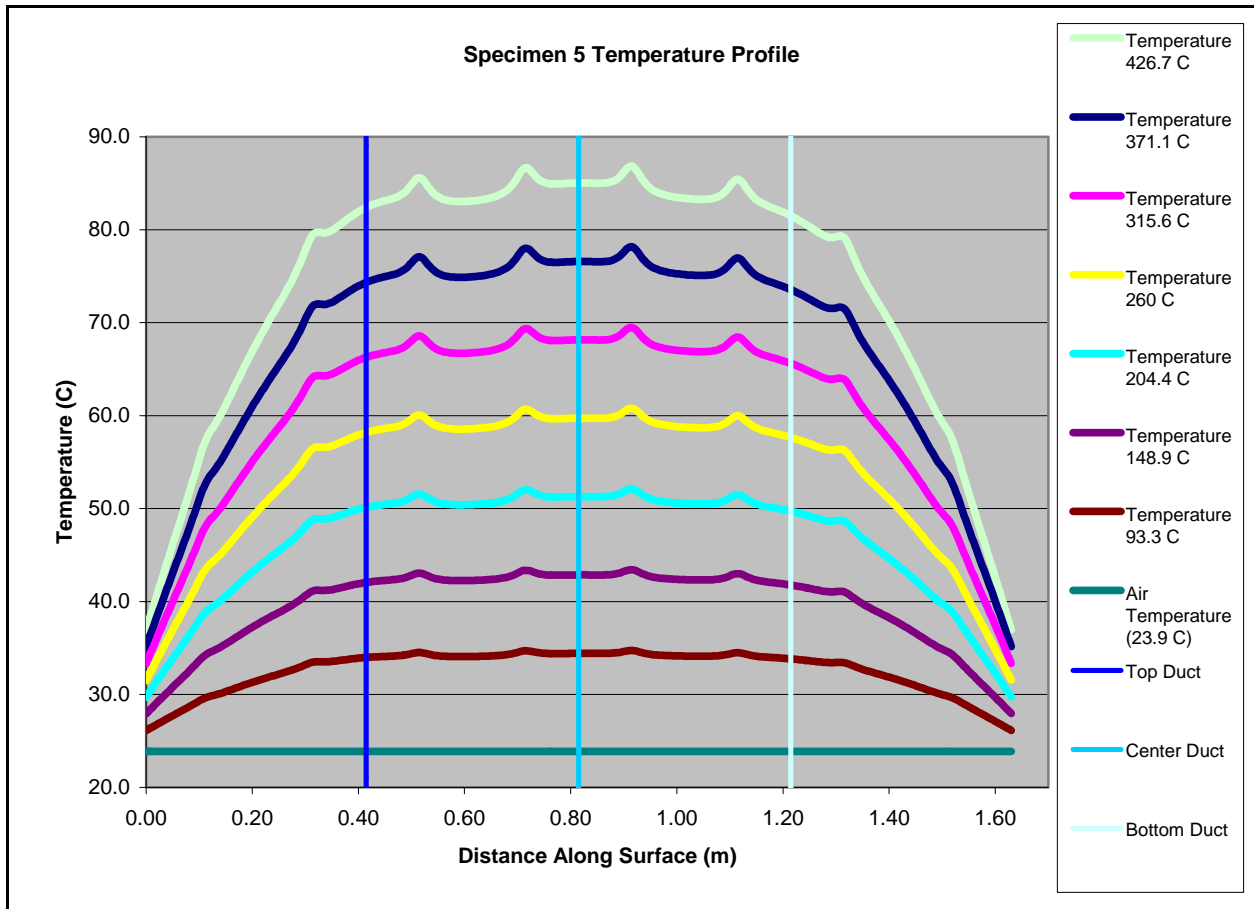
The trends observed regarding depth of concrete cover in Specimen 3 were very similar to those observed in Specimen 5. The bottom tendon was located 5 cm (2 in) closer to the heated surface than the top, but each contains the same amount of post-tensioning steel. As seen in Specimen 3, the bottom tendon appeared the coldest because of the large concrete cover distance between the tendon and the unheated surface. This large volume of concrete allowed the thermal energy to dissipate throughout the cross-section as it flowed through the thickness of the specimen. Figure 3.14 is a temperature profile plot with respect to position along the bottom surface of the model for seven different temperature loadings for Specimen 5.

Figure 3.14 - Temperature profile along bottom surface of Specimen 5 for various temperature loadings

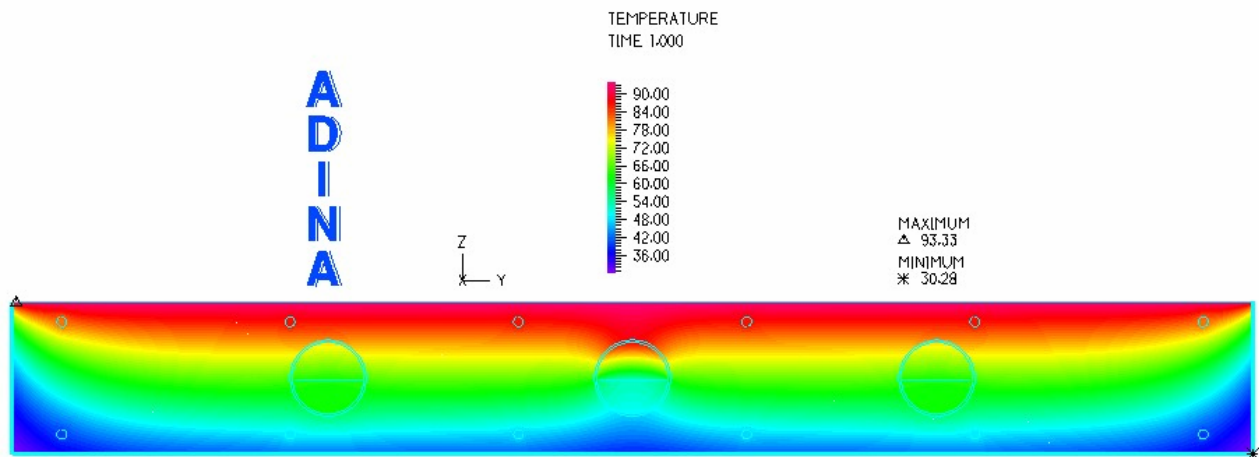
Figure 3.17 - Temperature distribution throughout Specimen 7 with a 93.3°C (200°F) temperature loading from ADINA

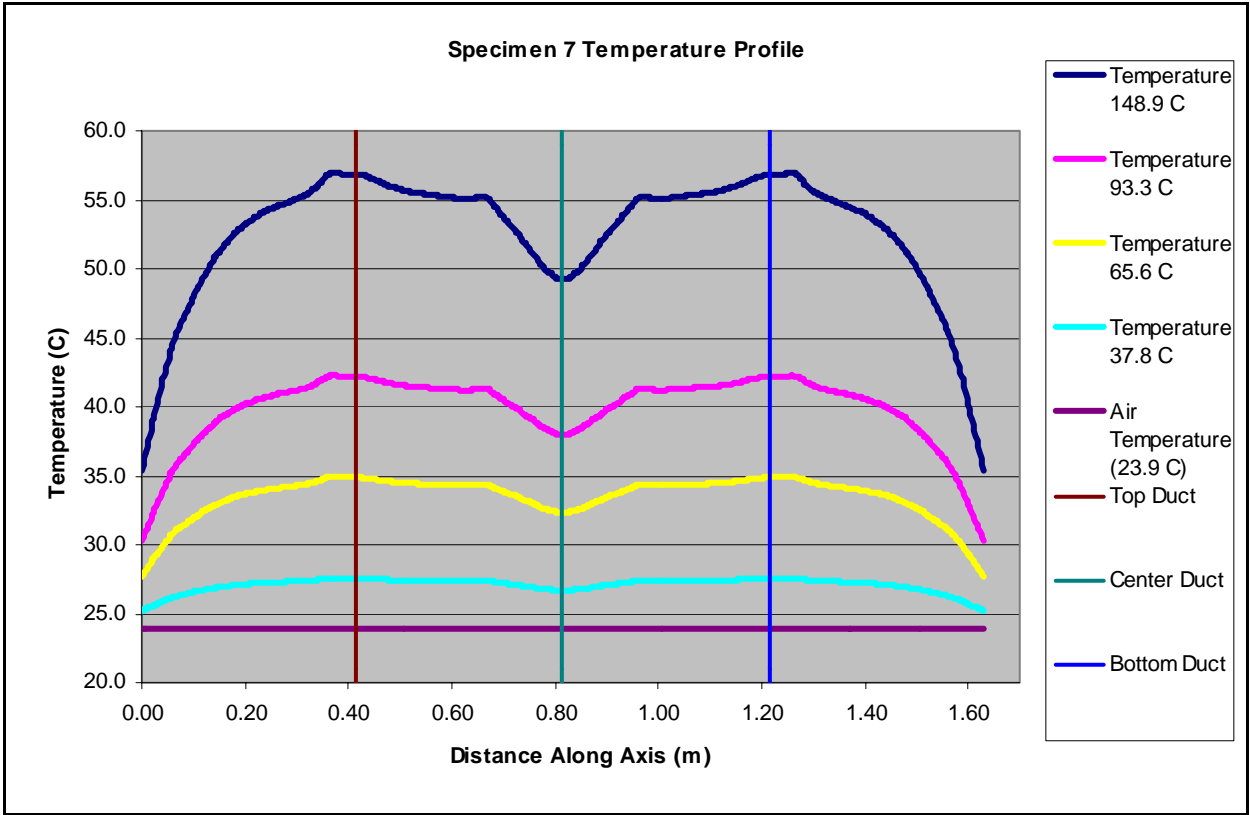
Figure 3.18 - Temperature profile along bottom surface of Specimen 7 for various temperature loadings

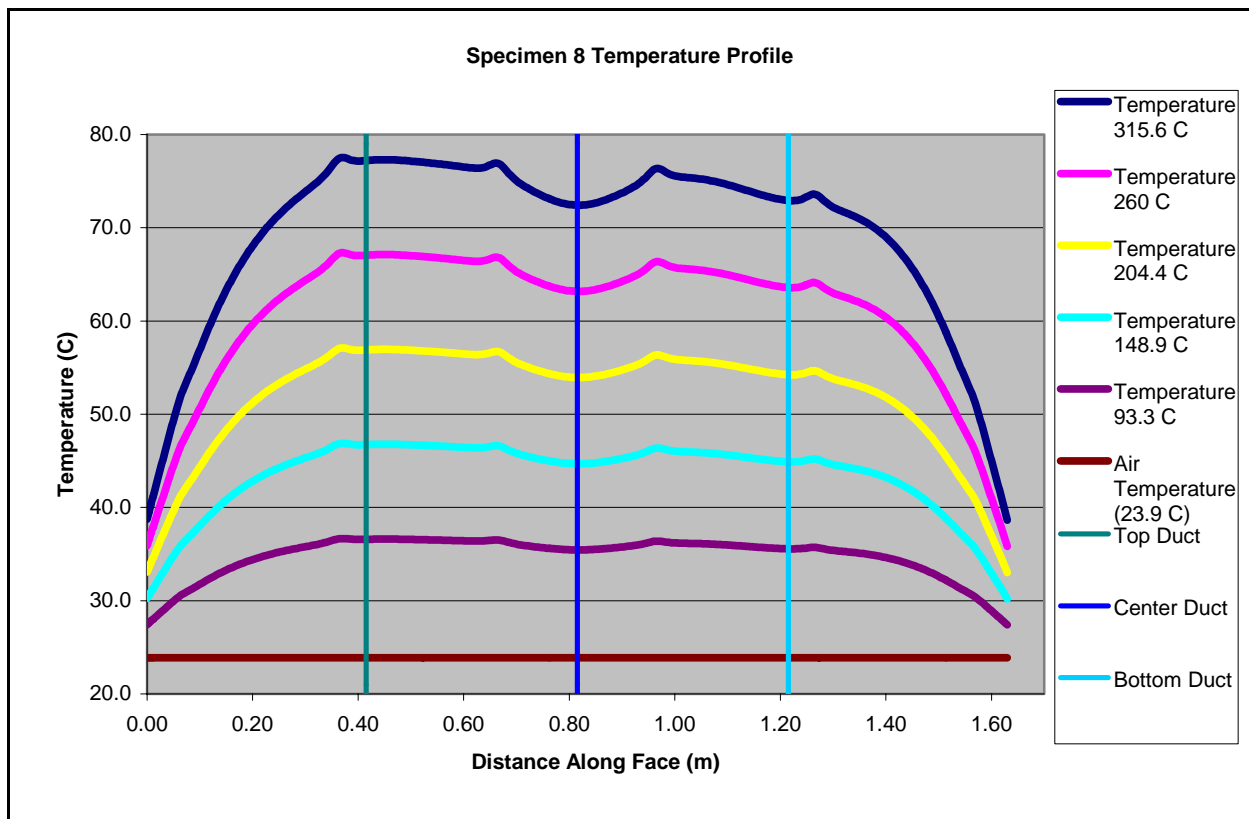
Figure 3.20 - Temperature profile along bottom surface of Specimen 8 for various temperature loadings

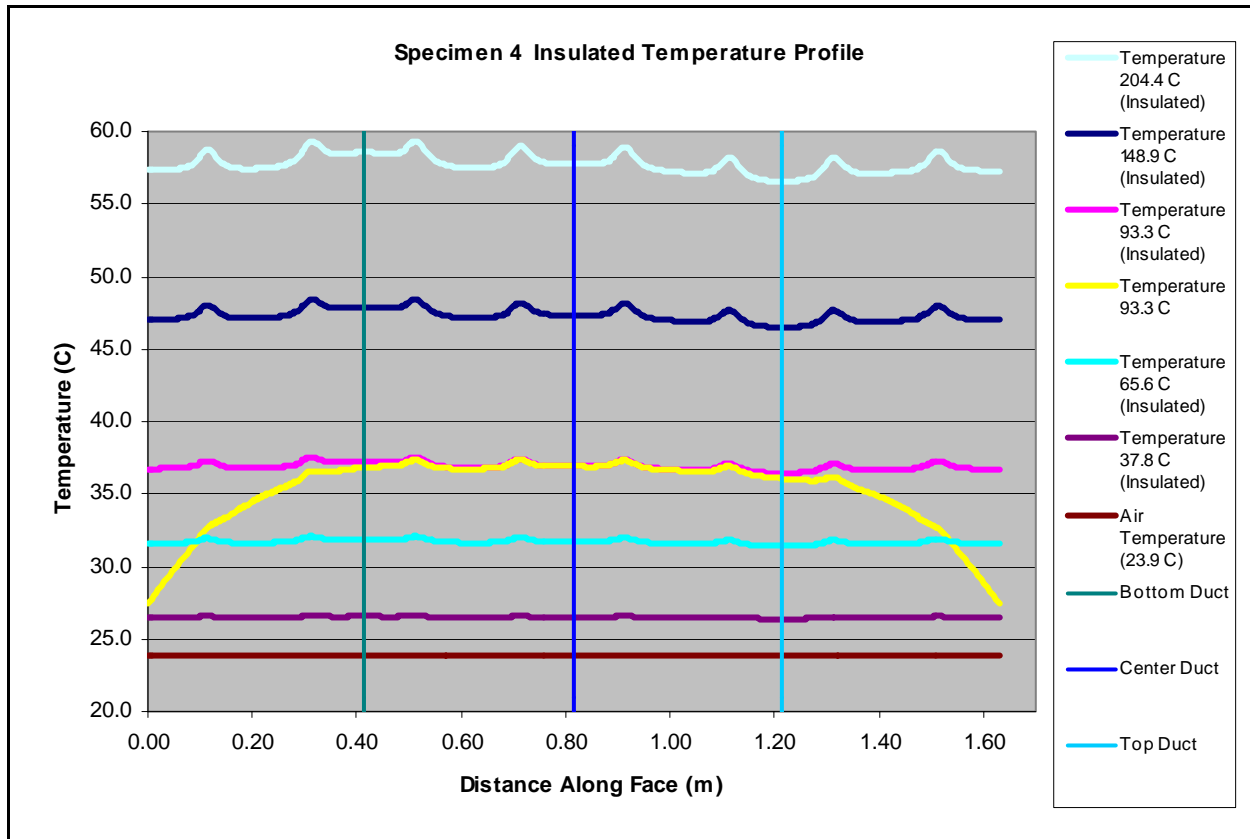
Figure 3.22 - Insulated temperature profile along bottom surface of Specimen 4 for various temperature loadings

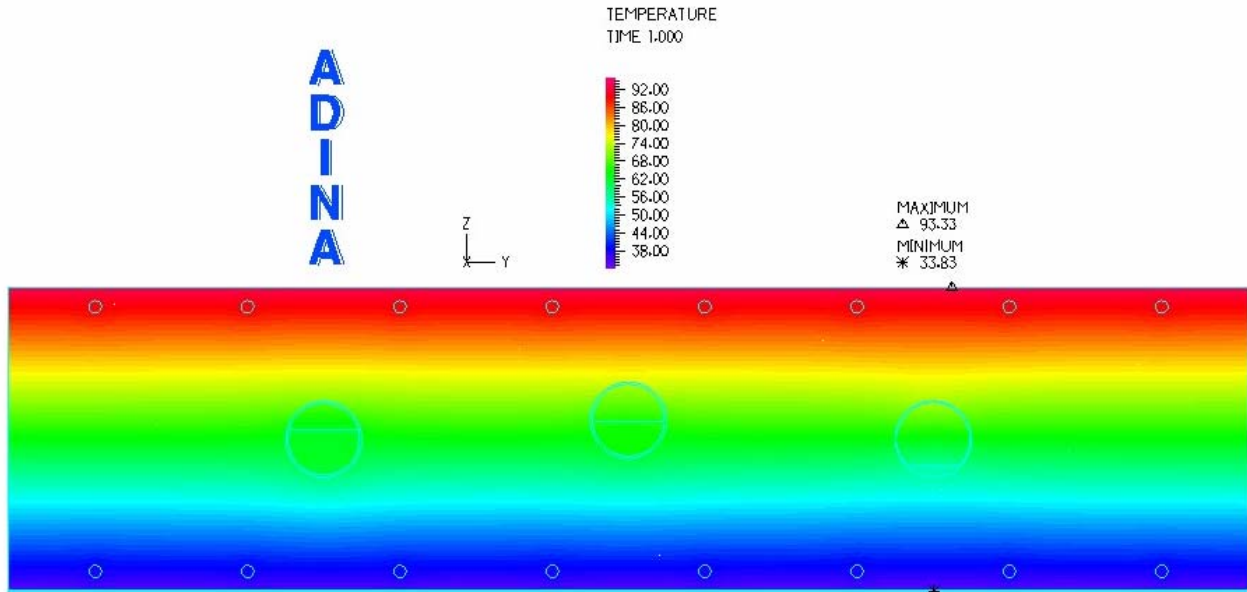
Figure 3.23 - Temperature distribution throughout Specimen 6 with a 93.3°C (200°F) temperature loading with insulated edge elements

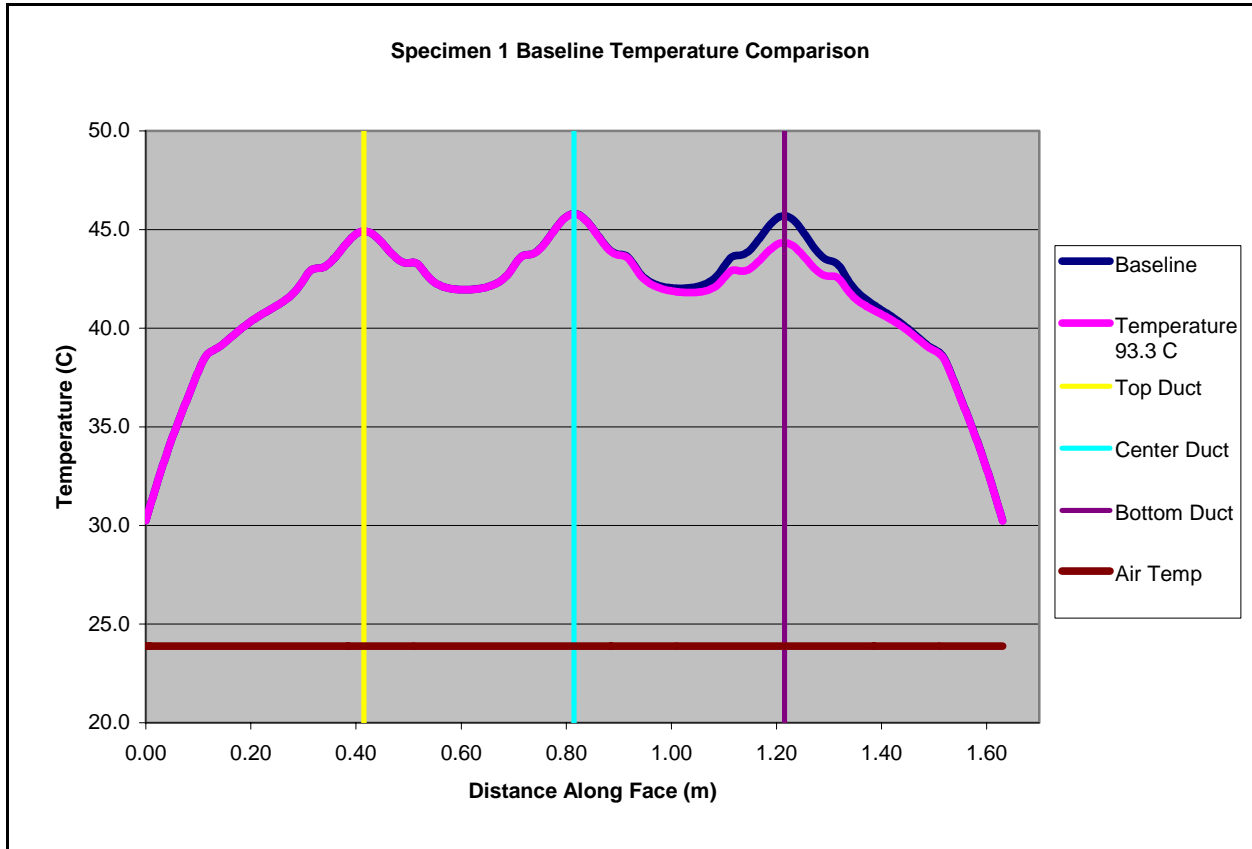
Figure 3.25 – Baseline temperature comparison for Specimen 1

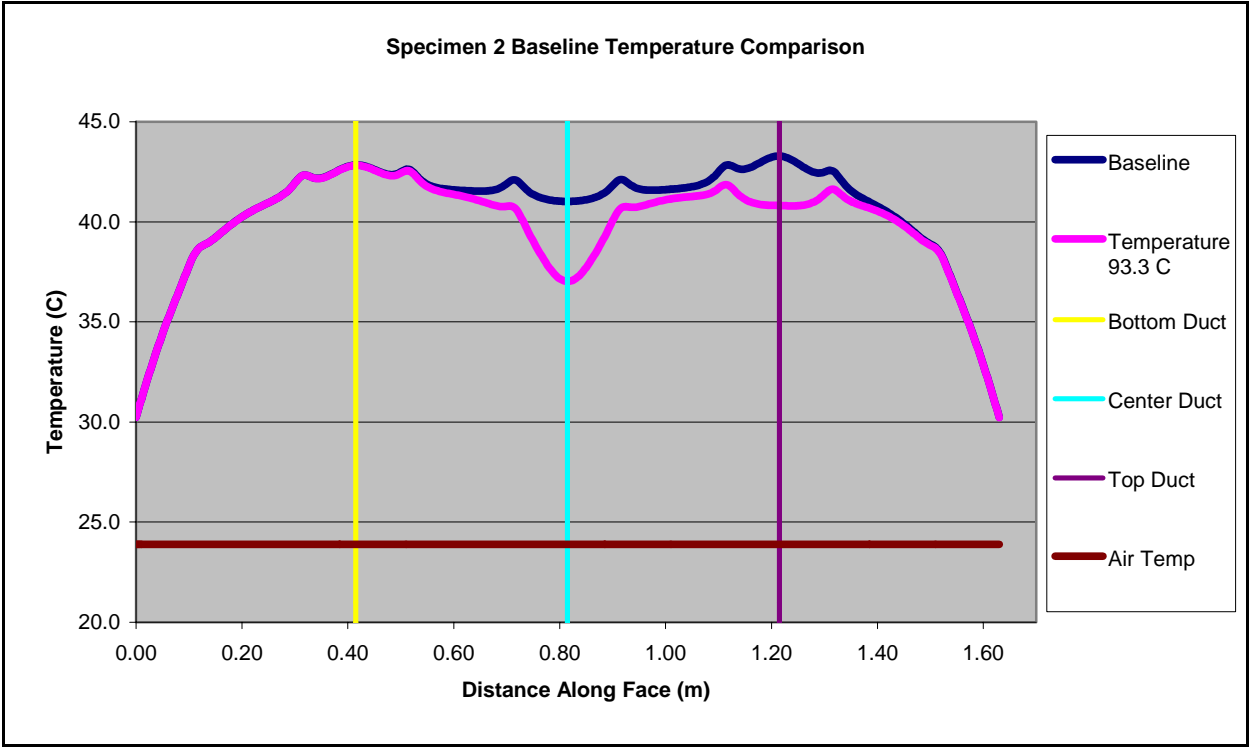
Figure 3.26 – Baseline temperature comparison for Specimen 2

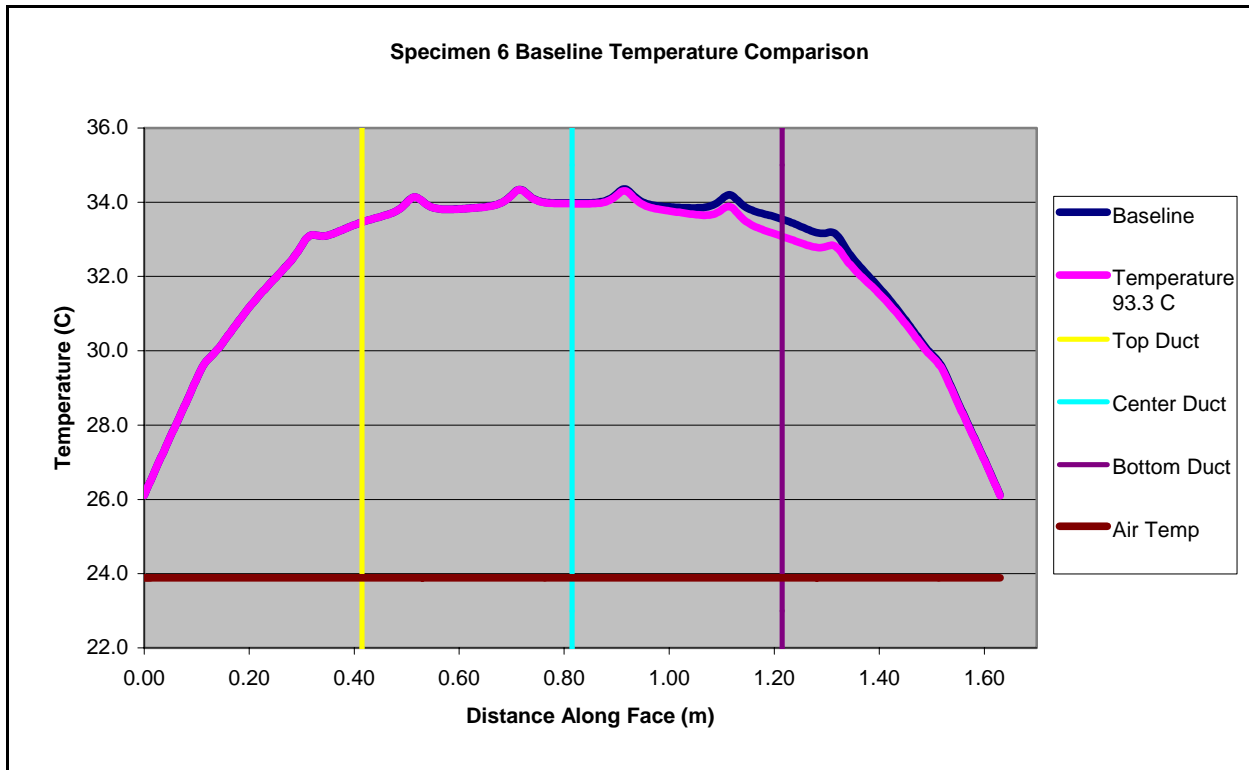
Figure 3.28 – Baseline temperature comparison for Specimen 6

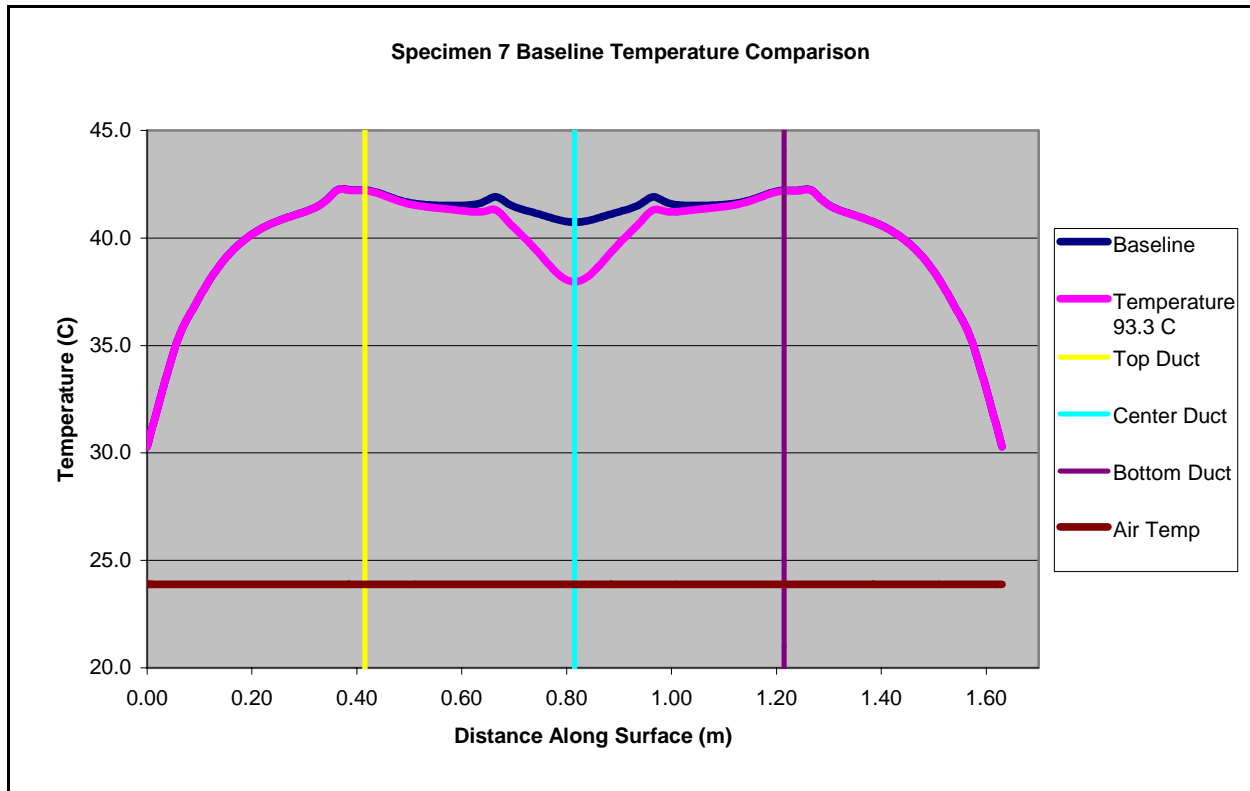
Figure 3.29 – Baseline temperature comparison for Specimen 7

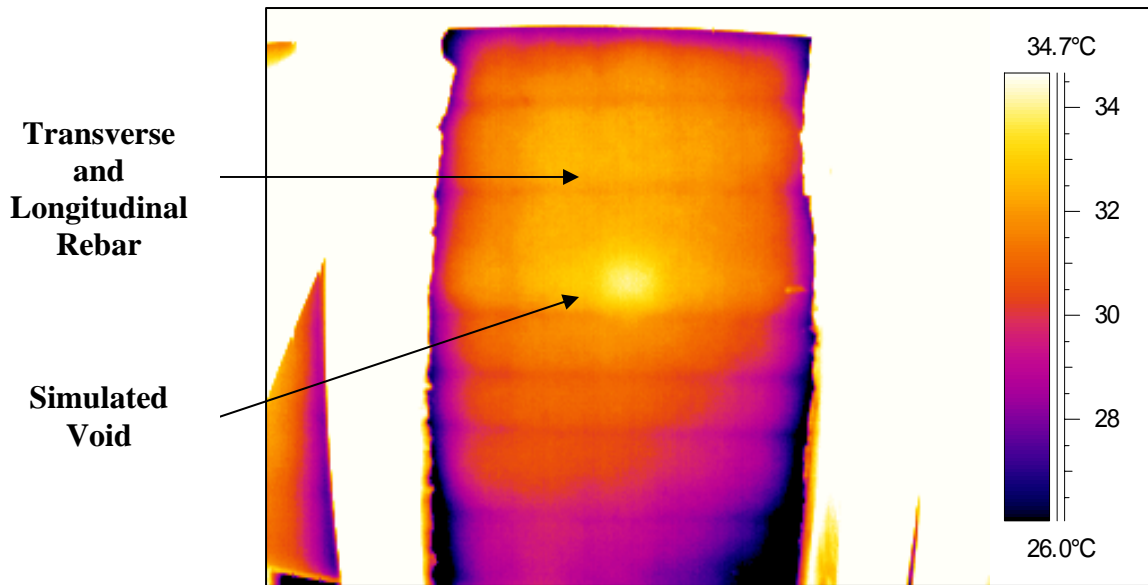
Figure 3.32 - Interior image of Specimen 2 (Pearson, 2003)

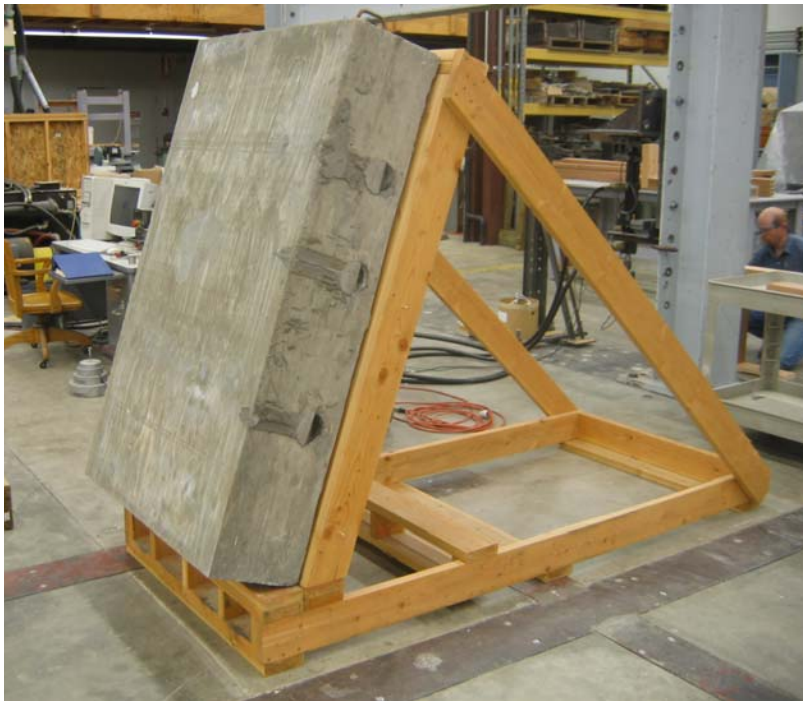
Figure 4.2 – Wood support frame supporting Specimen 8

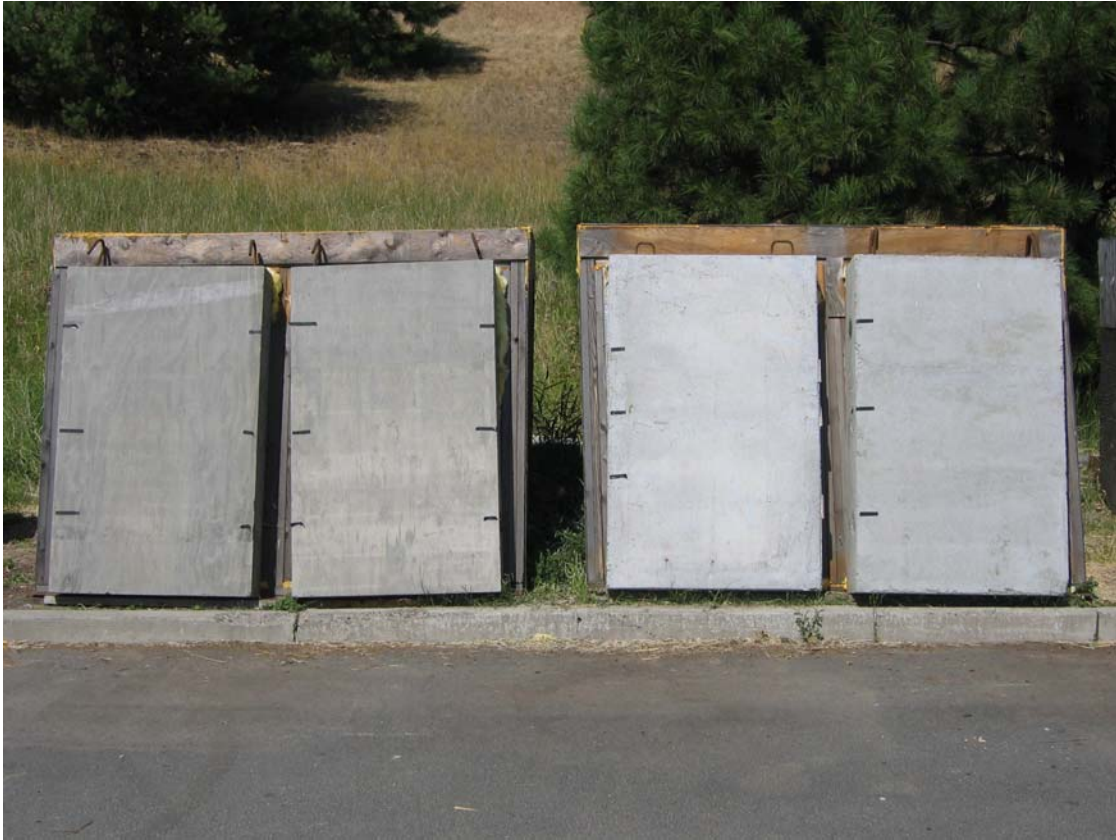
Figure 4.3 – Solar heating test setup

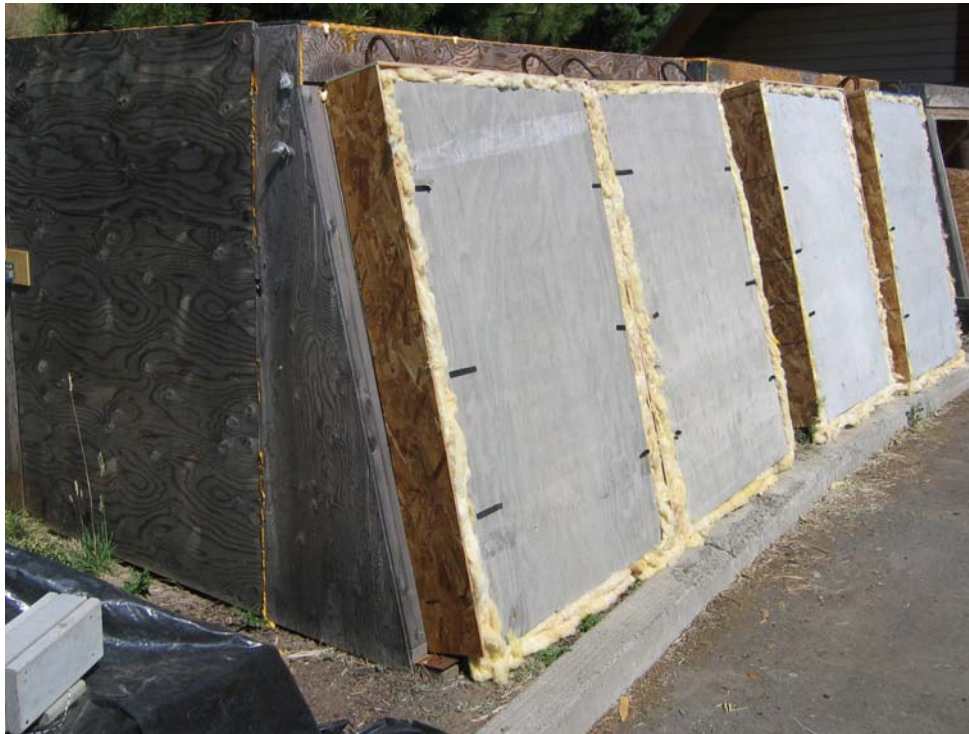
Figure 4.4 – Insulating barriers installed on the specimens

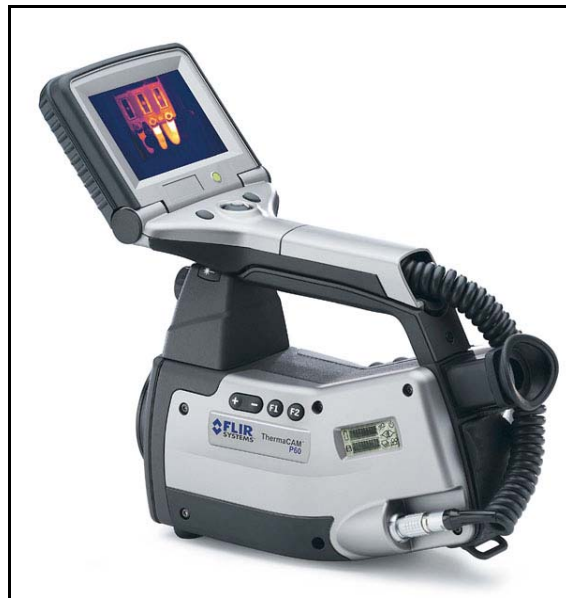
Figure 4.5 – FLIR Systems ThermaCAM P60 (FLIR Systems, 2005)

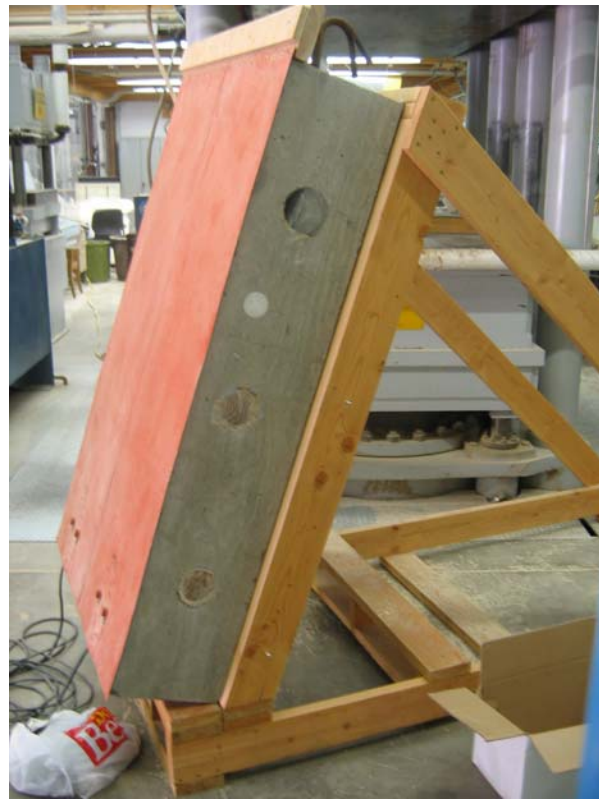
Figure 4.6 – Silicone rubber flexible heating blankets applied to Specimen 4

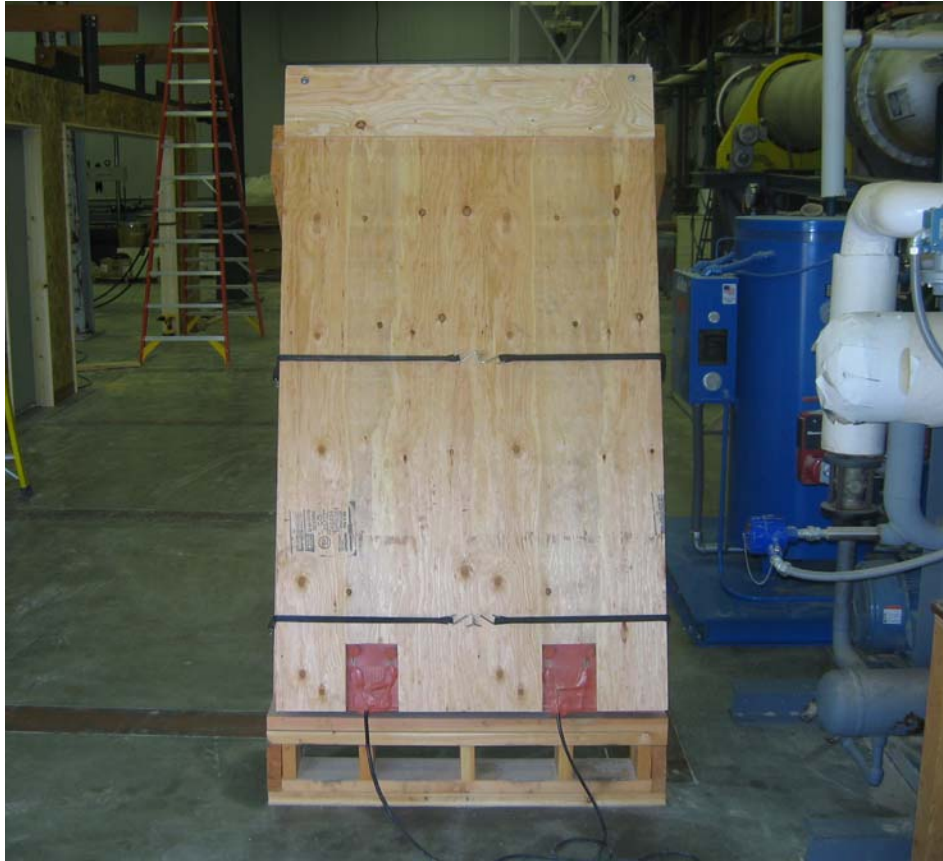
Figure 4.7 – Plywood insulating shield
