BLAST EFFECTS ON PRESTRESSED CONCRETE BRIDGES

A thesis submitted in partial fulfillment of the requirements for the degree of

MASTER OF SCIENCE IN CIVIL ENGINEERING

WASHINGTON STATE UNIVERSITY
Department of Civil and Environmental Engineering

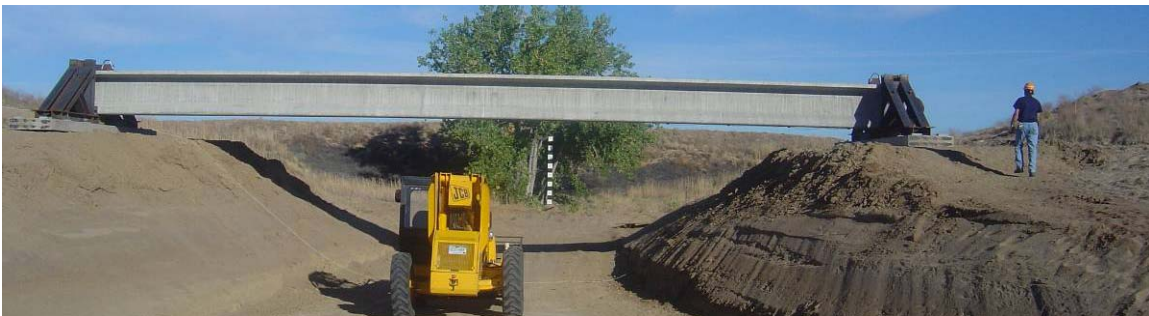
Figure 4-1: Test Setup

For the loading from above scenario, the equivalent of 257 pounds of TNT was used. The analytical model was approximated as 250 pounds. The bottom of the charge was placed three feet above the girder. Accounting for the size of the charge, a standoff distance of four feet was used for the analysis. The container for the explosive fuel resulted in an approximately spherical blast wave, as was modeled in ABAQUS. Figure 4-1 shows the test setup for the girder.

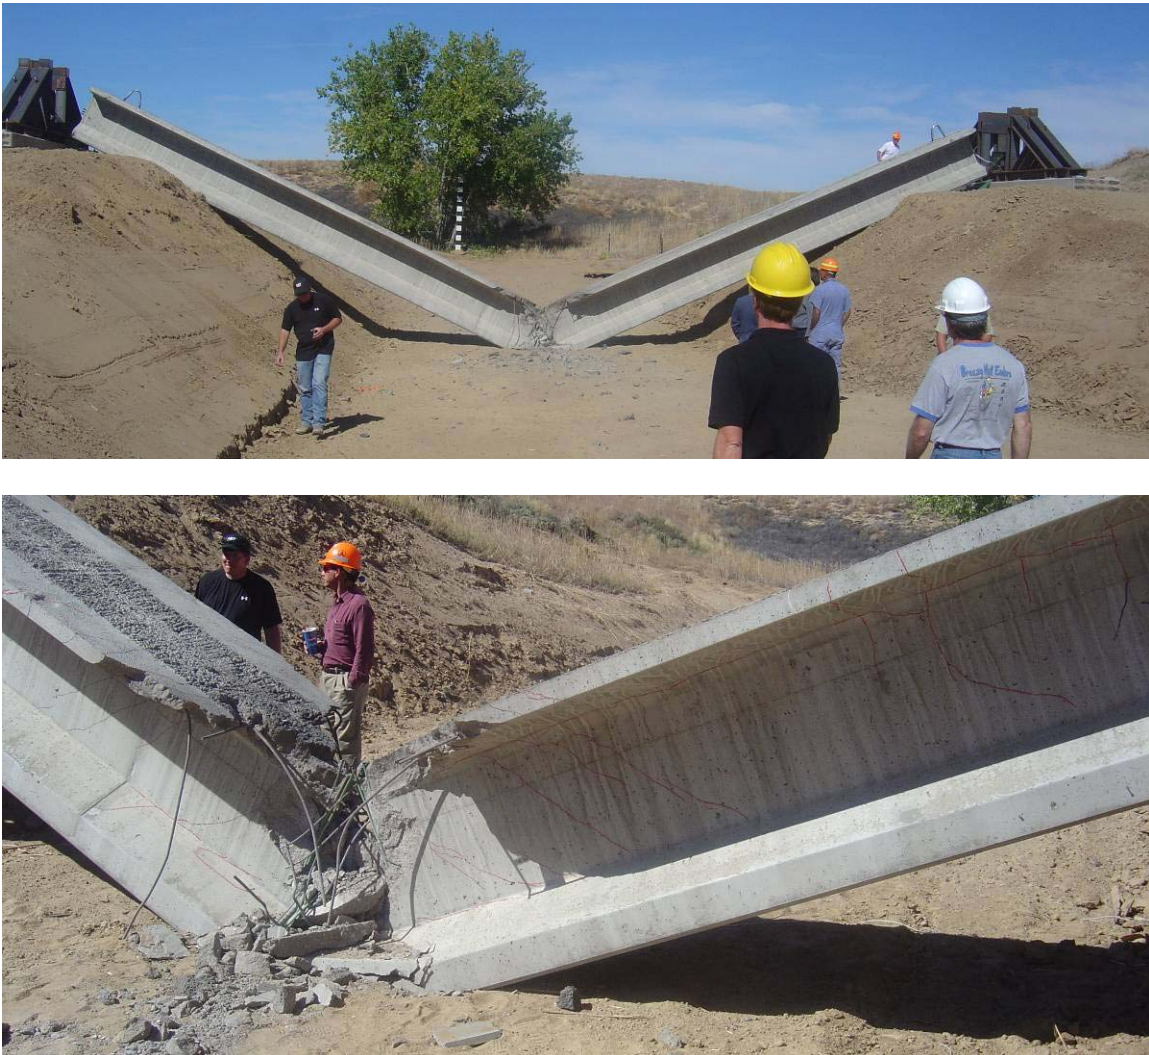
Figure 4-2: Damage from Blast Above, Experimental

Examination of the girder after the test indicated that a little over 3.5 feet of the top flange and web had been rubblized. Additionally, heavy cracking could be seen for about four or five feet on either side of the destroyed web. Figure 4-2 shows the damaged girder.

Near the location of the blast, large 45° cracks were observed. There was also longitudinal cracking on the underside of the flange where it intersected with the web.

This cracking pattern is consistent with shear failure at the location of the blast. Due to the high pressures and rapid application, the pressure wave essentially punched through the girder. The longitudinal cracking also indicates localized flexure of the flange.

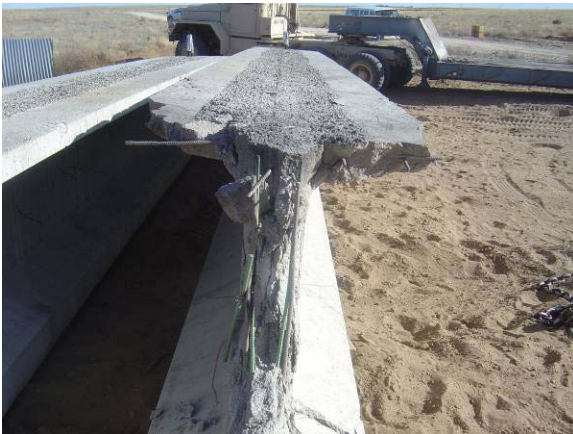
Figure 4-5: Web Cracking-Blast Above, Experimental

Examination of the damaged cross section revealed vertical cracks within the web (shown in Figure 4-5). Investigation of the direction of principal plastic strain within the model revealed the same type of cracking (shown in Figure 4-6).

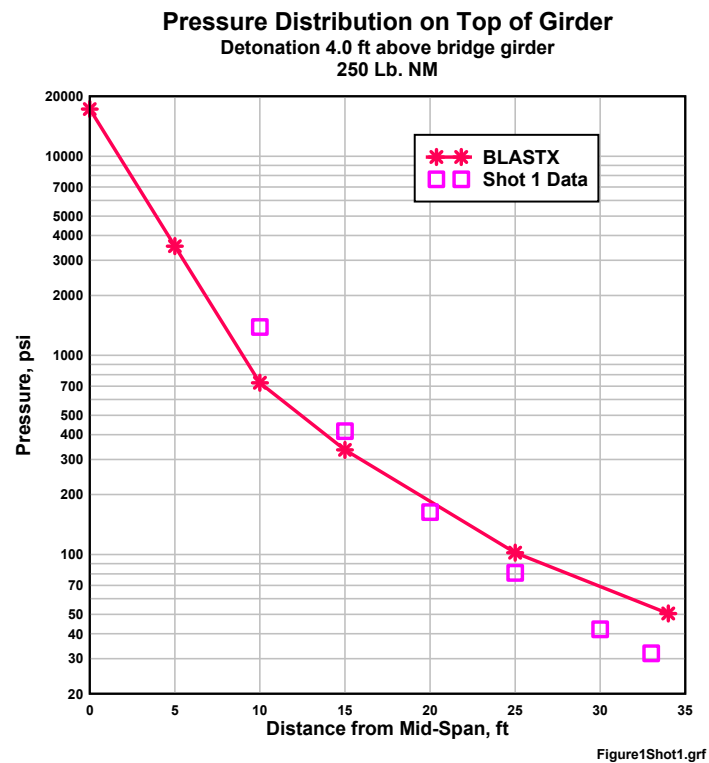
Figure 4-7: Pressure-Girder Blast Above (Ertle, et al., 2008)

Thus, through similar levels of damage and similar directions of stress, the finite element model was deemed to be a reasonable match. Additionally, pressure sensors placed on top of the flange indicate that the pressure predictions from BEL are in good agreement with actual pressures (Ertle, et al., 2008). Figure 4-7 shows predicted and measured values from the test.

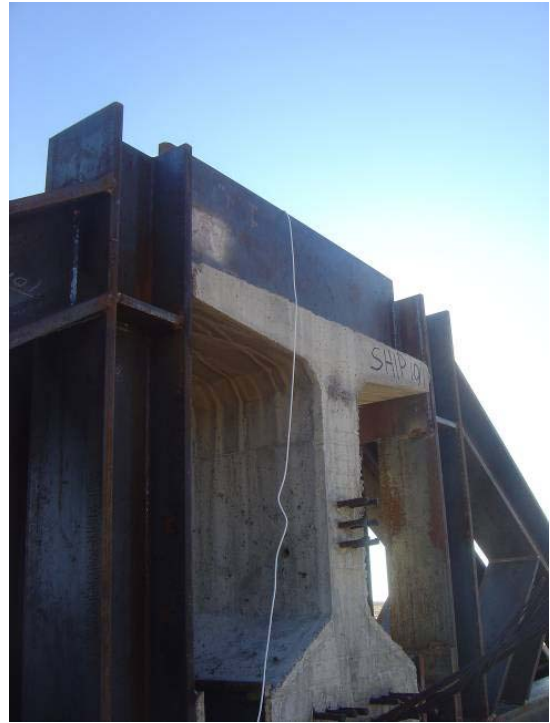
Figure 4-8: Explosion Below-End Support

For the loading below scenario, the equivalent of 530 pounds of TNT at a standoff of about ten feet was used. The analytical model was approximated as 500 pounds. The container for the explosive fuel again resulted in an approximately spherical blast wave, as was modeled in ABAQUS. The girder setup was similar to the loading from above scenario except that additional plates were welded to the supports to hold the girder down. This is shown in Figure 4-8.

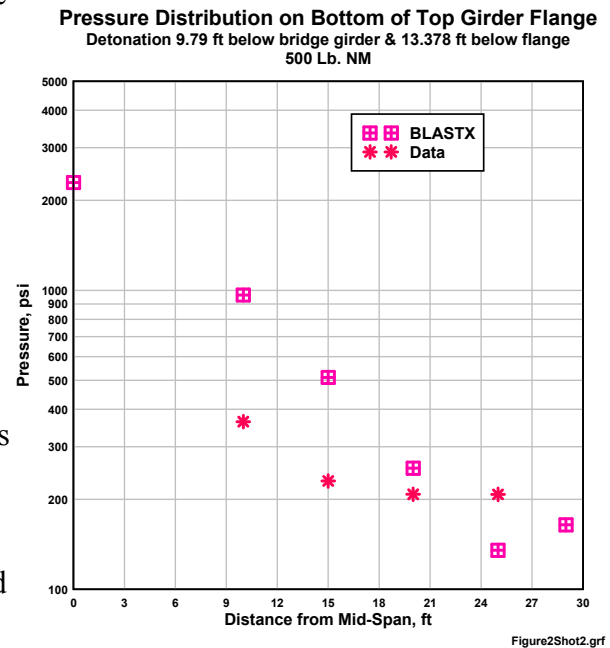
Figure 4-9: Pressure-Girder Blast Below (Ertle, et al., 2008)

Pressure sensors located on the girder once again measured the blast wave. This time however, there was a notable difference between predicted pressures and measured values. It was seen that the pressures obtained from BEL may be two or three times the actual value (Ertle, et al., 2008). This is shown in Figure 4-9. Thus, it is expected that the damage and cracking in the model should be greater than observed. It is noted here that BEL is intended for predicting

pressures on the top of flat bridge decks. It does not have the capability to account for wave reflection off the ground. In addition, it cannot account for the complicated geometry below the bridge deck. Thus, it is not well suited to predicting pressures on anything other than a flat surface. However, it is the best tool available for this research.

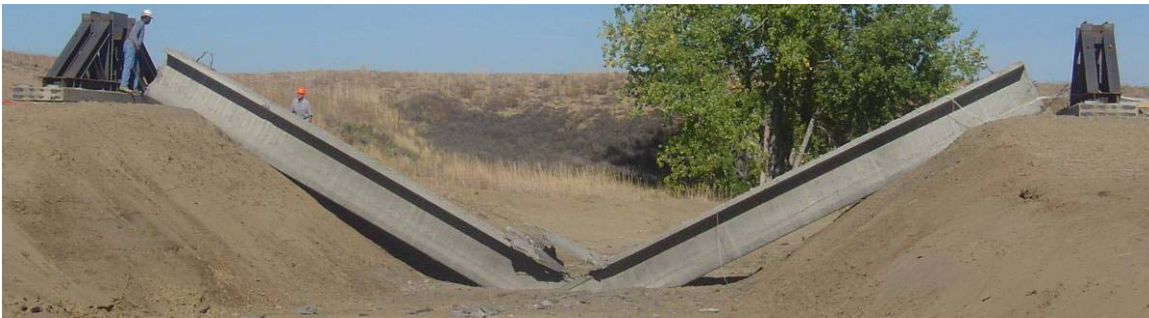
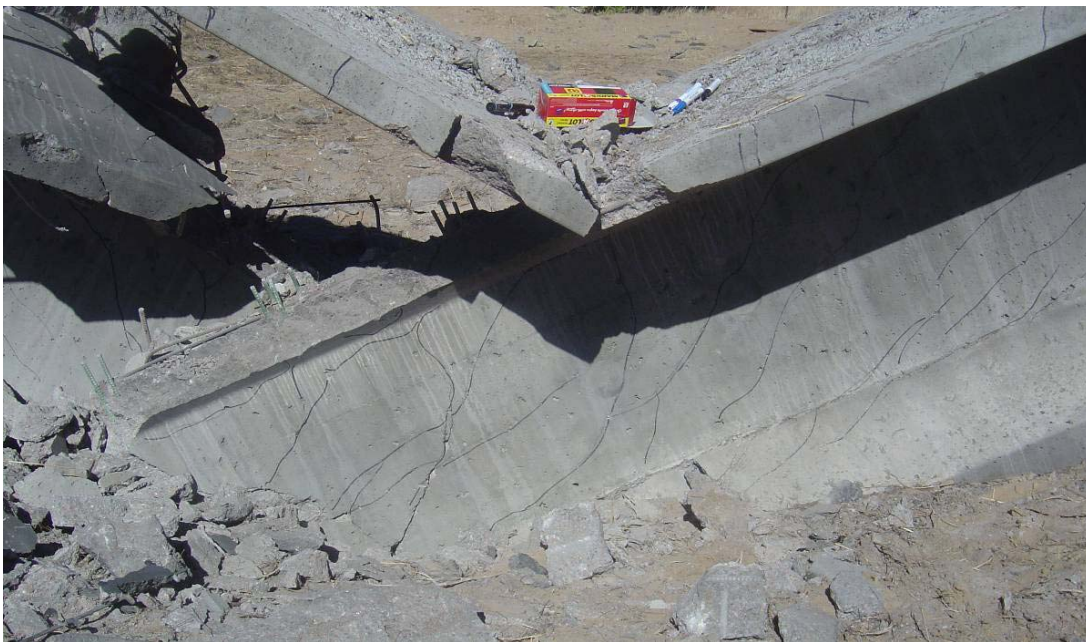
Figure 4-10: Damage from Blast Below, Experimental

Examination of the girder after the test indicated that less than a foot of the web had been rubblized, although a length of about nine feet was missing from the top flange. It is noted that the detached top flange may have been a result of the girder falling rather than an exclusive result of the blast wave. Additionally, heavy cracking could be seen for about 10 feet on either side of the destroyed web. Figure 4-10 shows the damaged girder.

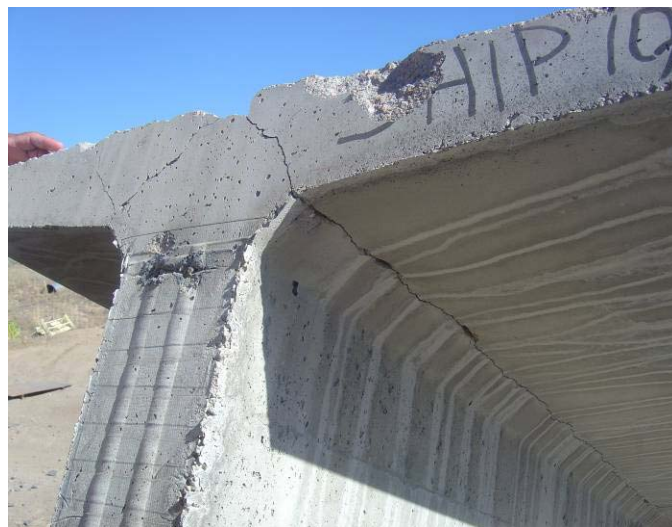
Figure 4-11: Longitudinal Cracking at Web-Flange Intersection

Near the location of the blast, large 45° cracks were again observed. These were oriented in the opposite direction of the blast from above scenario, as would be expected. This cracking pattern is consistent with shear failure at the location of the blast, similar to the first scenario. Longitudinal cracking was also observed in this case, but to a much larger degree than before. Figure 4-11 shows this cracking pattern.

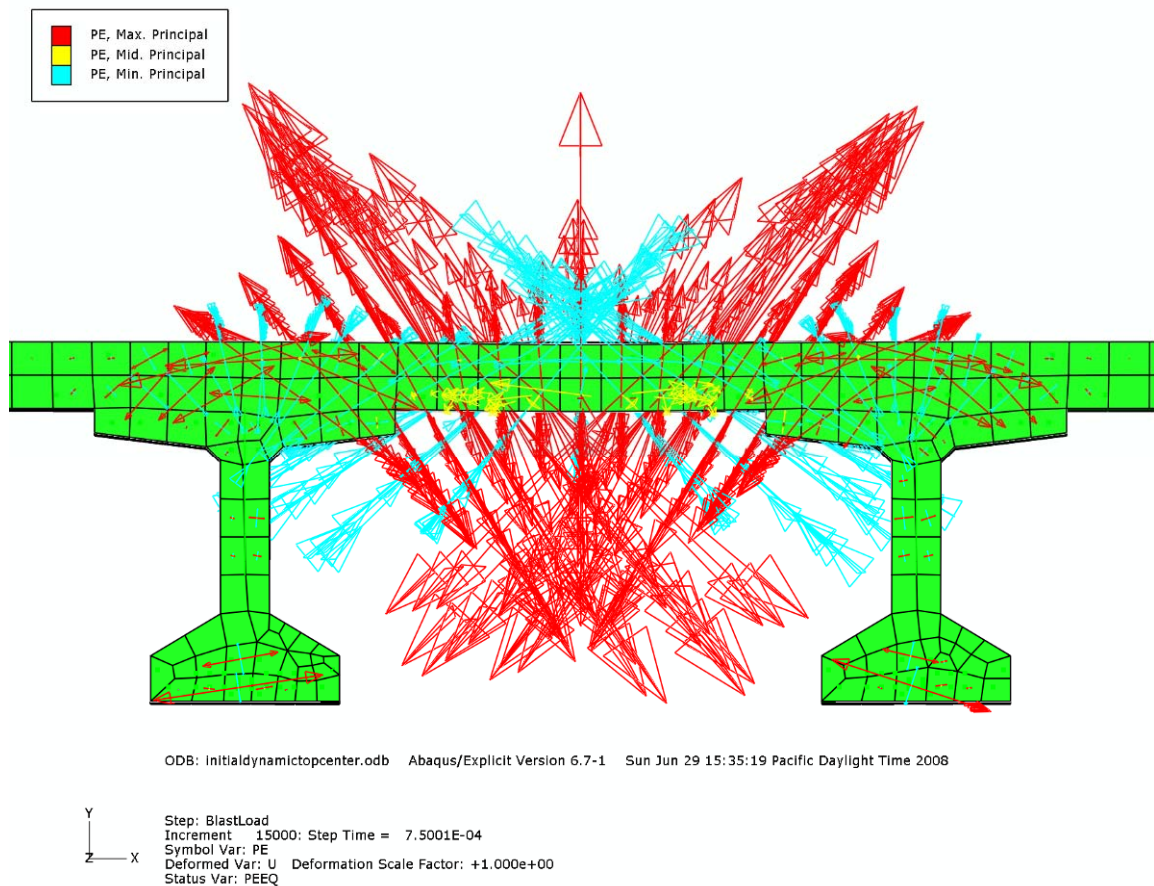
Figure 5-3: Cracking Direction-Blast Above, Between Girders

Examining the direction of principal plastic strain illustrates again that shear is the predominant form of failure. At less than one millisecond into the analysis, when the pressure wave is still being applied, the strong tendency to punch through the deck can be seen. This is shown in Figure 5-3.

These results imply that at this level of blast, the bridge would not be destroyed. If the bridge was wide enough, the area with the damaged slab could even be blocked off and the rest of the lanes of traffic could be immediately reopened.
